# **China Lake Shoreline and Stream Survey 2003**

Surveyors:  
David Landry, China Lake Association  
Jenna Richardson, China Region Lakes Alliance

# Shorefront and Stream Survey: West Basin 2003

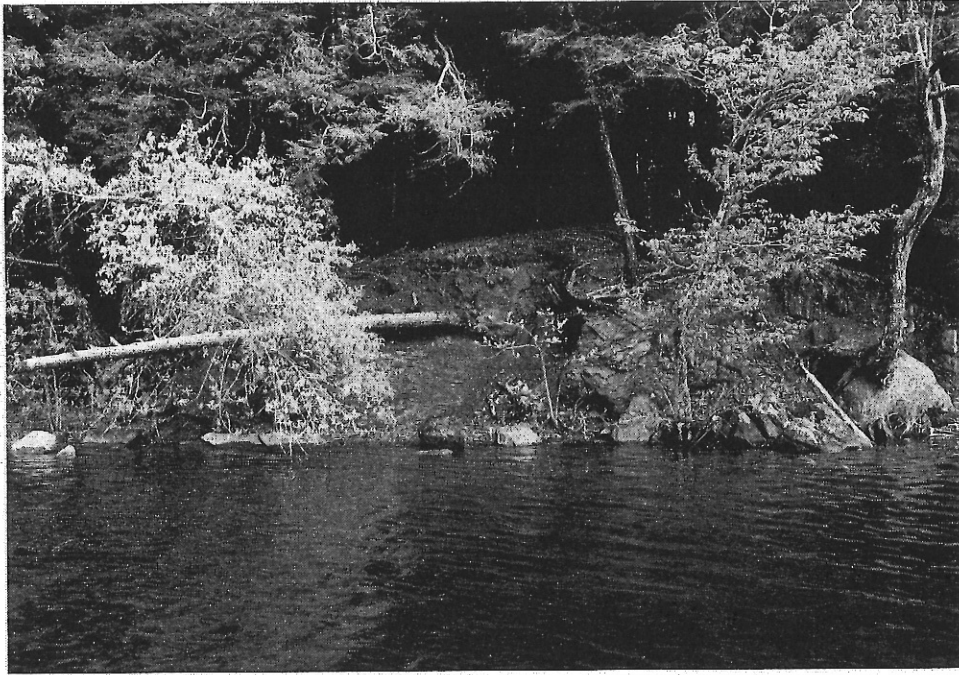
Site 44

Site #	Site Description	How many photos?	Linear Feet of erosion
44	Upland erosion just East of KWD beach on North side of the narrows. Very steep slope.	1	10
45	50 Feet of low level erosion, but well vegetated	1	50
46	Very small amount of erosion, potential for much more if the water level is raised, 30 Ft. section	1	30
47	Minor eroding area, 100 ft., soft shore, but not much wave action in cove.	1	100
48	Evidence of past "ice-barging" of rock. No evidence of recent vegetation or soil damage.	2	-
49	150 Ft. of "at risk" area that might erode with higher lake levels	1	150
50	5-6 ft. of bare soil, where tree is being undercut, next to Shorey property	1	6
51	100 ft. of "at risk" area, very low in water with no rip rap barrier, just beyond Shorey Brook	1	100
52	100 ft. of "at risk" area	1	100
53	120 ft. of low shoreline with slight erosion, near beaver dam that is next to Mile Shoal, some dirt coming from under the trees	1	120
