# **China Lake Shoreline and Stream Survey 2003**

# **Shorefront and Stream Survey: West Basin 2003**

# West Basin Shorefront and Stream Survey 2003

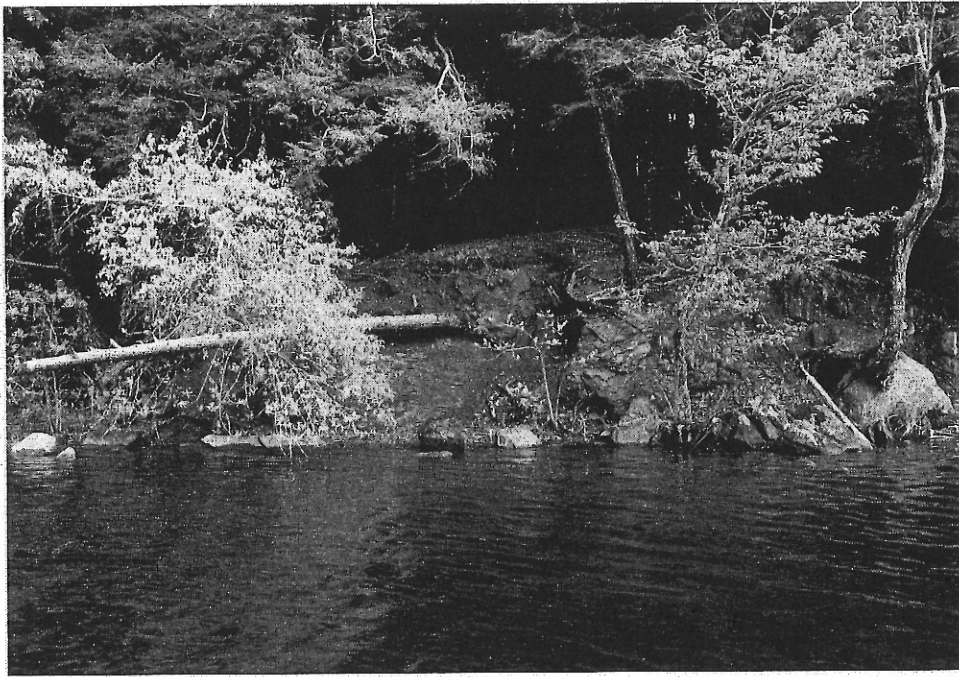
Site 44

Site #	Site Description	How many photos?	Linear Feet of erosion
44	Upland erosion just East of KWD beach on North side of the narrows. Very steep slope.	1	10
45	50 Feet of low level erosion, but well vegetated	1	50
46	Very small amount of erosion, potential for much more if the water level is raised, 30 Ft. section	1	30
47	Minor eroding area, 100 ft., soft shore, but not much wave action in cove.	1	100
48	Evidence of past "ice-barging" of rock. No evidence of recent vegetation or soil damage.	2	-
49	150 Ft. of "at risk" area that might erode with higher lake levels	1	150
50	5-6 ft. of bare soil, where tree is being undercut, next to Shorey property	1	6
51	100 ft. of "at risk" area, very low in water with no rip rap barrier, just beyond Shorey Brook	1	100
52	100 ft. of "at risk" area	1	100
53	120 ft. of low shoreline with slight erosion, near beaver dam that is next to Mile Shoal, some dirt coming from under the trees	1	120

<b><u>Site #</u></b>	<b><u>Priority</u></b>	<b><u>Comments</u></b>
<b>57</b>	<b>High</b>	<b>Severe erosion</b>
<b>44</b>	<b>High</b>	<b>Steep slope, severe erosion</b>
<b>55</b>	<b>High</b>	<b>Slumping shoreline, large area</b>
<b>50</b>	<b>Medium</b>	<b>Severe erosion but very small area</b>
<b>53</b>	<b>Medium</b>	<b>Slight erosion, large area</b>
<b>47</b>	<b>Low</b>	<b>Minor erosion</b>
<b>54</b>	<b>Low</b>	<b>Steep bank, but mostly vegetated</b>
<b>45</b>	<b>Low</b>	<b>Minor erosion</b>
<b>46</b>	<b>Low</b>	<b>Minor erosion</b>

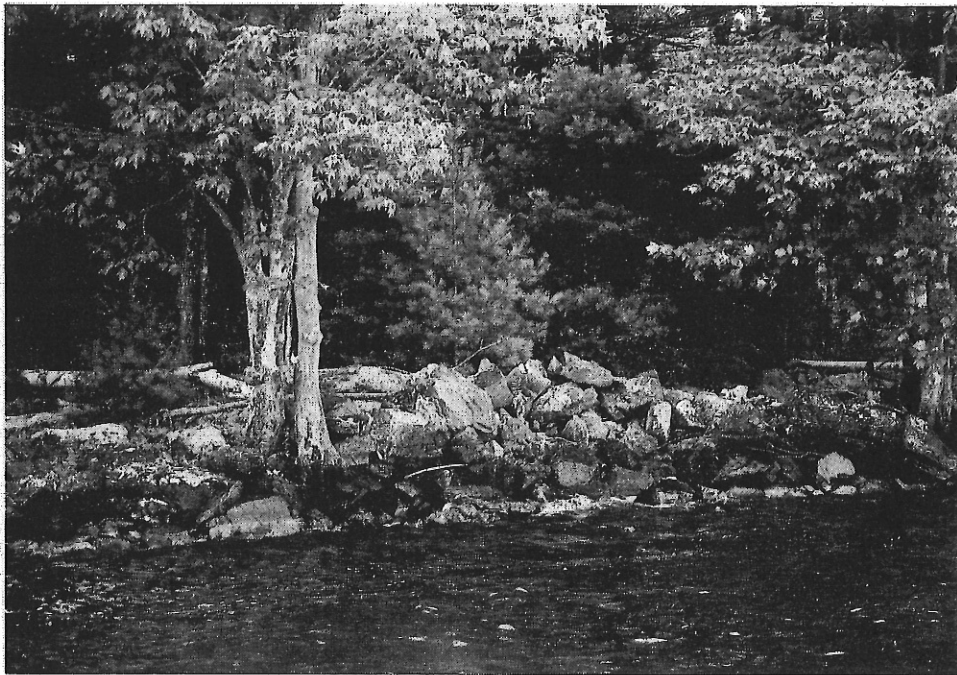
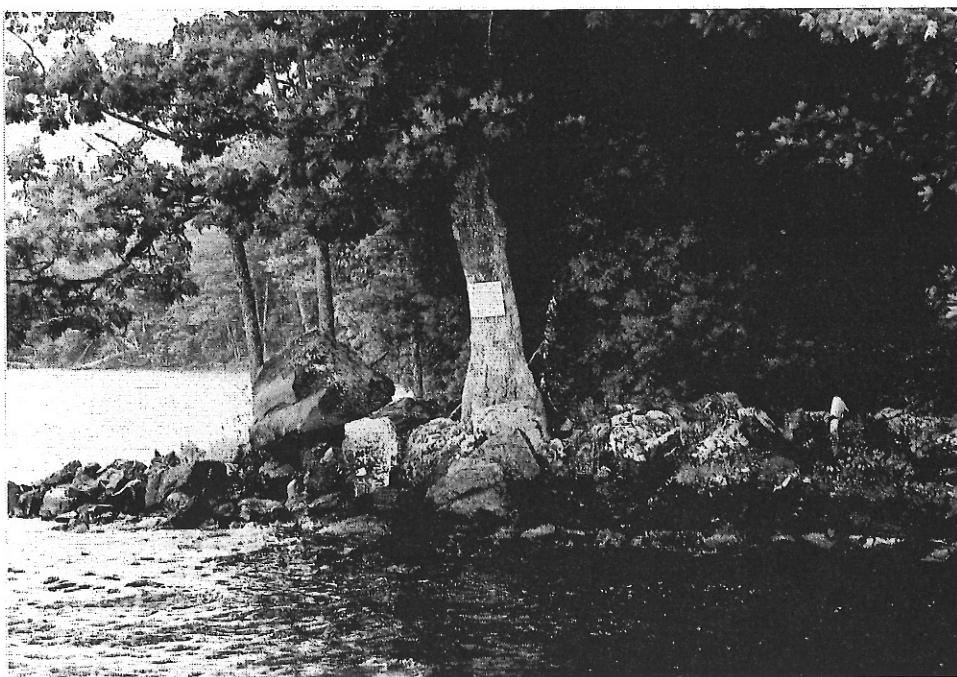
Site 48a

Site 48 was not an eroding site. It was included to show "ice-barging" that sometimes occurs to large rocks. Local residents familiar with this part of the lake report that rocks have been stable for the past 20 years.

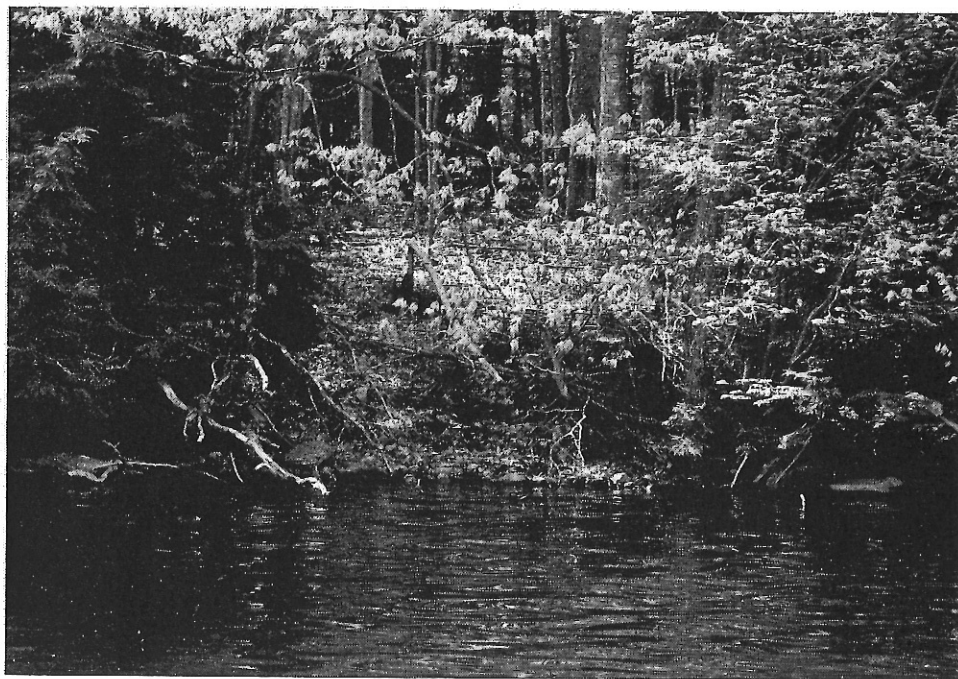
Site 54

54	Steep bank, mostly vegetated, but slightly eroding	1	75
55	350ft. of slumping shoreline, next to the new house in boggy, wetland cove	1	350
56	250 ft. of "at risk" area, no active erosion, but low shoreline	1	250
57	Bank collapsing: 40 ft across with 5 ft. face, upland erosion, severe	1	40

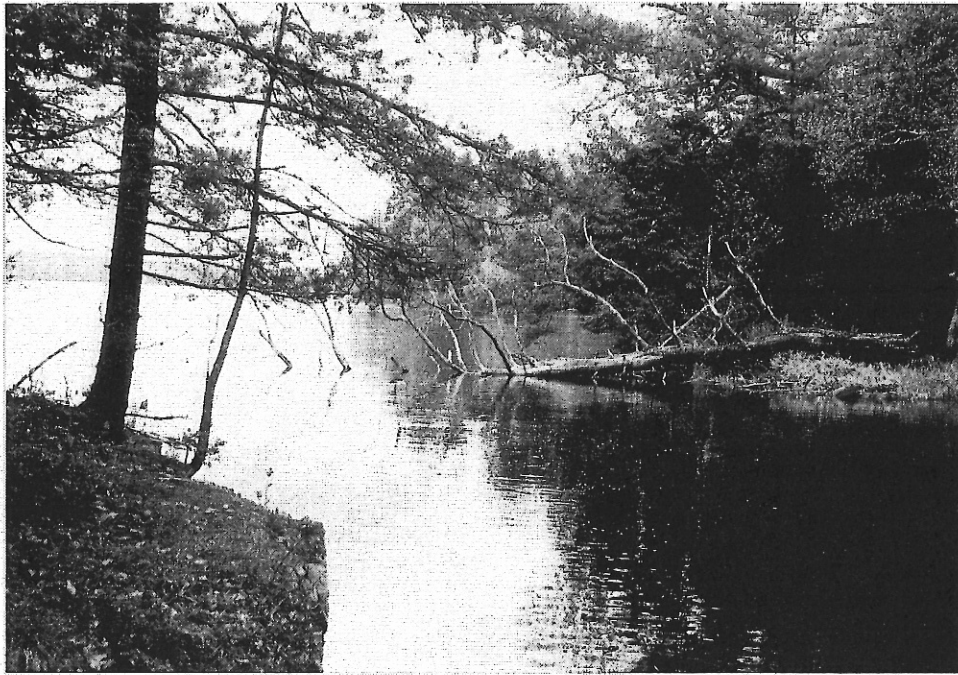
Site Q

**Q. Ward Brook-** this stream is the largest contributor to the West Basin draining several square miles of land. Between the lake and the Stanley Hill Road, the watershed of the brook contains forested land with no recent logging activity and a 20 acre upland pond. Closer to the Stanley Hill Road is a 15 acre wetland. The brook traverses the Stanley Hill Road East of Meadow Brook Farm. The headwaters of the brook are West of the Maple Ridge Road with the course between the Maple ridge and Stanley Hill Road being mainly undisturbed woodlands. Some light logging is taking place in this area. The stream is stained with tannins South of the Stanley Hill Road but is free of suspended matter.

Site	Site Description	How many photos?
Q	Ward Brook: moderate flow, tannins in water make it appear brownish, but it is clear, no sedimentation, 3 ft. deep in inlet area, well vegetated stream banks	1
R	Small intermittent stream: low flow, about a foot wide, but probably not draining a large area, also probably dries up in the summer, running clear	3
S	"Bog Brook" Running clear from a large bog: moderate flow, Signs of human activity along the shore of the stream from many years ago. Wide stream and no undercutting, well vegetated, running clear	2
T	"West Vassalboro Stream" Low flow, drainage from West side of Vassalboro boat landing, drains from farm up the rd. at the four corners, running clear	2
U	Roadside drainage ditch, East of Vassalboro boat launch, comes from across Rt. 32, low flow, except in heavy rain when the retention pond it comes from overflows into the lake	2
V	"Shorey Brook" moderate flow, 3 ft across, a little smaller than Bog Brook, flowing heavily over many rocks, crystal clear	3

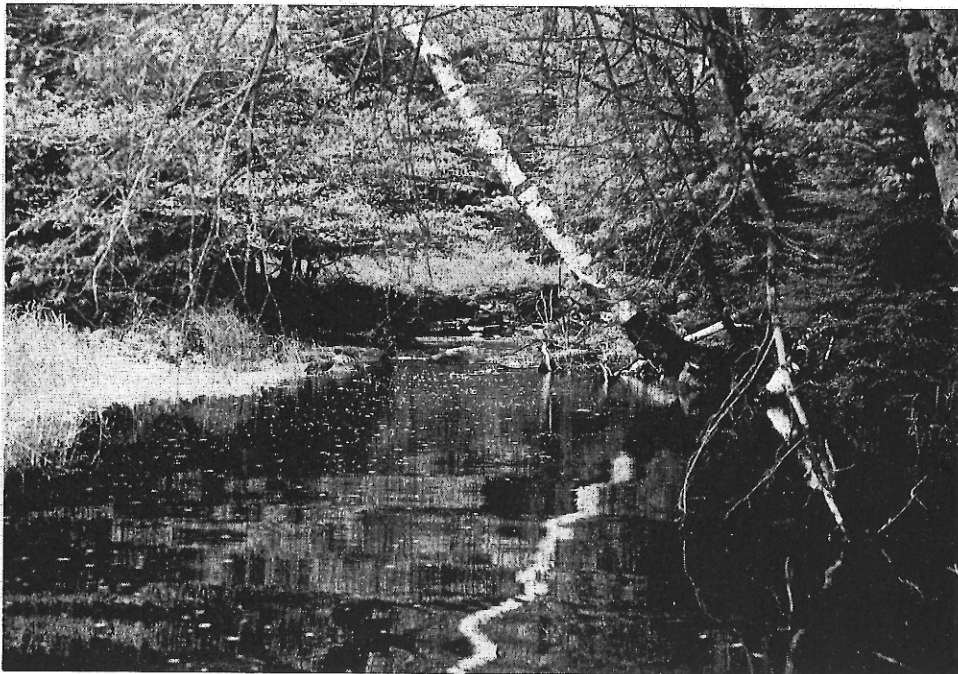
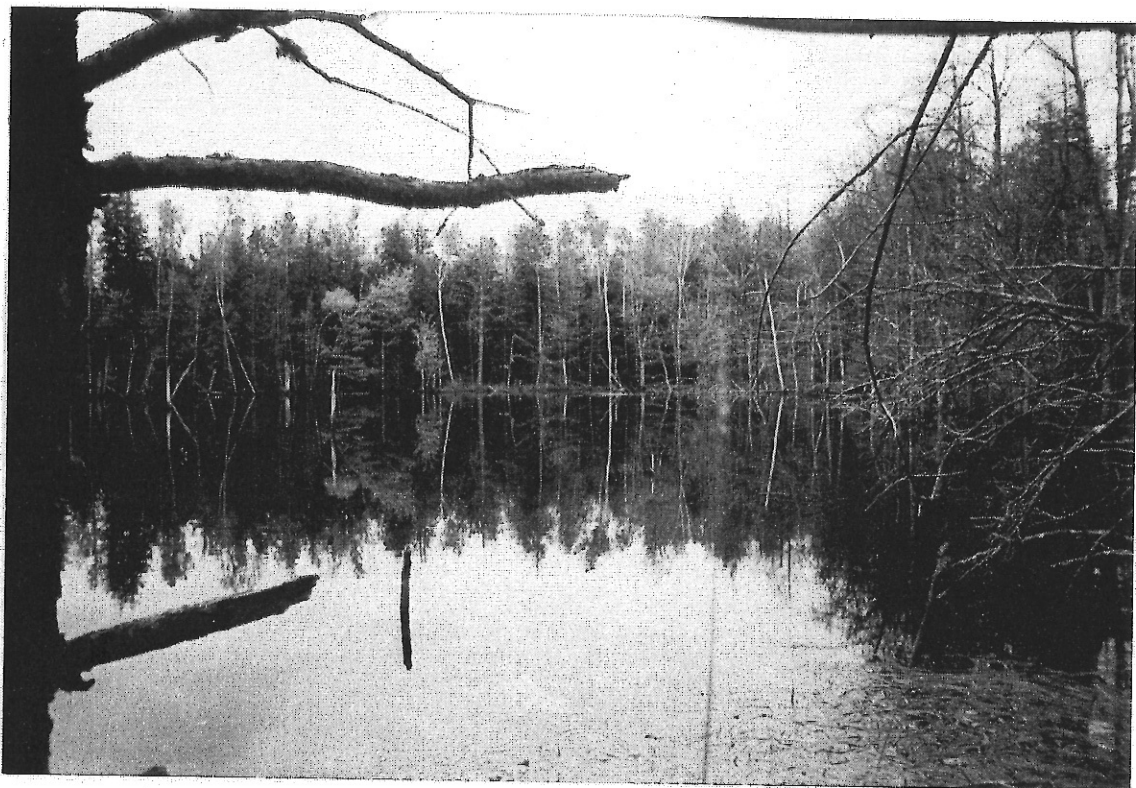
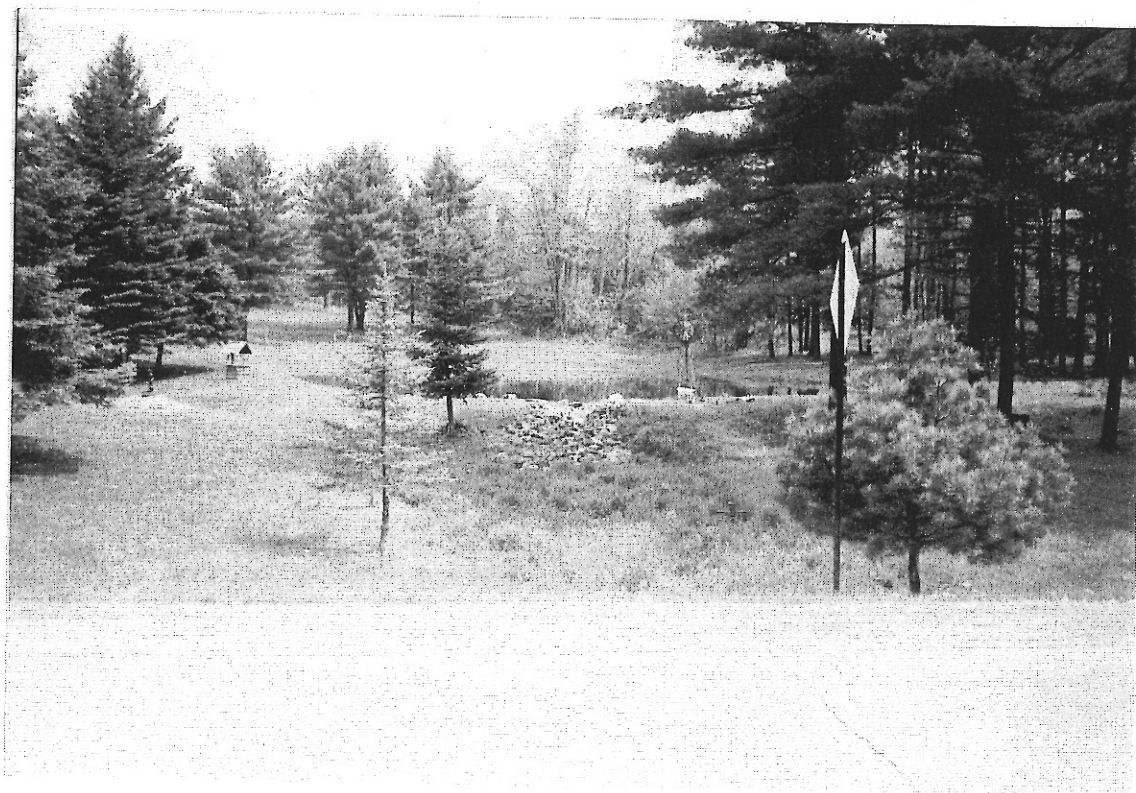
Site Ra

**R. Small intermittent stream with minimal flow.** This stream has two small contributing branches starting North of the Stanley Hill Road. One branch is from a manmade pond (photo) on the East side of a residential property with a smaller branch being found on the West side of the house. Both branches cross the road in culverts join and the flow down to a 5 acre pond (photo) . Minimal flows are noted from the pond to the lake and locals note water flows only in very wet times.

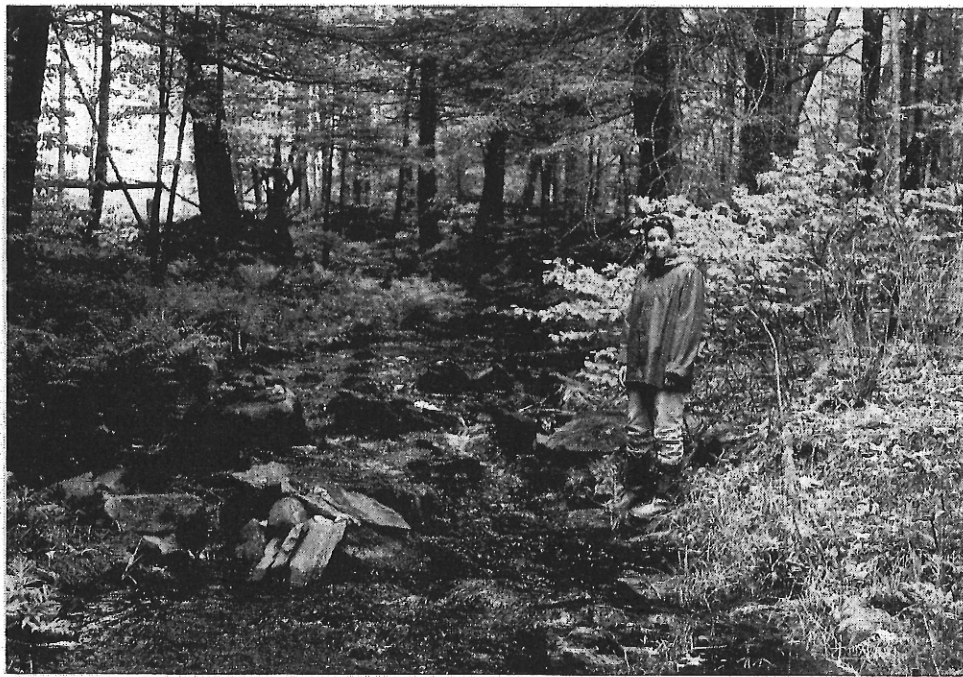
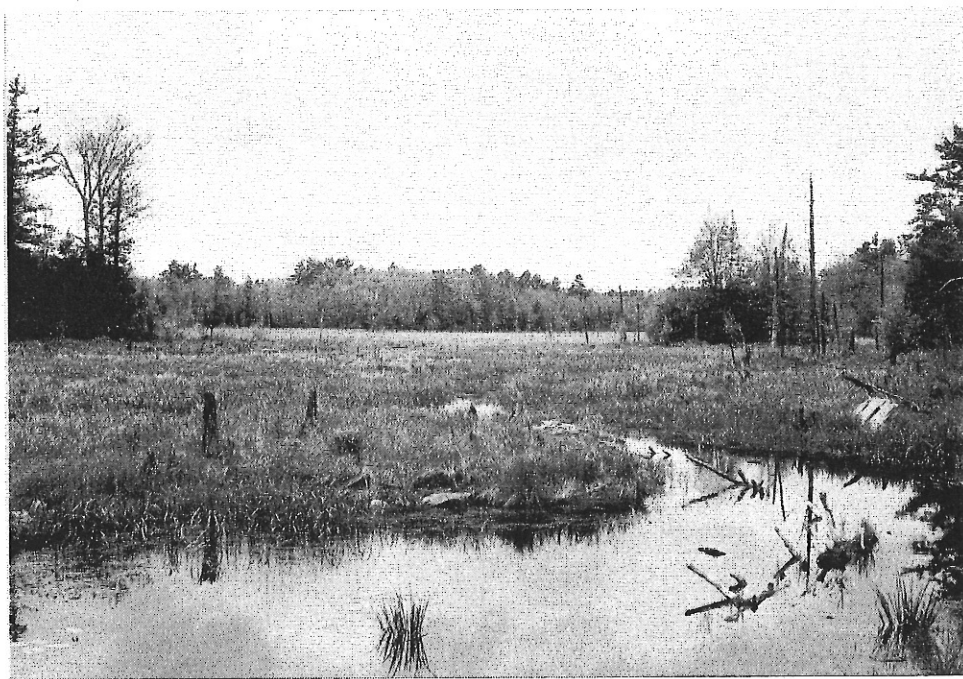
Site Sa

**S. "Bog Brook"** runs clear (photo) from a 20 acre bog (photo) located 300 feet from the lakes edge. Signs of human activity along the stream and bog from many years ago are noted including an old dam at edge of bog. The source of the water is the land at the junction of the Brann road and the Stanley Hill Road. It is noted that a junk yard lies along and in some of the wet land above the bog. This brook is second in water volume (for the west basin - Ward brook being the biggest).

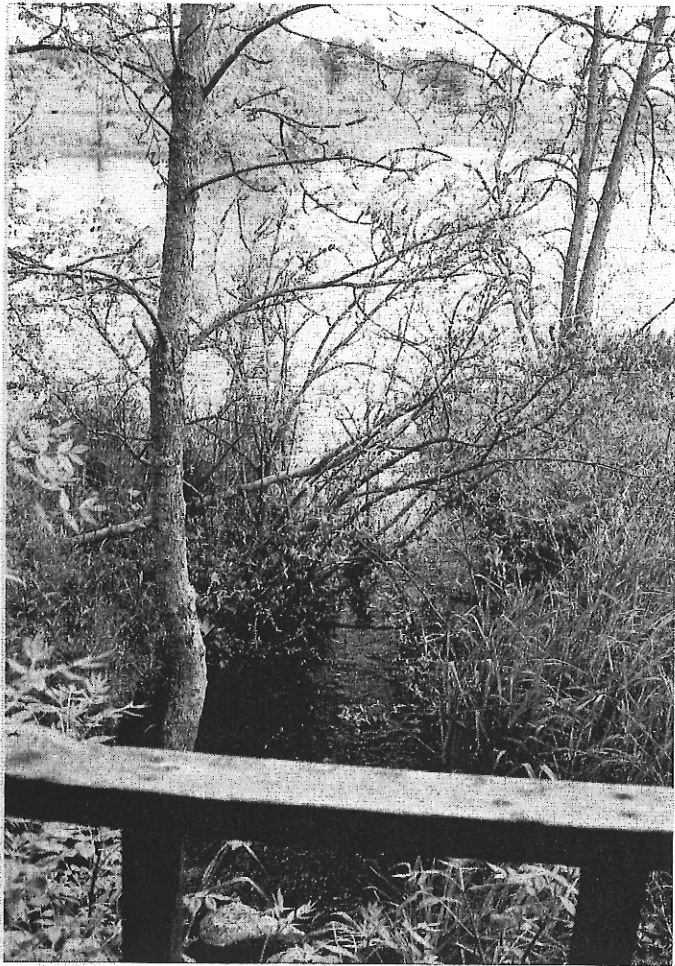
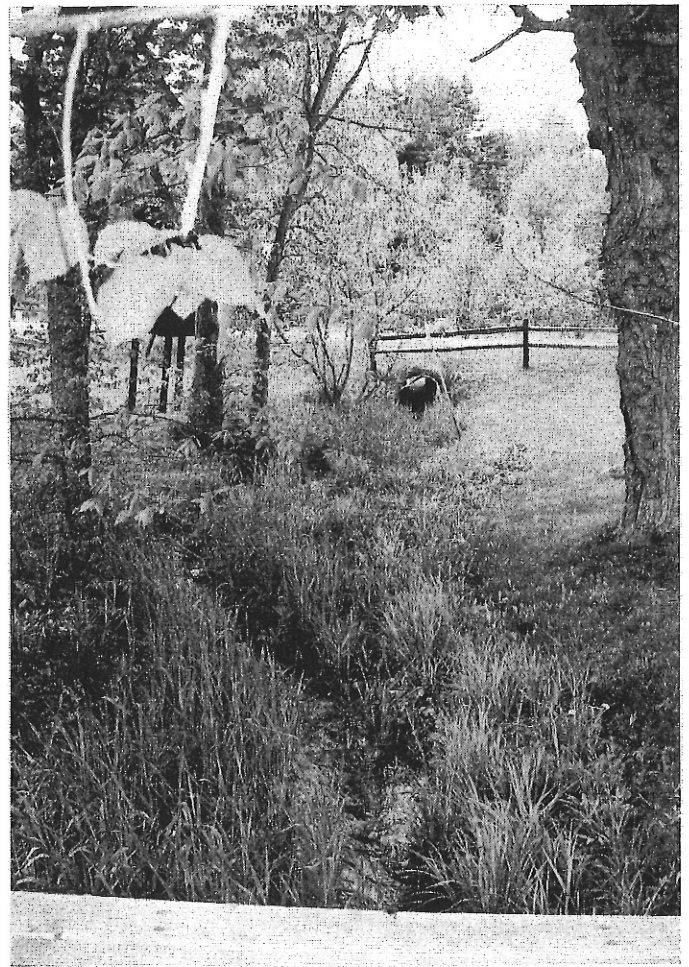
Ta

**T. Stream at Western side of East Vassalboro boat landing (photo).** Drains area along Route 32 (Photo) and from area to the South of Route 32 that includes a farm.

<u>Site</u>	<u>Priority</u>	<u>Comments</u>
Y	High	Bank erosion is severe
W	High	Runoff from Rt. 32 deposits soil into lake
U	Medium	Drainage ditch with high velocity
V	Medium	Moderate flow from developed area
T	Medium	Flows from developed areas
X	Low	No sign of erosion, flows from
S	Low	undeveloped lands
Q	Low	same as above
R	Low	same as above

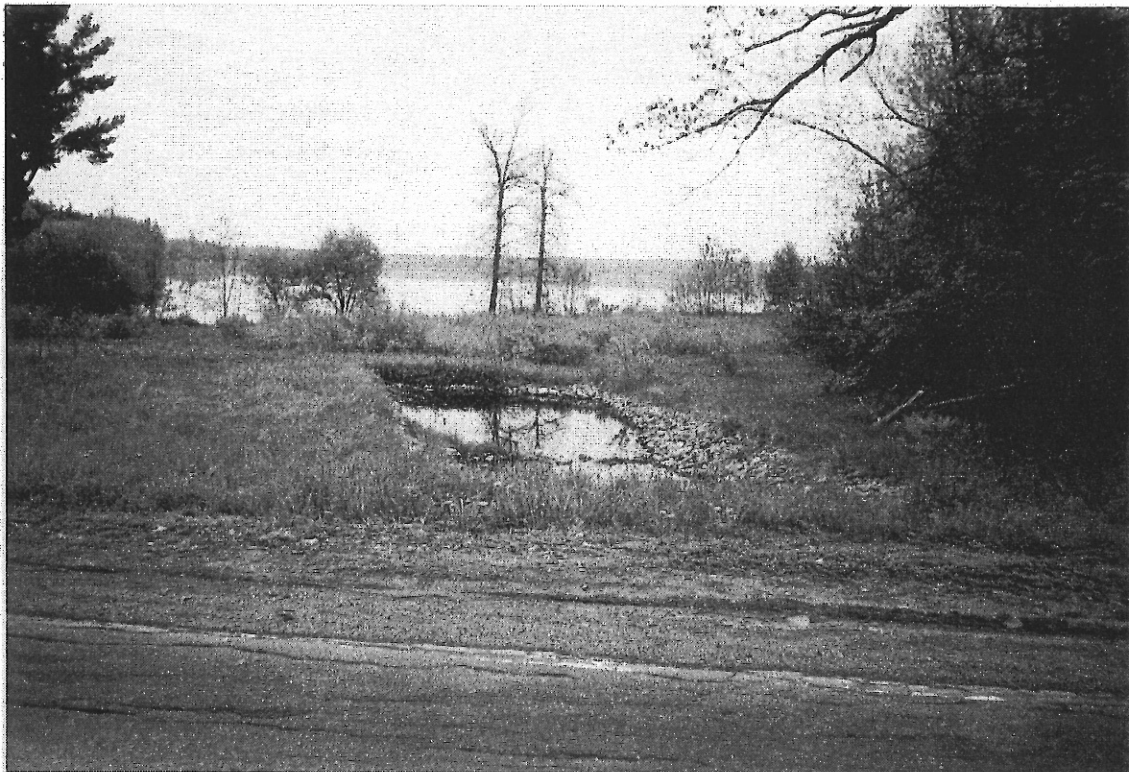
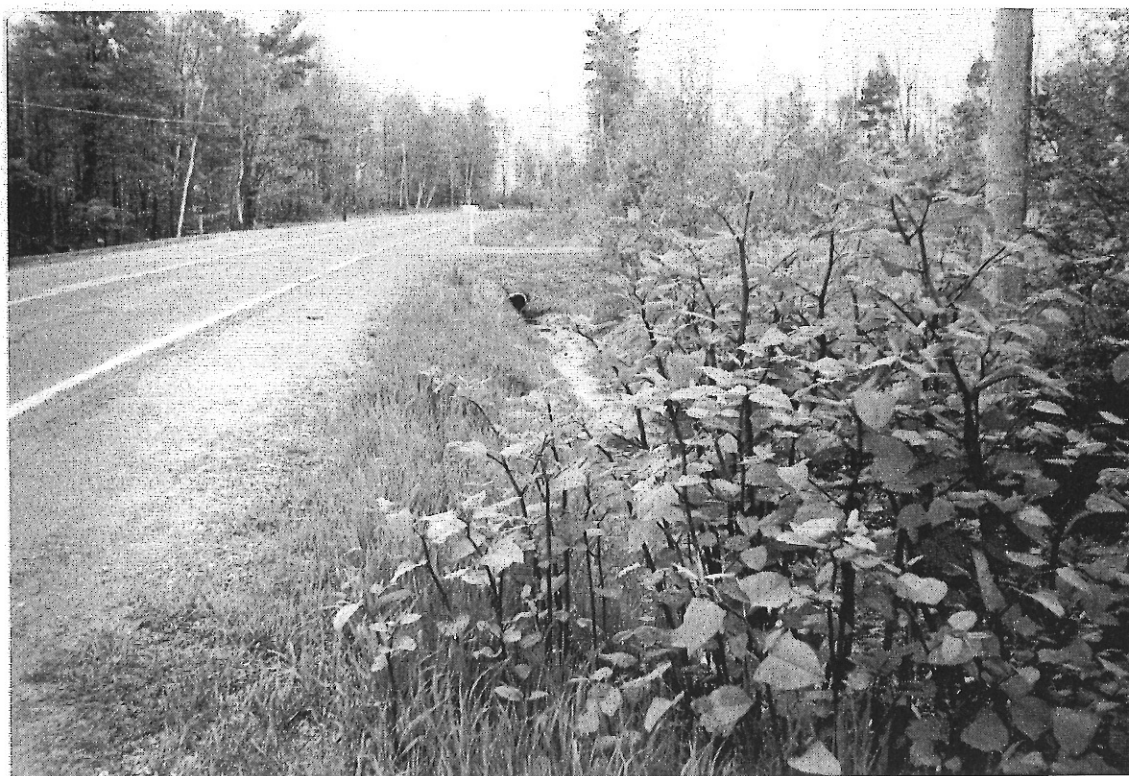
Site Ua

**U. Roadside drainage East of the landing (photo)** crosses the highway and ends in a small retention pond (photo). During periods of heavy rain the pond overflows into the lake.

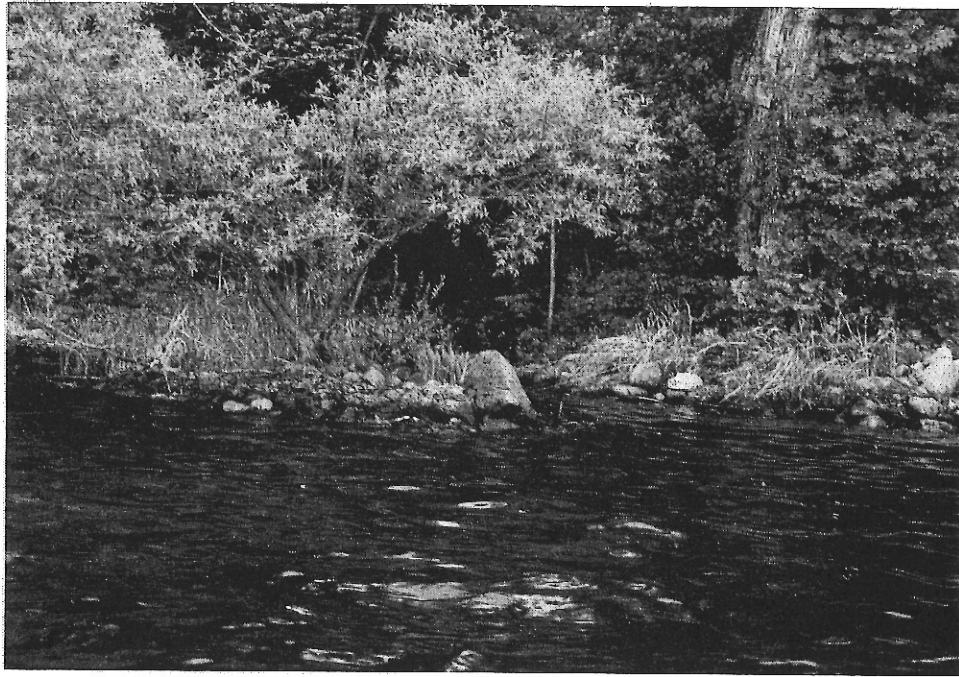
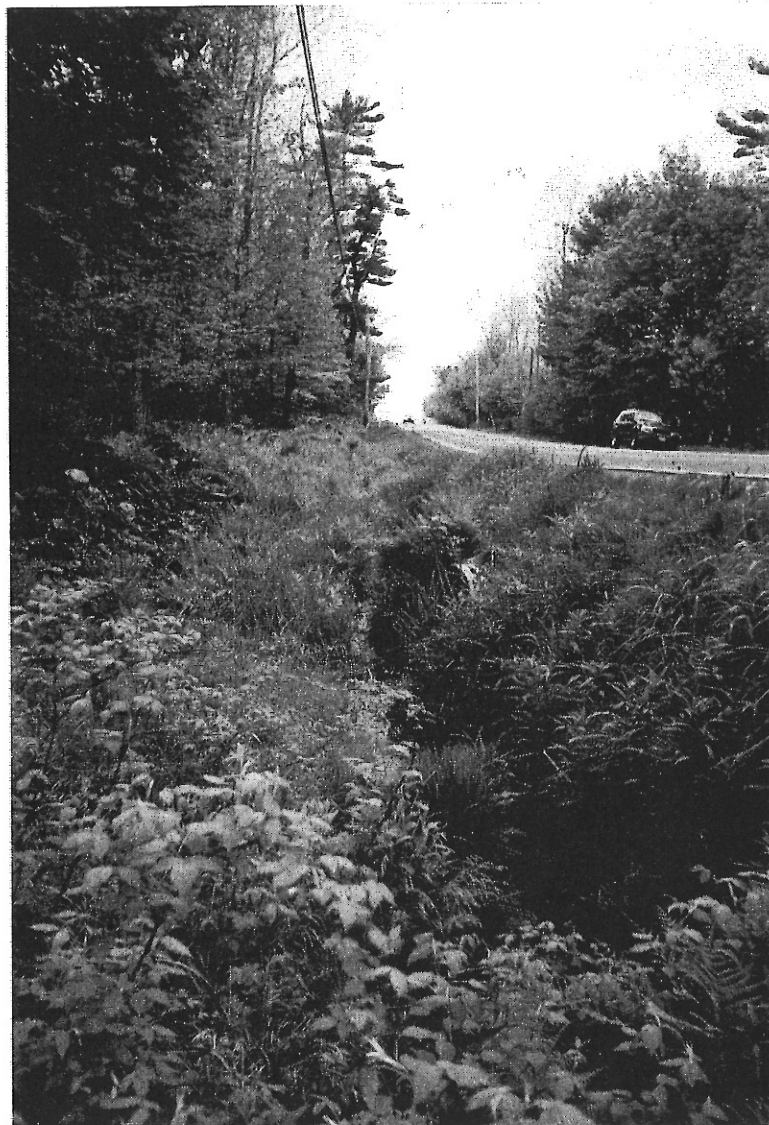
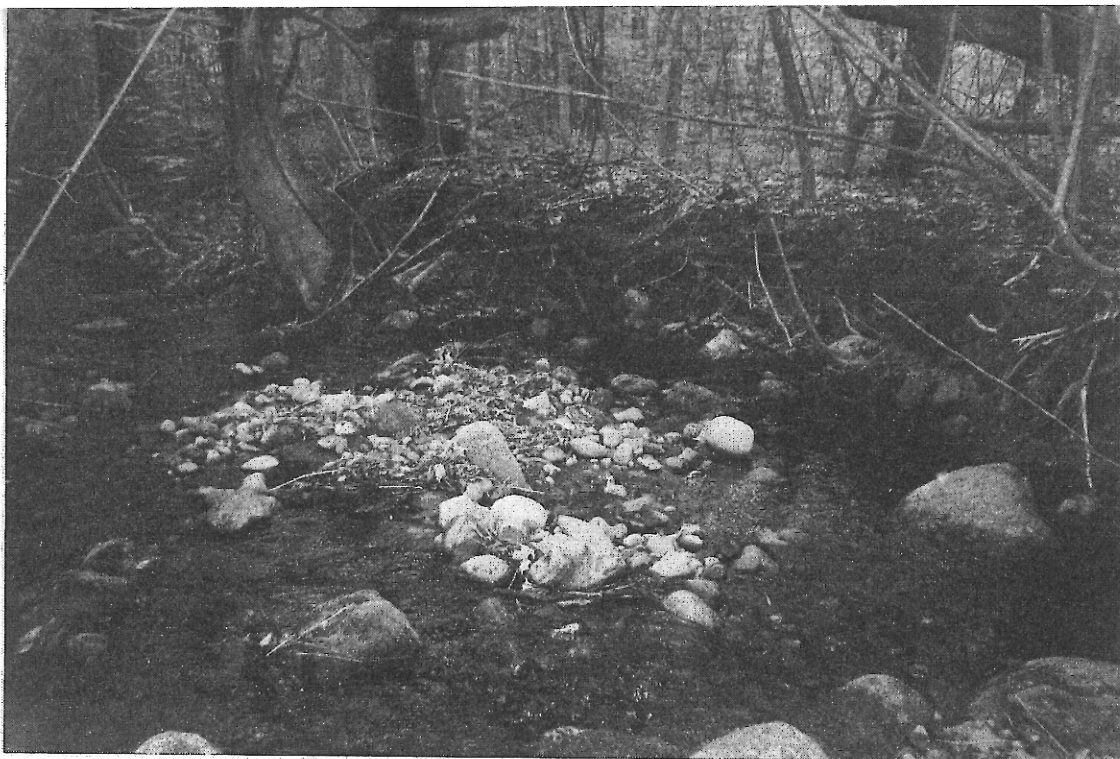
Site Va

**V. "Shorey Brook"** seen emptying into the lake (photo) immediately to the East of the Shorey Property. The stream's source is in wet areas South of Route 32 and then from road side ditching (photo). The stream can recruit significant volumes of water from the road side ditches and eroded stream banks are evident. (photo) The stream ran clear at the time of the survey. This stream is the third largest stream flowing into the West basin.

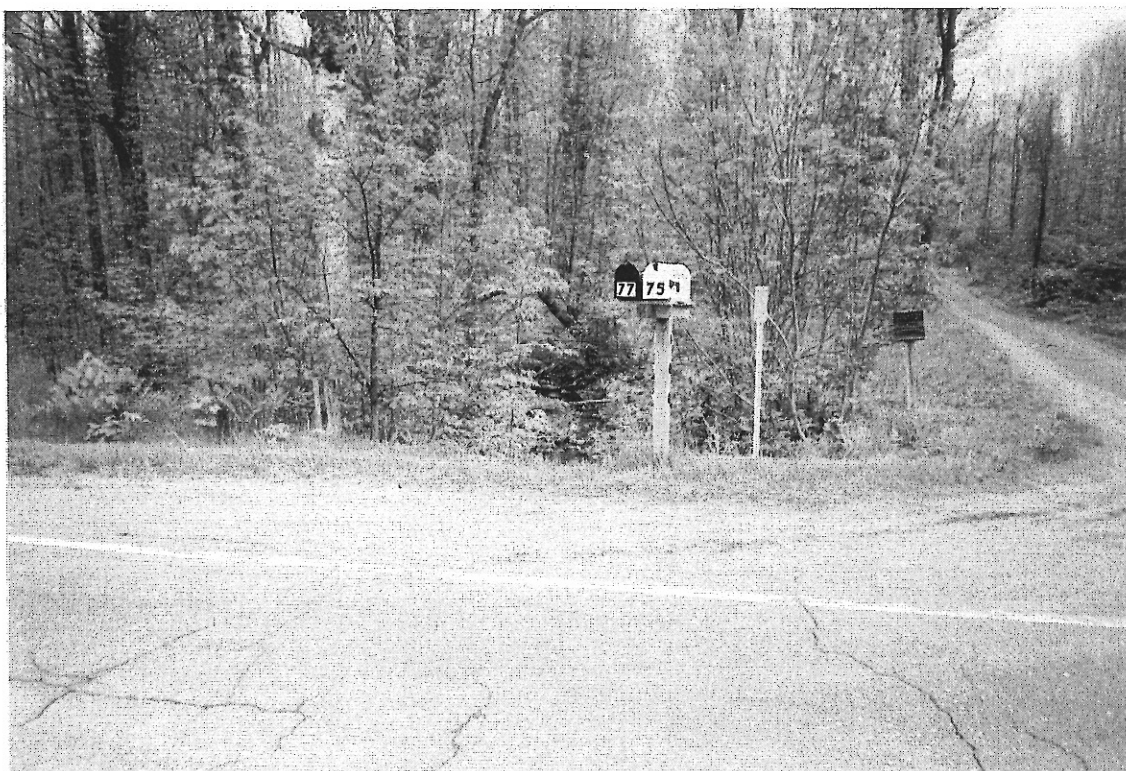
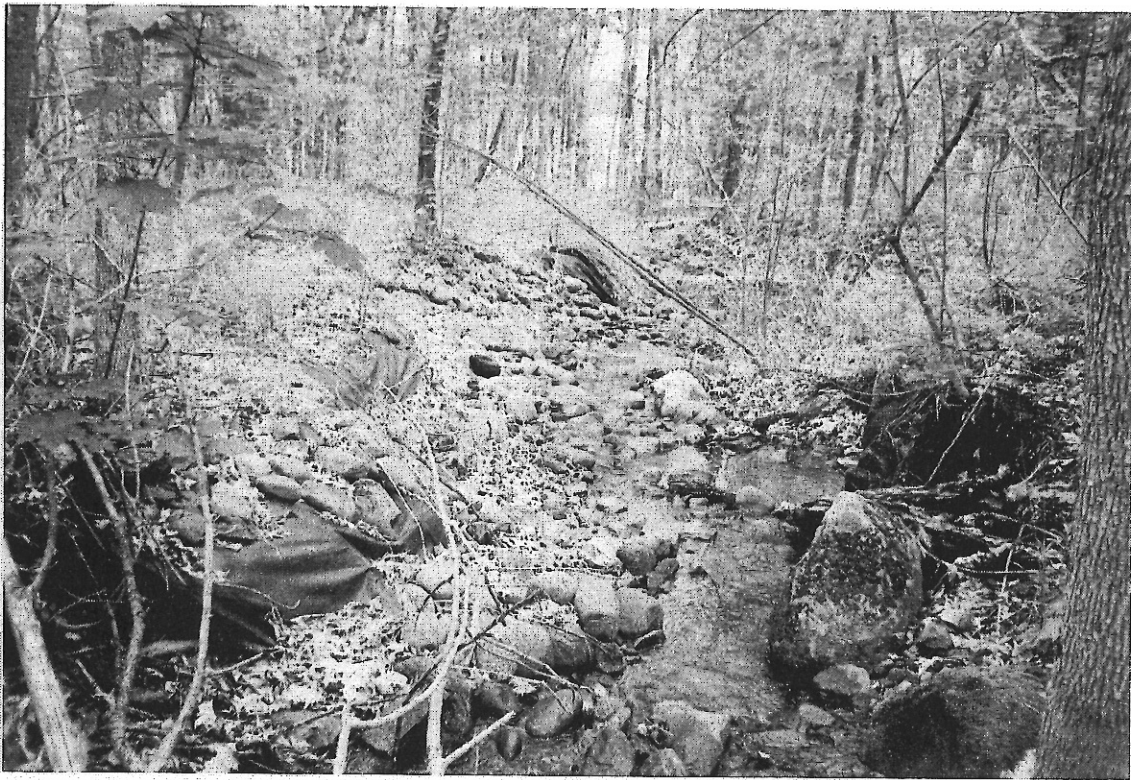
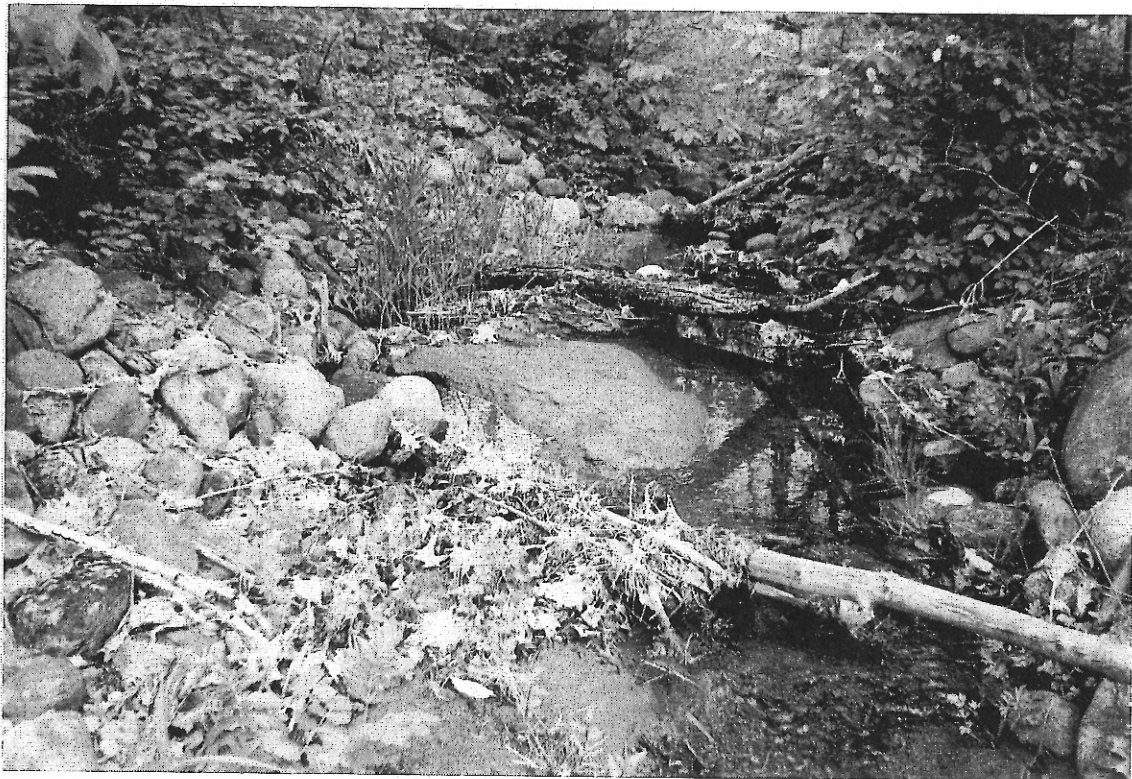
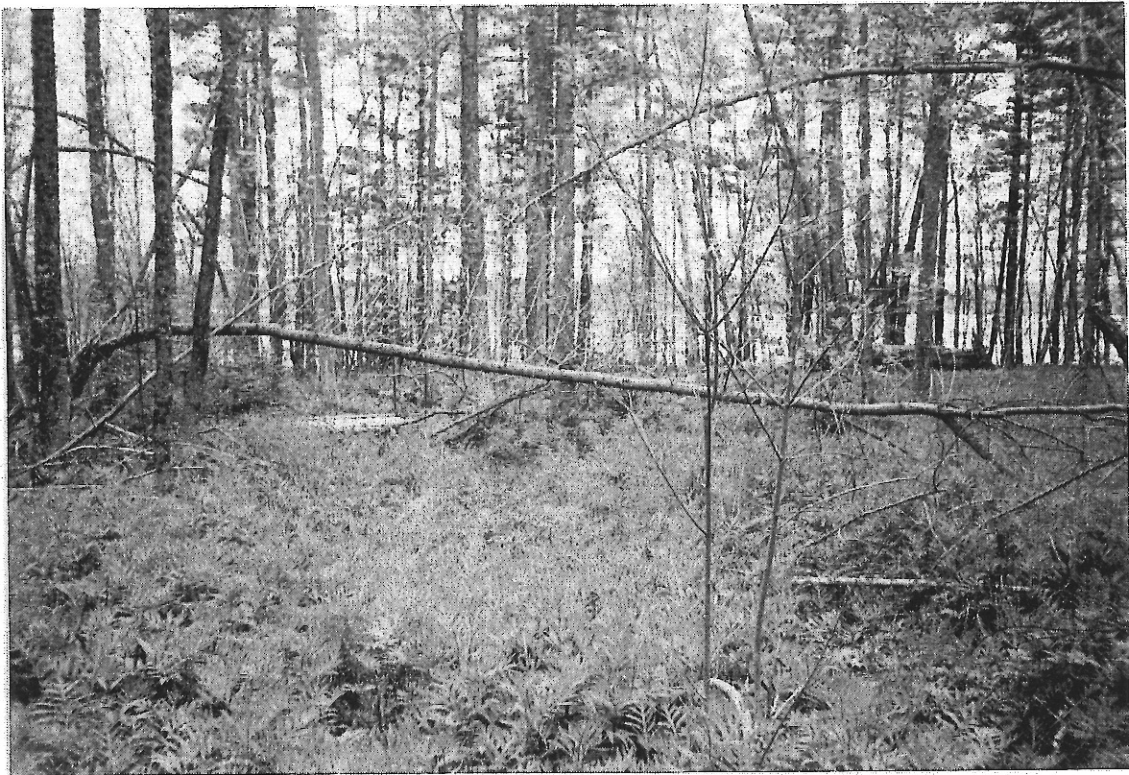
Site Wa

**W. "Shorey Brook- East".** This smaller stream empties into the lake 200 feet to the East of the first brook. It is smaller in it's usual contribution to the lake but recruits large amounts of water from Route 32 ditching. The stream crosses Route 32

obscured by undergrowth at mailbox 77/75(photo). Extensive stream bank stabilization was done about 8 years ago with rock and fabric seen (photo). Silt was evident (photo) in the stream. Before emptying into the lake water slows in a large low area (photo) where many of the fines seem to settle out. Of all the streams surveyed, this stream has the potential to carry the most soil into the lake during heavy rain events. A residential property is within 15 feet of the stream near Route 3 with runoff from the area evident along the stream bank.

W	"Shorey Brook East" moderate flow in upland (mostly from roadside ditching), but low flow closer to lake There is a low area adjacent to lake where water slows down.	4
X	"Bradley Stream" Across from Bradley Island: low flow, barely a stream	1
Y	"Two Loons Stream" low flow, but evidence of high velocity flow during rain events. Lake in the cove where this empties is full of sand and silt that has been deposited there over the years.	3

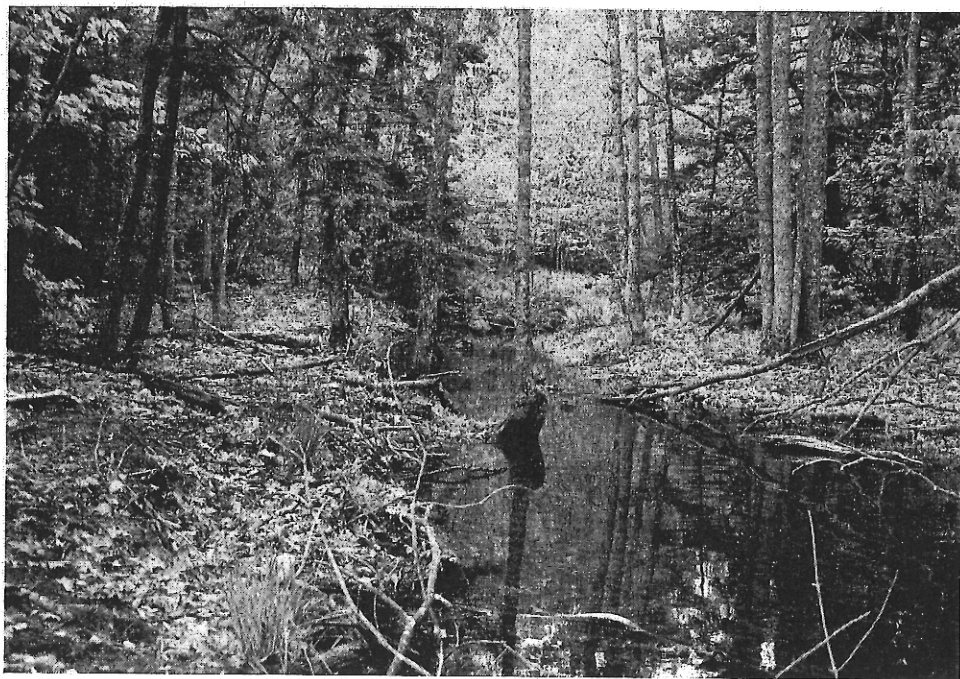
Site X

**X. "Bradley Stream"** across from Bradley Island is low flow, intermittent draining adjacent wet areas.

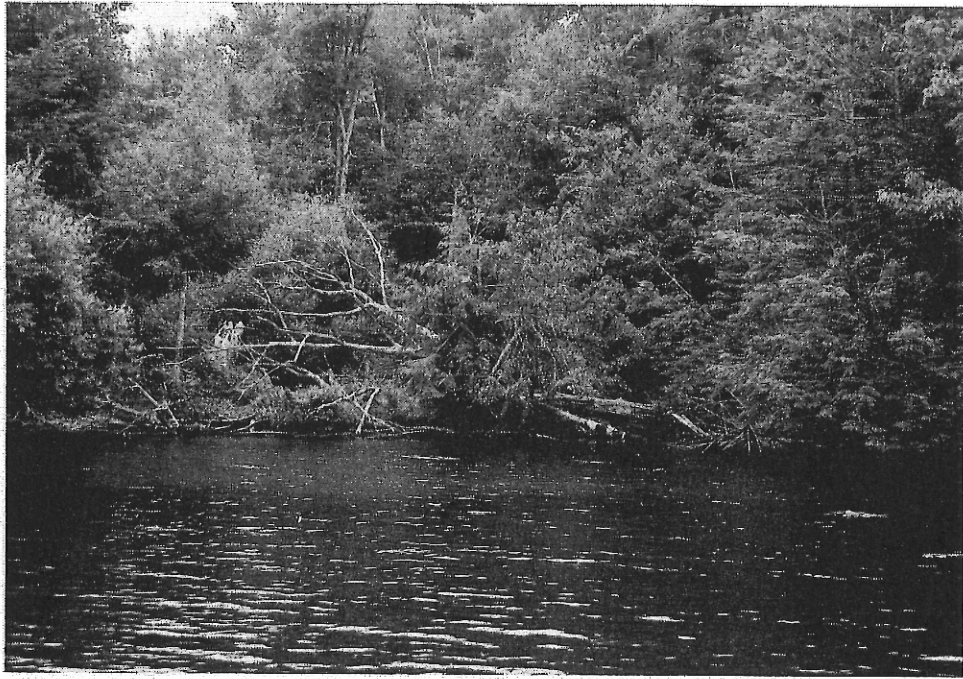
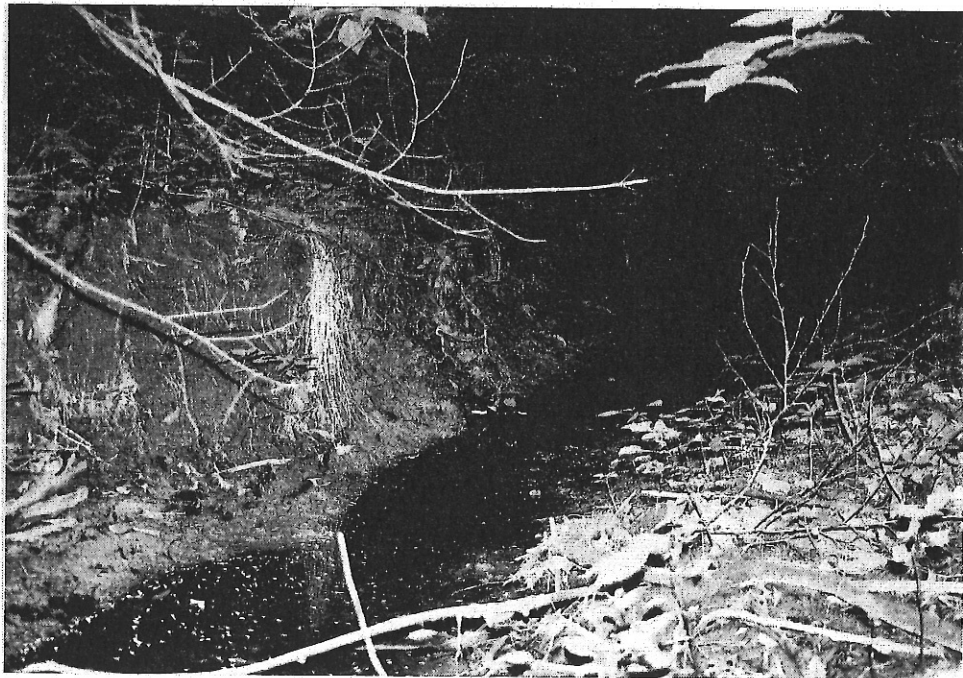
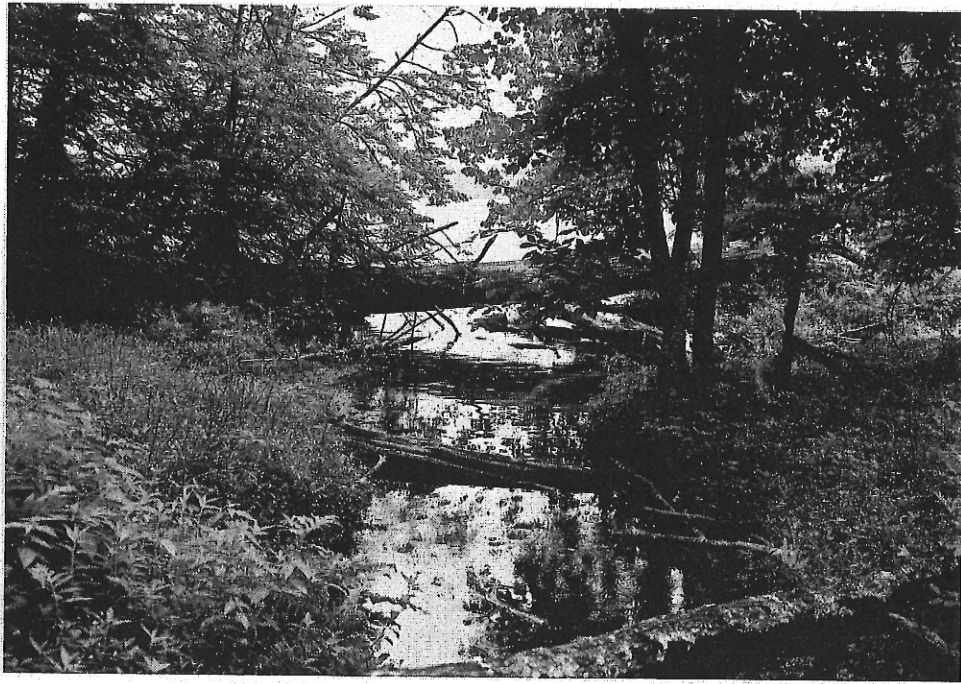
Site Ya

**Y. "Two Loons Stream"** This low volume stream empties into the lake around a group of blow downs (photo). The banks are deeply cut (18-24 inches) (photos) with a lot of silt and fine material evident in lower part of the stream. The stream's watershed includes fields in the two loons farm area. There is evidence that during periods of heavy rainfall significant volumes of water and soil are washed into the lake.
