# China Lake Association

## CHINA LAKE WATERSHED SURVEY 2000

**PRELIMINARY RESULT**  
**SHORE FRONT SURVEY**  
**STREAM AND TRIBUTARY SURVEY**

## SHORE FRONT SURVEY EAST BASIN 2000

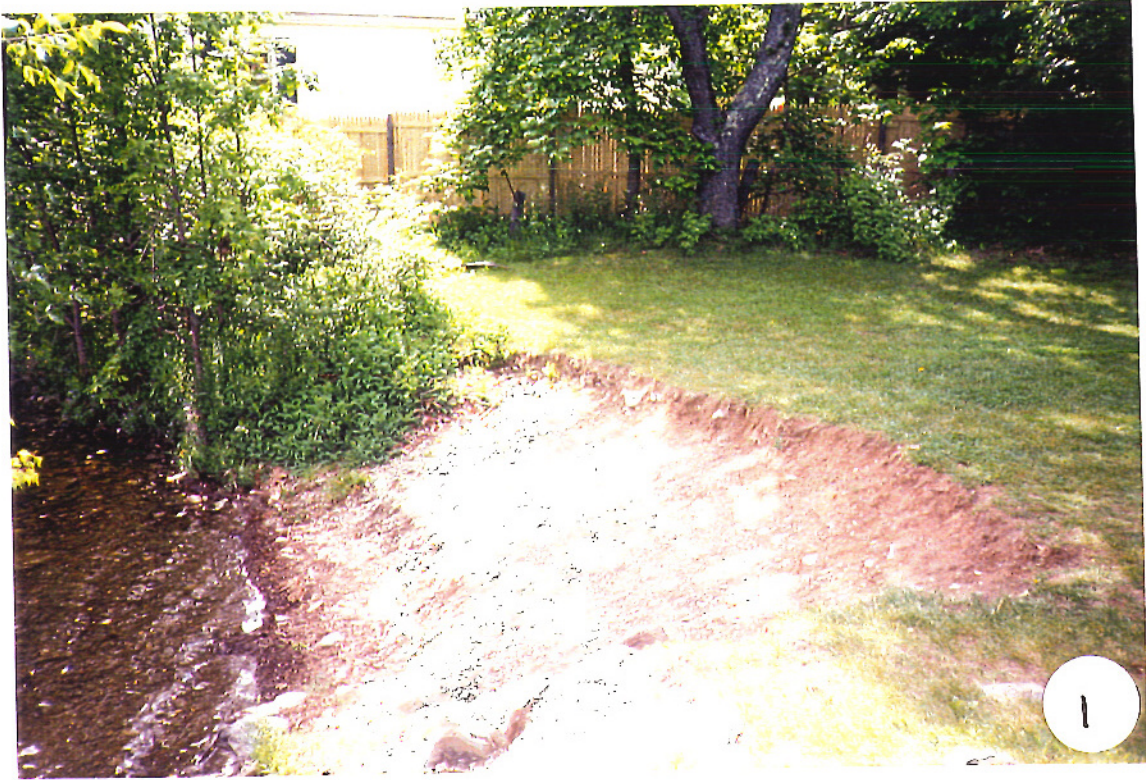
**6/6/00 S.W. +4**

This is the Baptist Beach in China Village should bank erosion due to foot traffic. Plans to reshape bank are in progress.

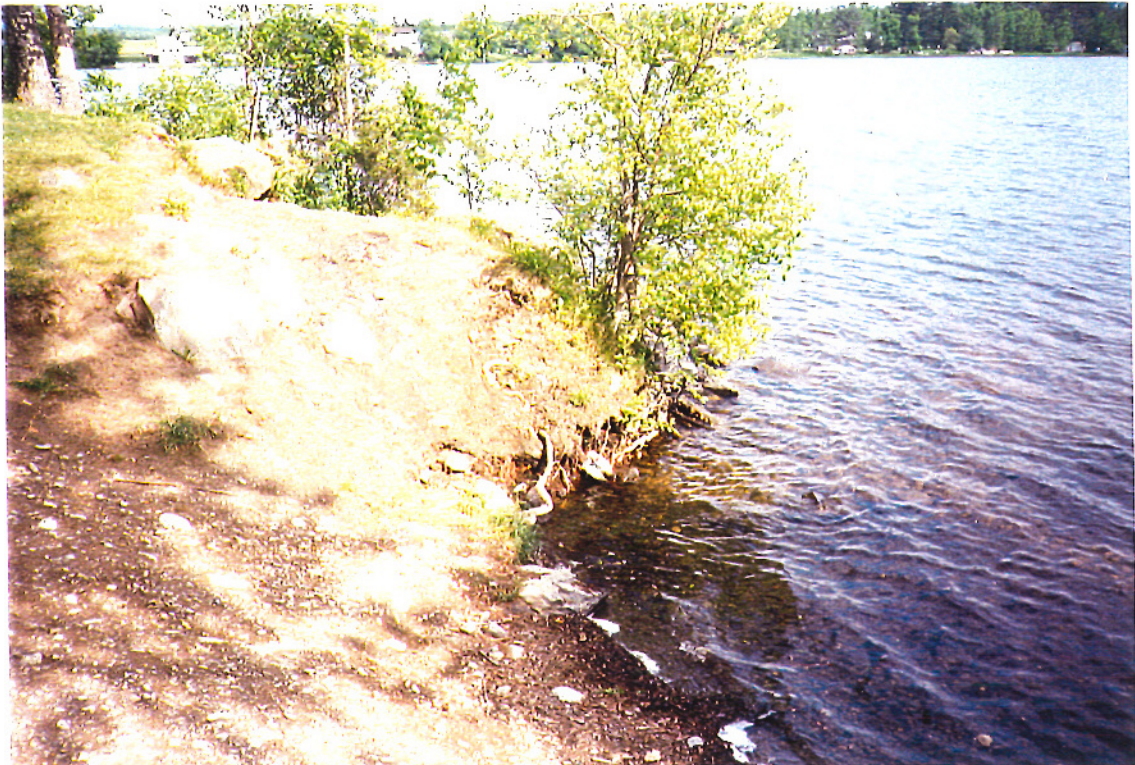
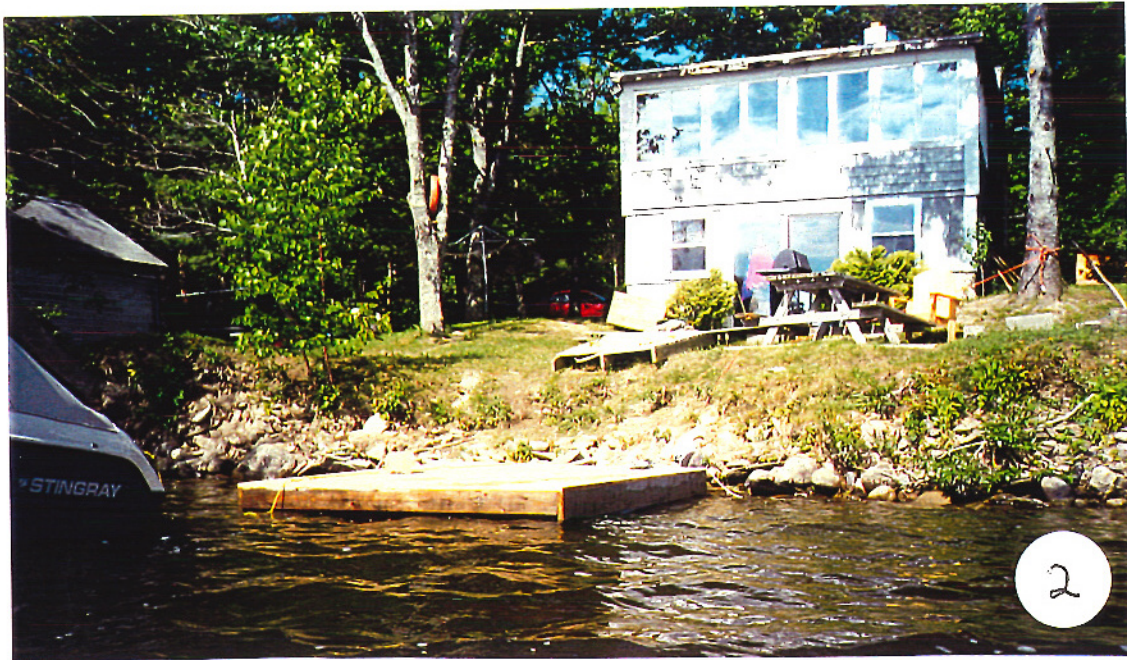
**6/6/2000 S.W. +4**

Upland erosion along the left side of camp down to docks. Needs seeded and replanted. Property on FR #2 owner Calvin Bubar 968-5362 winter address 27 Lincoln Sr , Brewer, Me **Intermediate Priority**

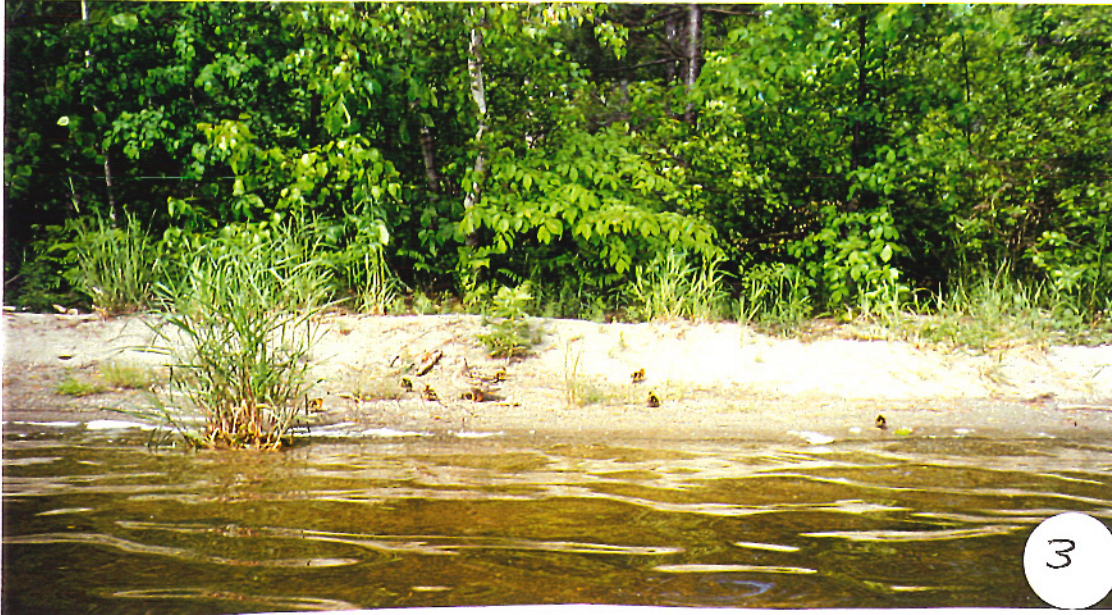
SEVERAL SITES OFF OF FIRE ROAD 4 AND 5 SHORE IS BEACH WITH MINIMAL EROSION. **LOW PRIORITY**

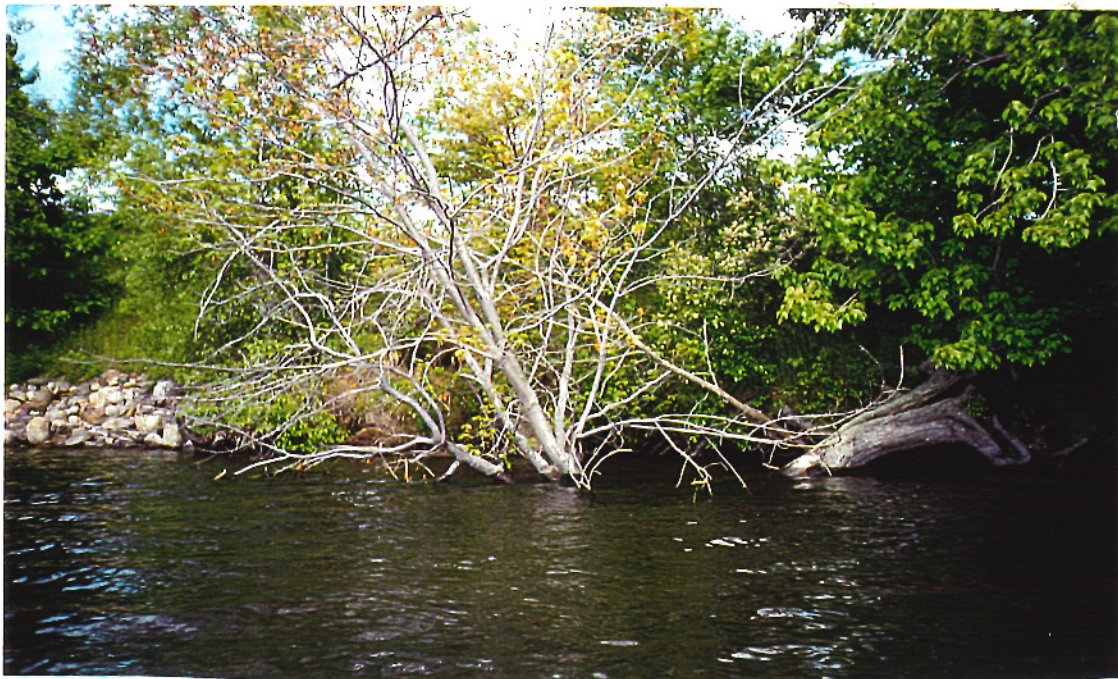
**6/9/00 S.W.+4**

Point of land extending back into Wentworth Cove has been eroding for a number of years with wave action washing over vegetation at current water levels. Much of what was land (120 square feet) has lost most of soil and is a small rock base now. Access difficult, Low Priority

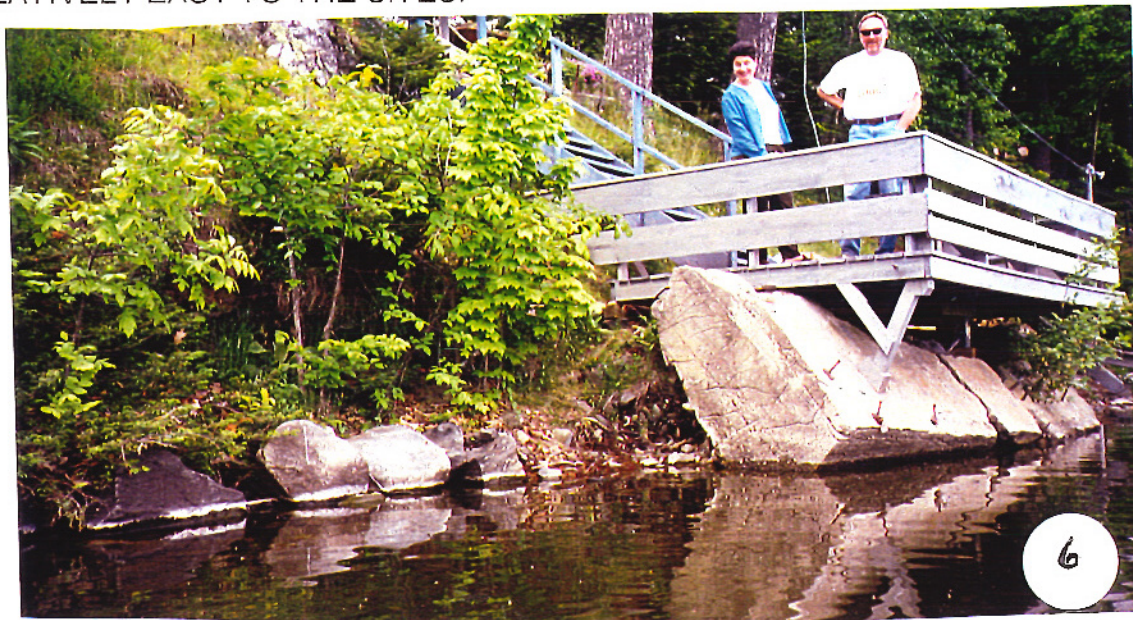
ALLEN PELLETIER SMALL AMOUNT OF EROSION AROUND LANDING. ARE INTERESTED IN RIPRAP 15 FEET INVOLVED EXTENSIVELY BUT WOULD LIKE 100 FEET OF SHOREFRONT DONE. TEL 968-2304.

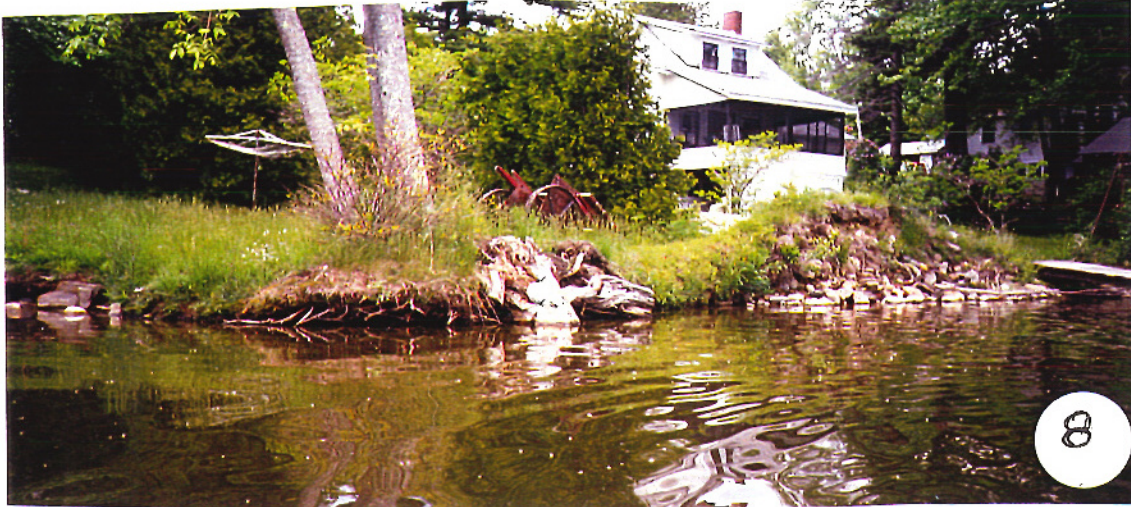
SITE BELOW NEXT TO PREVIOUS 2 SITES COTTAGE ALMOST FALLING IN LAKE. THIS IS AN AREA OF ICE DAMAGE. FLYER LEFT. SEE MAP OF SITES.

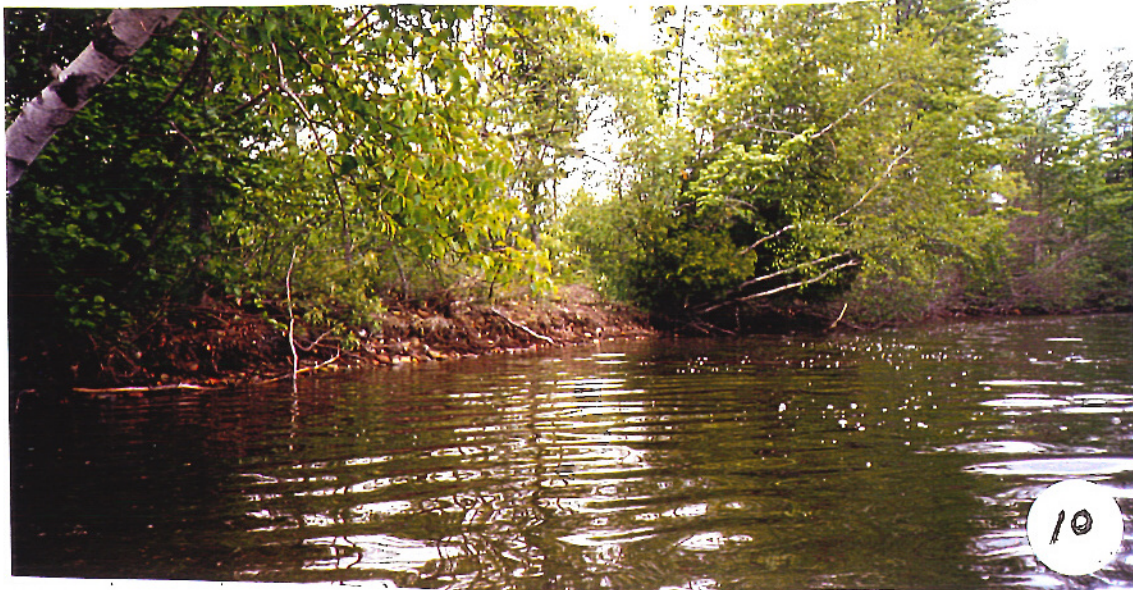
ERODING HILLSIDE SAME AREA, SAME OWNER 25 FEET HIGH AND 50 FEET ACROSS AT BASE NEED REVEGETATED IF POSSIBLE. **PRIORITY ?**

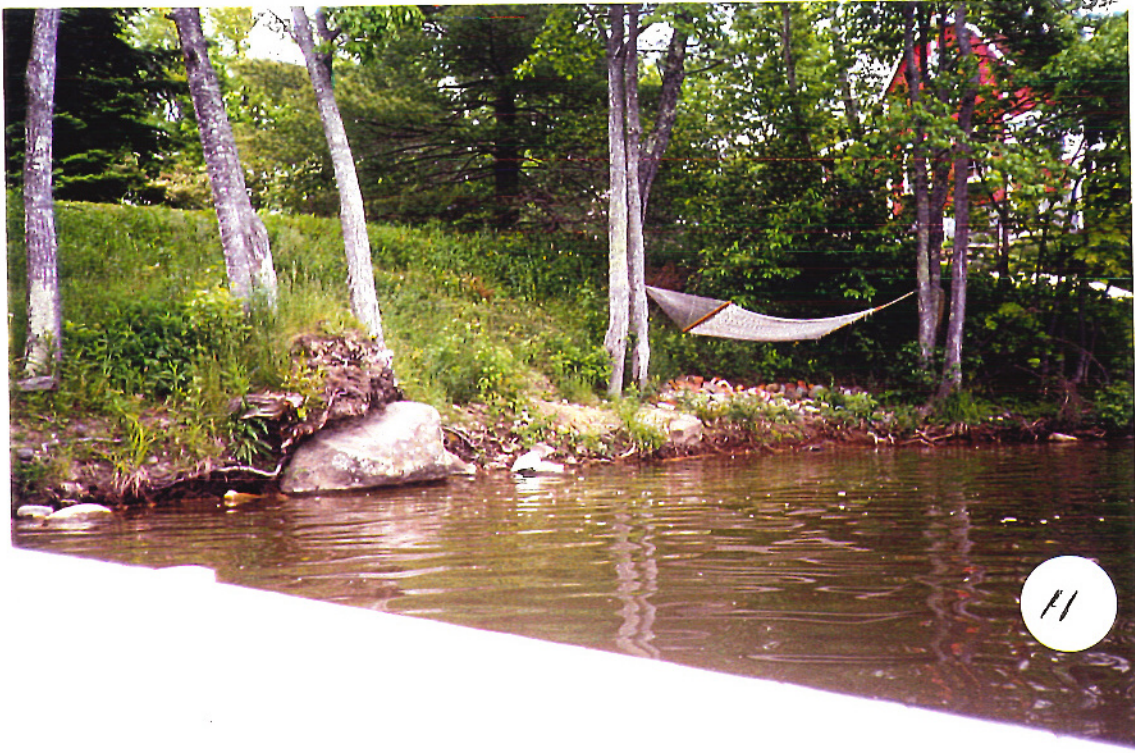
**6/9/00 S.W. + 4**

First camp in on F.R. 11 35 feet of eroding shore front with maximum bank height of 16 inches. Notice left in door.

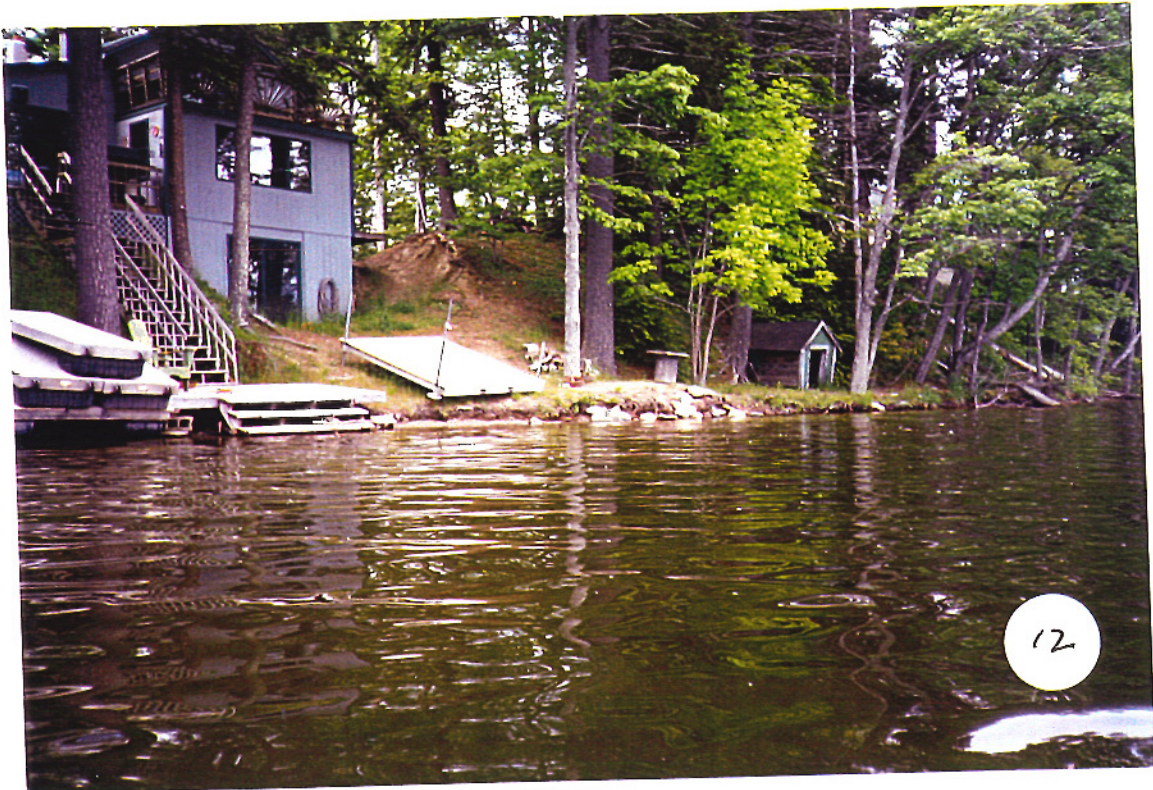
**6/9/00 S.W. + 4**

Second from last camp on F.R.11 owned by Stephen King of Augusta. 25 feet of shore front erosion with upland erosion needs rip rap and plantings. Notice left. Higher Priority.

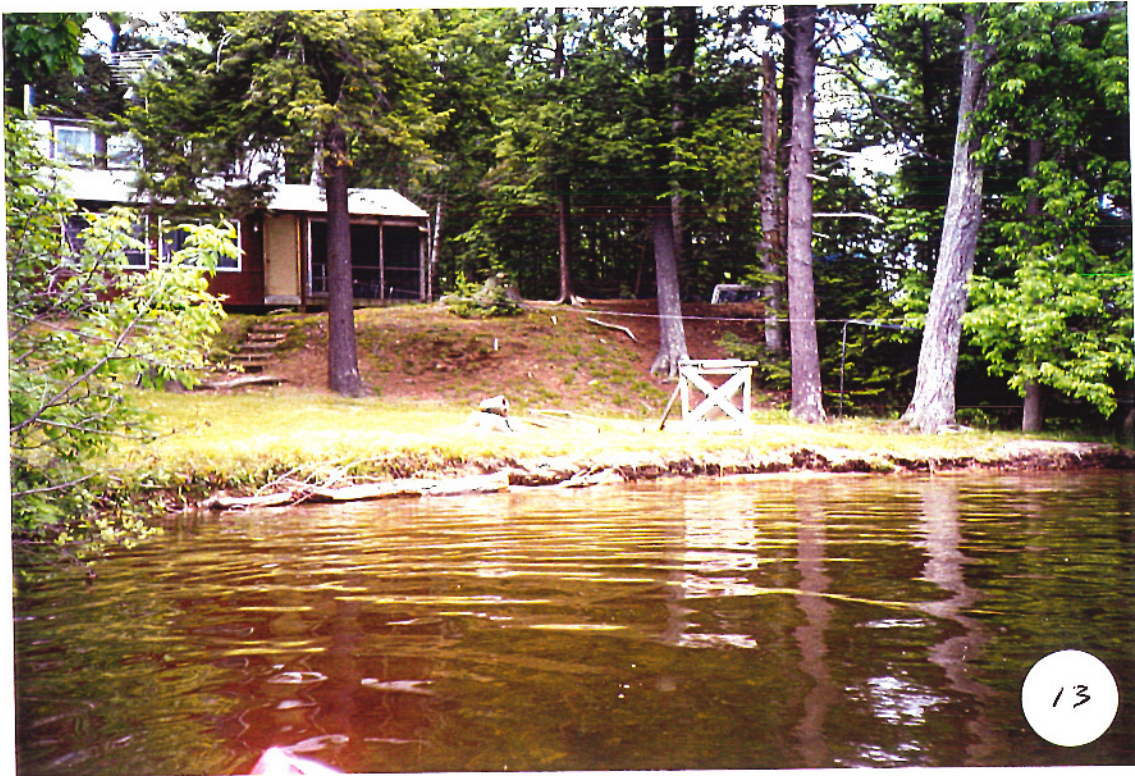
6/9/00 S.W. +4

Last camp on F.R. 11 owned by Roy Dowe of China 40 feet badly eroded bank to maximum height of 18 inches. High Priority project but spoke to owner who has little interest. He will consider.

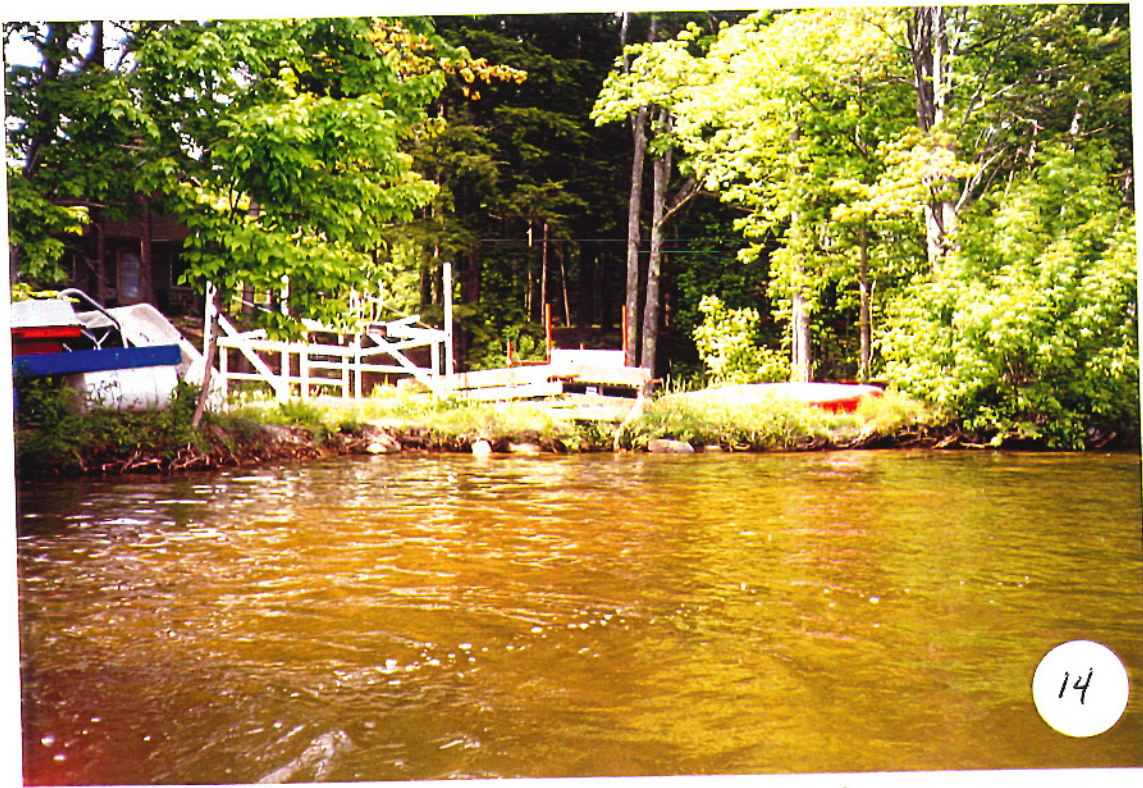
6/9/00 S.W.+4

Property between camps on F.R. 11 and 12 unknown owner similar type of erosion. No notice left.

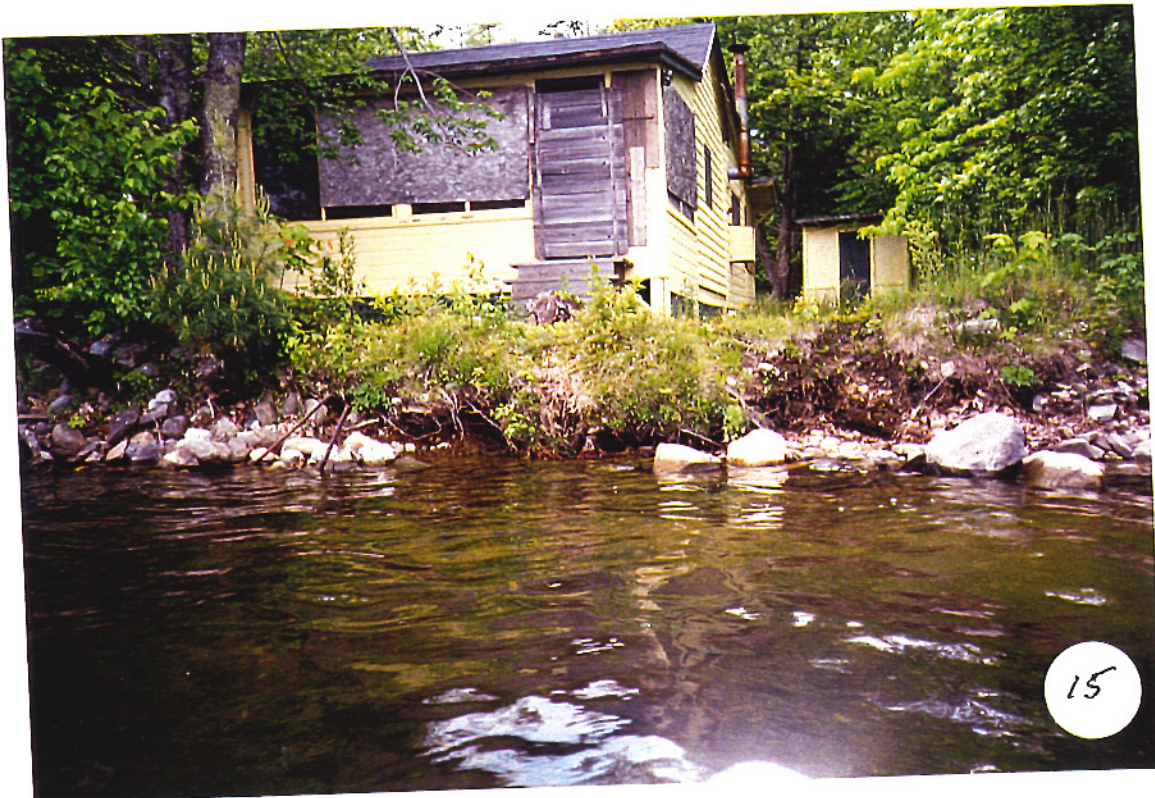
6/9/00 S.W. +4

Last property in on F.R. 12 falling down has what appears to be 50 feet of ice damaged shore out front with moderately significant erosion. High Priority. Notice left.

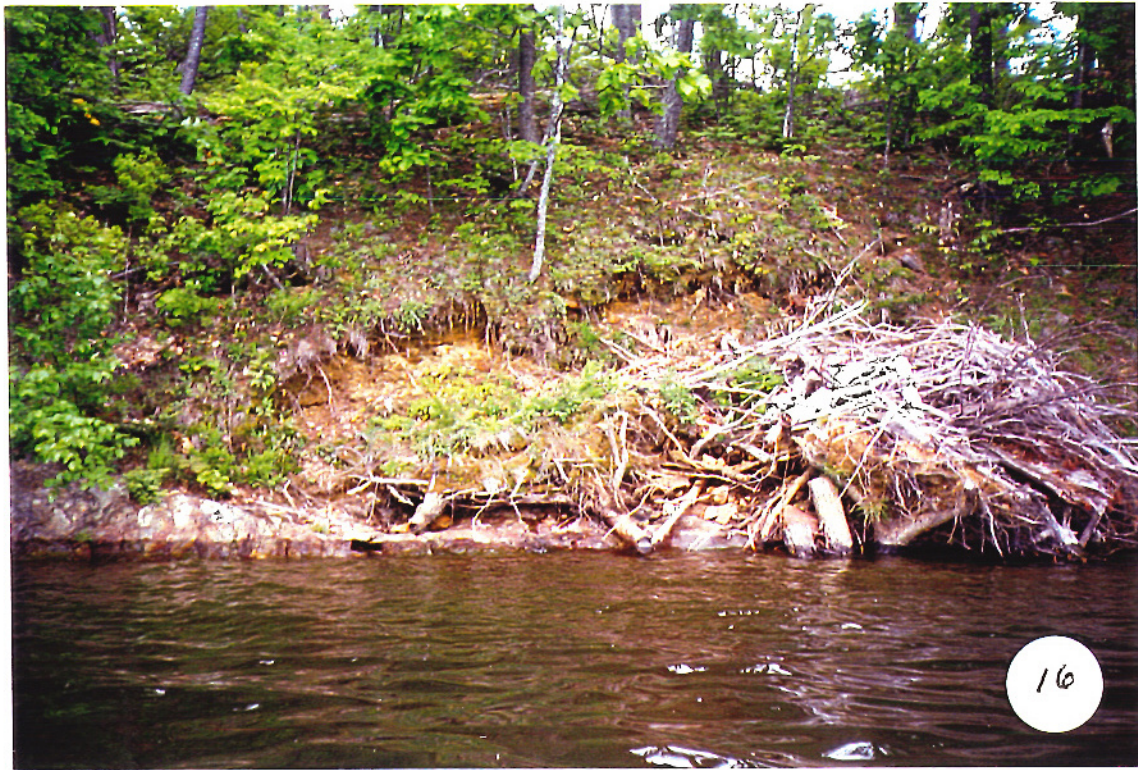
**6/9/00 S.W. +4**

Upland slumping of earth well above the water line does not appear to be caused by wave action. Difficult site access between F.R. 12 and 13.

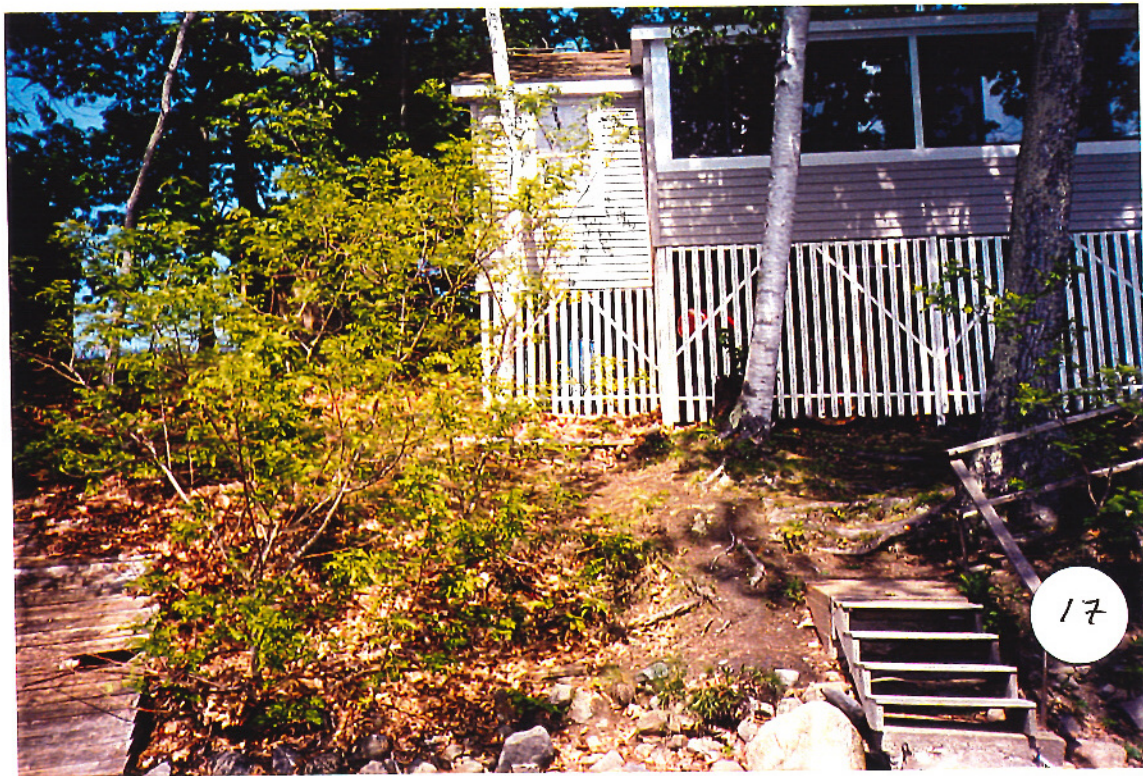
**6/9/00 S.W. +4**

Eroding ground around Tedstone camp on FR # 18 heavy foot traffic, steep slope. Medium-low priority.

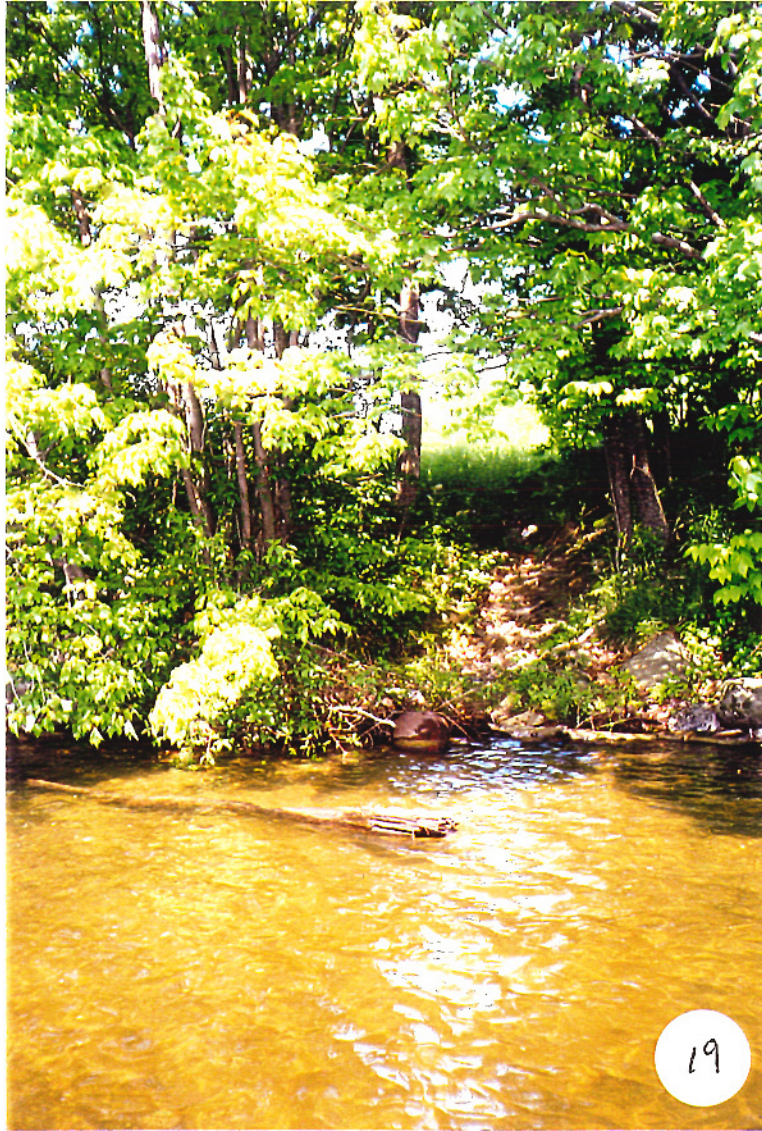
**6/10/00 S.W. +3**

From the lake this is the left side of Judy and Mike O'Brien at the end of the Neck Rd. There is a drainage ditch from the field that is eroded and dumping silt into the lake . May benefit from silt fence and rip rap. Tel #968-2873

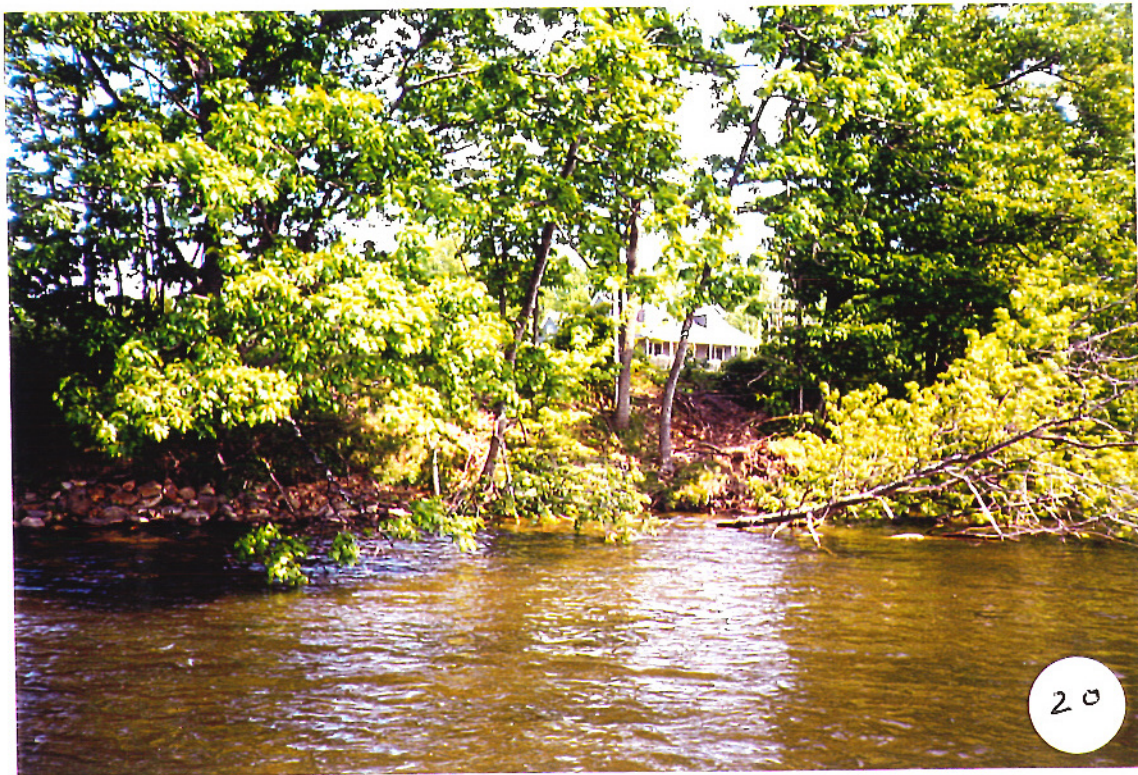
**6/10/00 S.W. +3**

KMD property adjacent to previous site 50 feet undercut bank with some collapse. Less severe than adjacent site was. Needs some chain saw work. Surprisingly the rest of the bank in this area looks good.

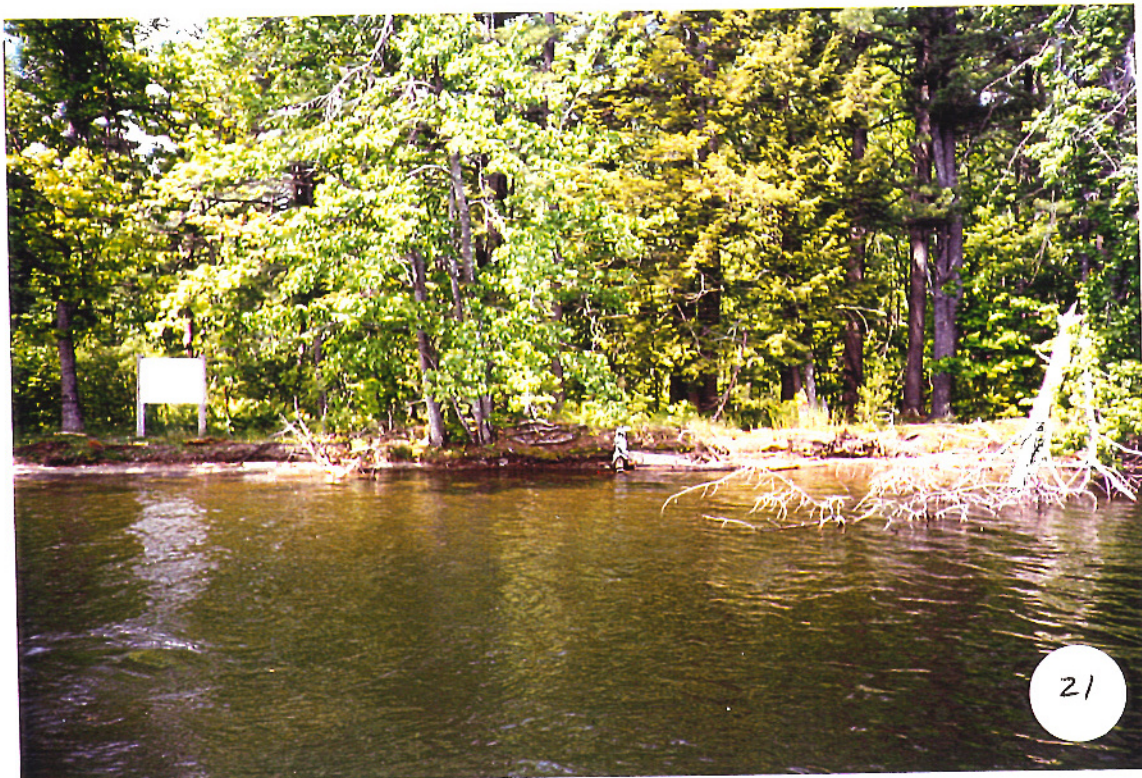
**6/10/00 S.W. +3**

This is KWD land on the South side of passage to West Basin at current water levels the site is stable. It is generally in better shape than the photo appears and because of remote location would be difficult to address. Lower priority.

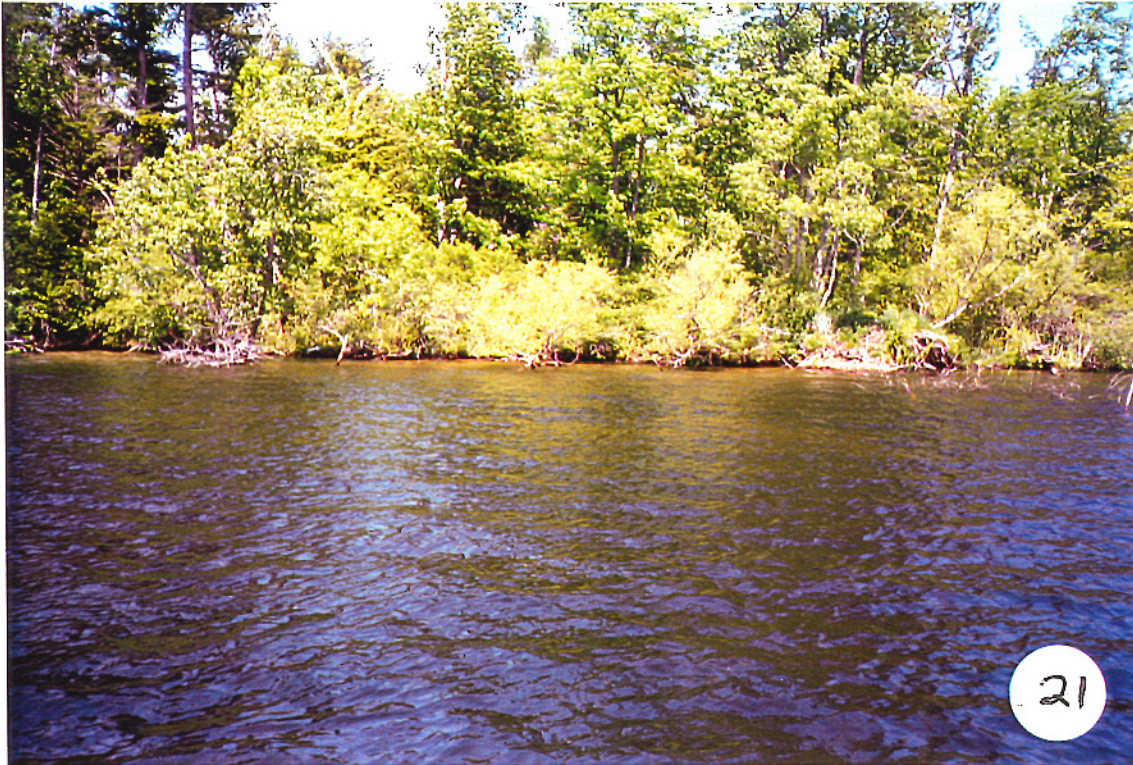
**6/10/00 S.W. +3**

This is KWD land immediately South of previous site. There is 200 feet of bank being slowly undercut at higher water levels or wave action than seen today ( 10 knot winds from the South with 8 inch waves.) The bank is well vegetated and rooted with no bare soil seen as I walked this area. Low priority

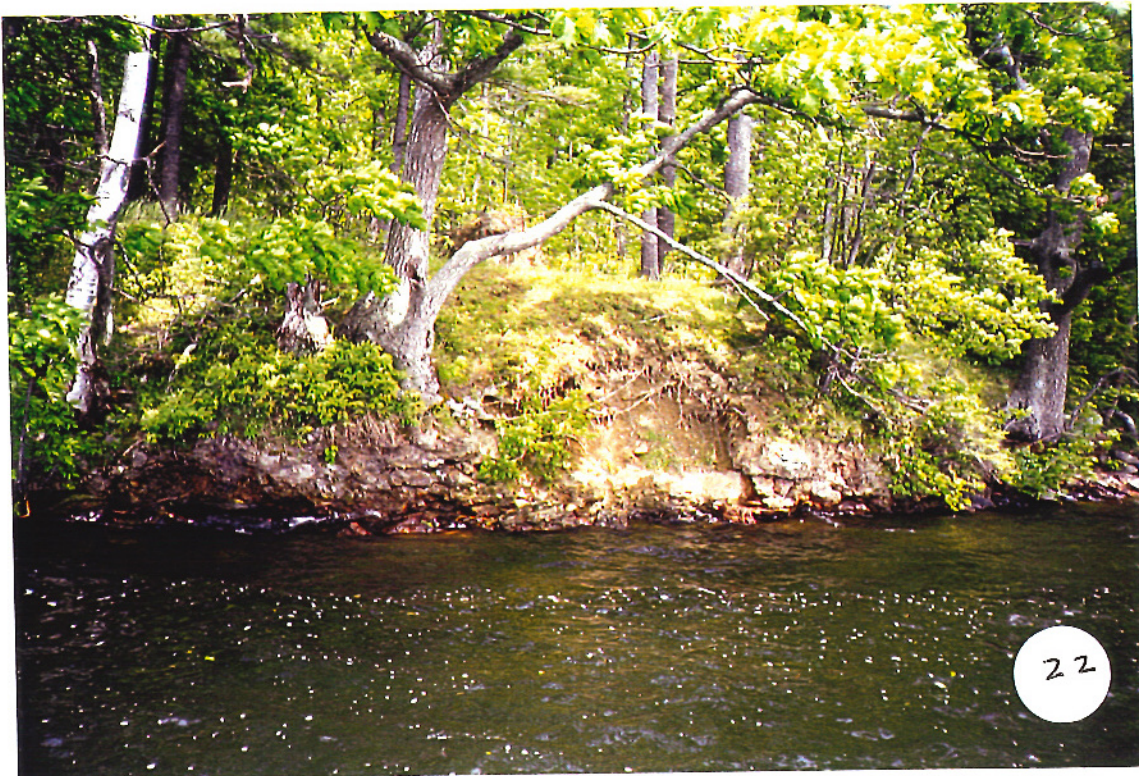
**6/10/00 S.W. +3**

This KMD site is an unstable upper bank caused by a large blow down barely seen at the top of slope. bare soil is 16 inches above current water levels with a large ledge below. Remote site Low Priority.

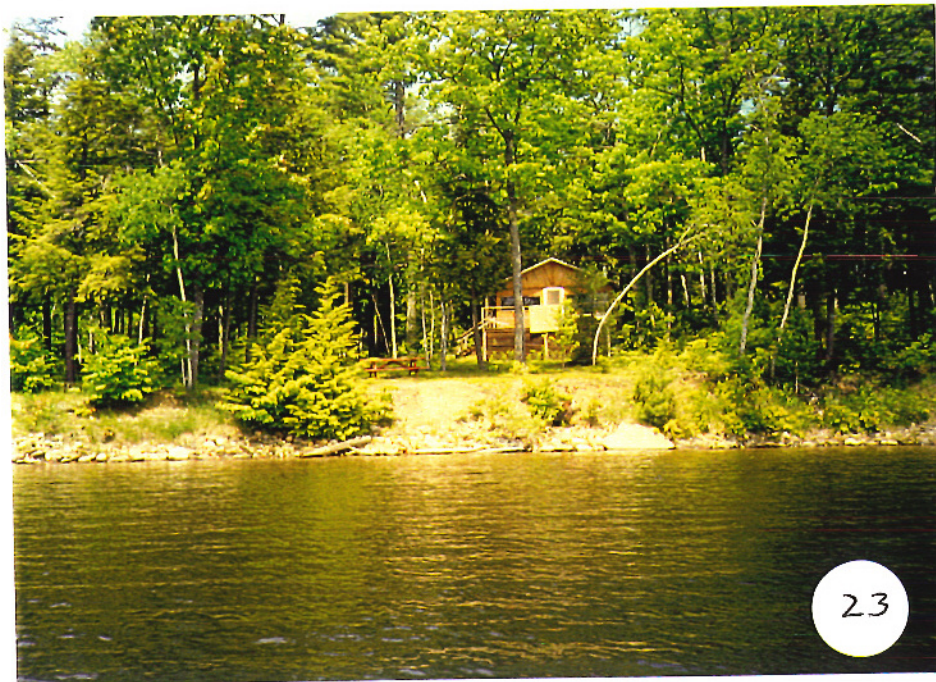
6/10/00 S.W.+3

Property of Bernard Pellerin FR #61 site of previous rip rap and revegetation now with up slope erosion fairly extensive in some places. Interested in plantings. Left info and talked with sister of owner (jackie)

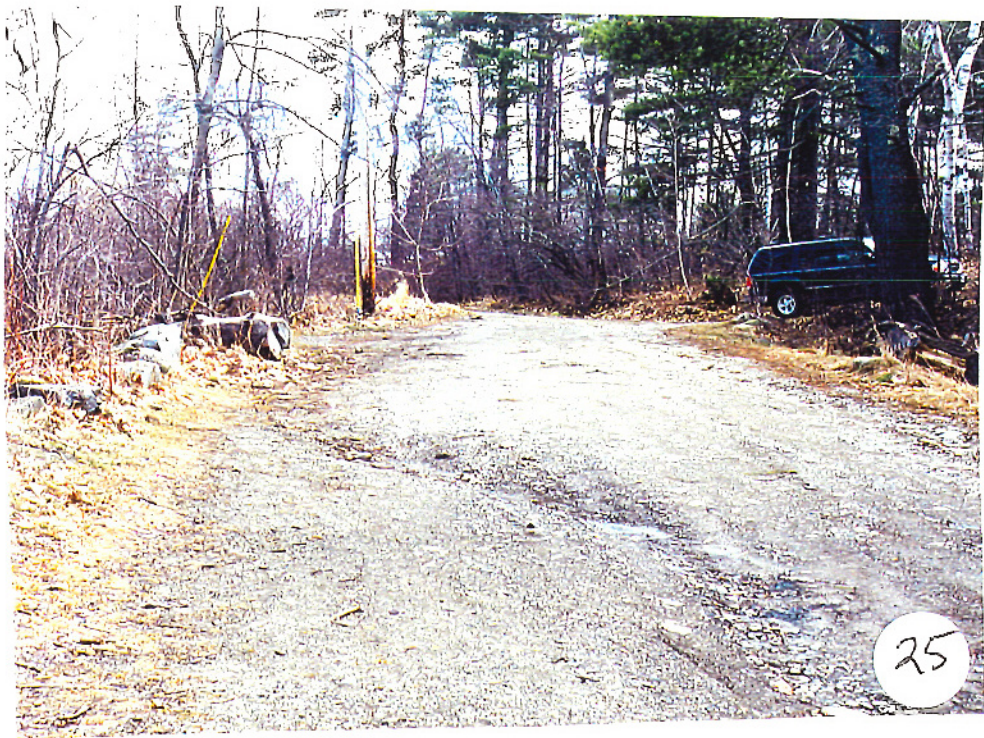
**6/22/00 S.W. +5**

South China boat landing was survey immediately after a brief thunder storm. There was significant runoff from site into the lake with obvious turbidity of the lake near the landing. High Priority.

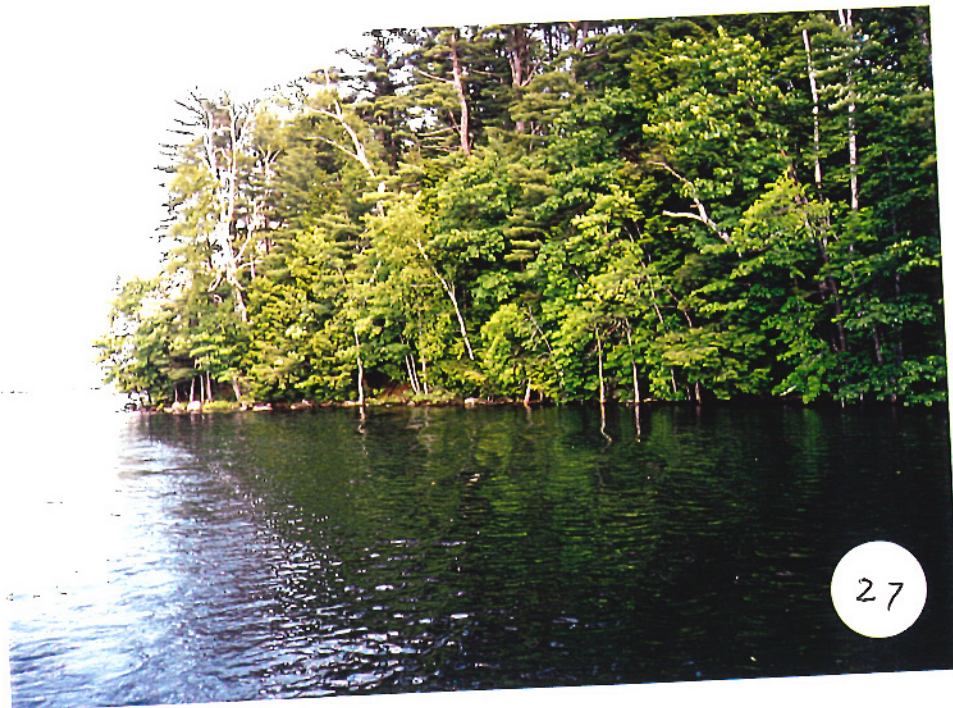
6/22/00 S.W. +5

This 2 photo set shows 600 feet of shore North of Jennings' boathouse that shows signs of past erosion with trees and roots in water but generally good rock protection of shore. Low Priority.

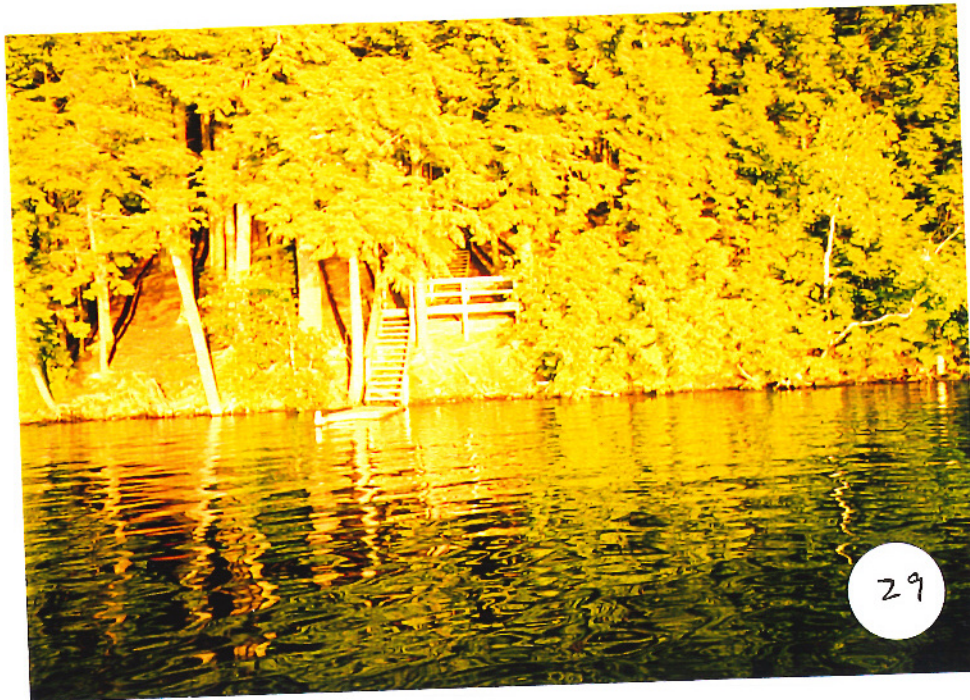
6/18/00 S.W. +5

Eroding bank above high water mark. 6 feet wide 4 feet in height. Low priority

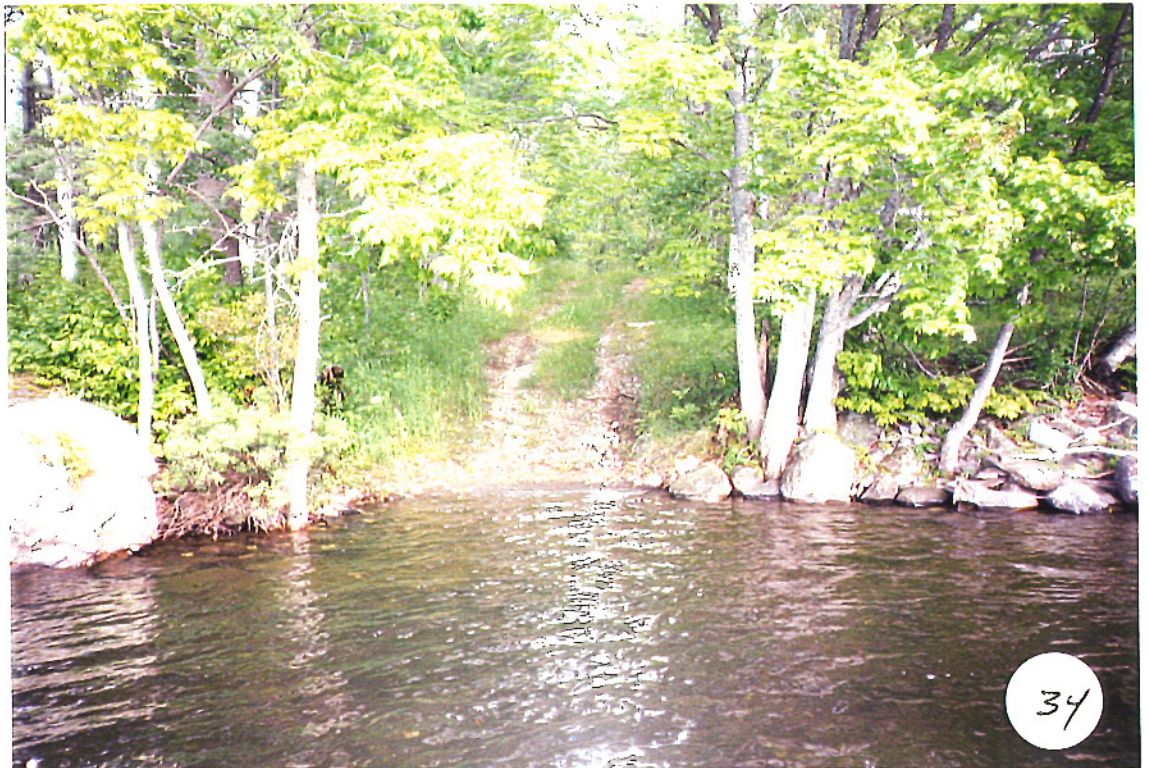
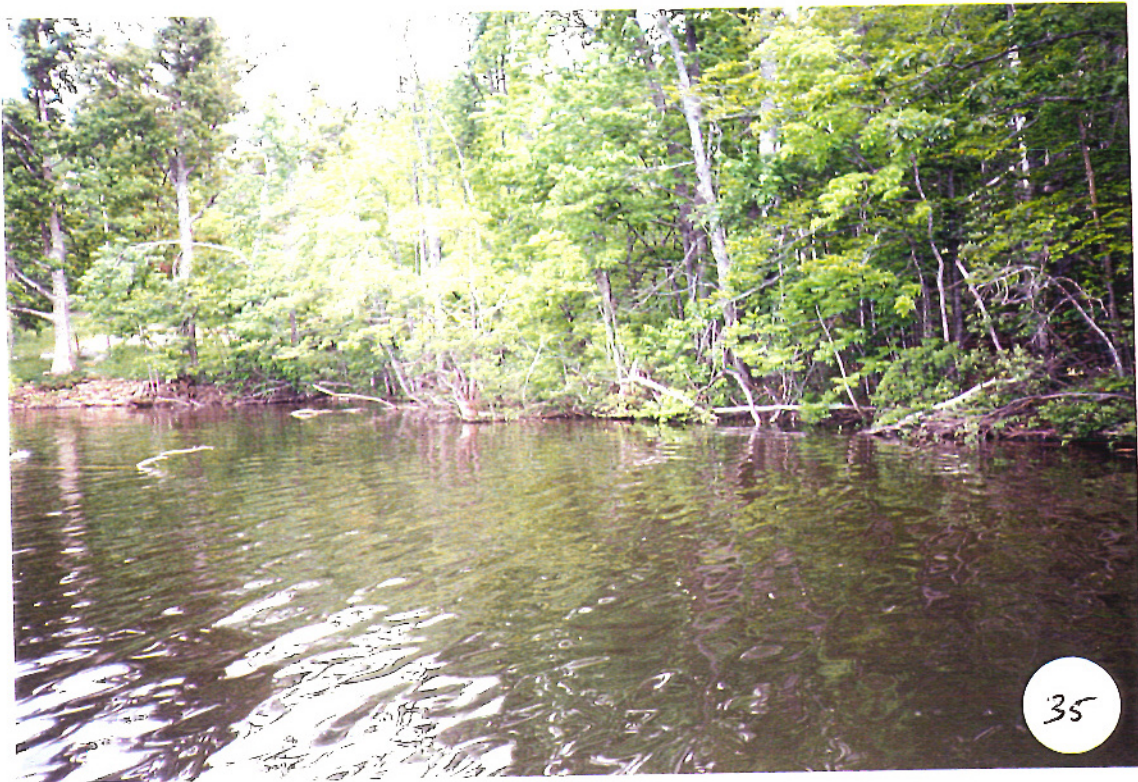
This is the bottom of FR # 41 at lower end of road, seen at top of photo, water runs down though vegetation but does reach lake. Should be remedied by reditching. The next photo is slightly to the South and is a local boat launch area with some minor upland erosion.

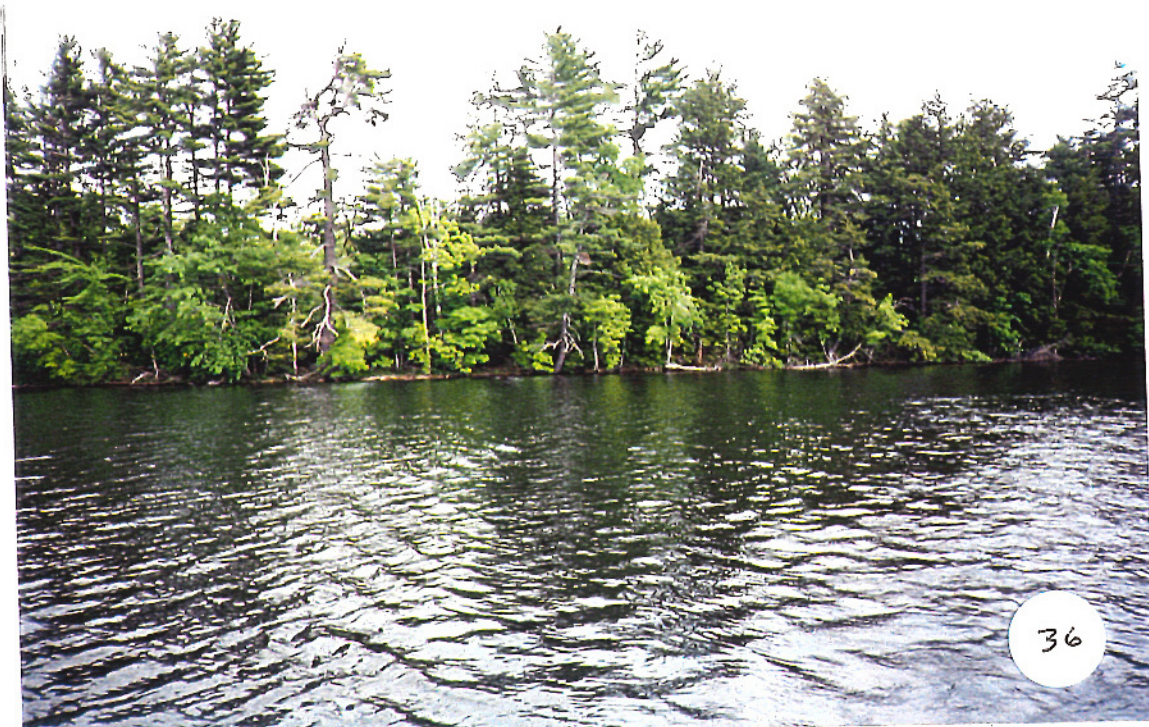
**6/12/00 S.W. +5**

600-foot section between Friend's Camp and Robert Priest property that has exposed soil and roots at current water levels more rock than that in next photo but still at risk. Priority Medium High but access may be a problem.
