# China Lake Association

## CHINA LAKE WATERSHED SURVEY 2000

**PRELIMINARY RESULT**  
**SHORE FRONT SURVEY**  
**STREAM AND TRIBUTARY SURVEY**

## SHORE FRONT SURVEY EAST BASIN 2000

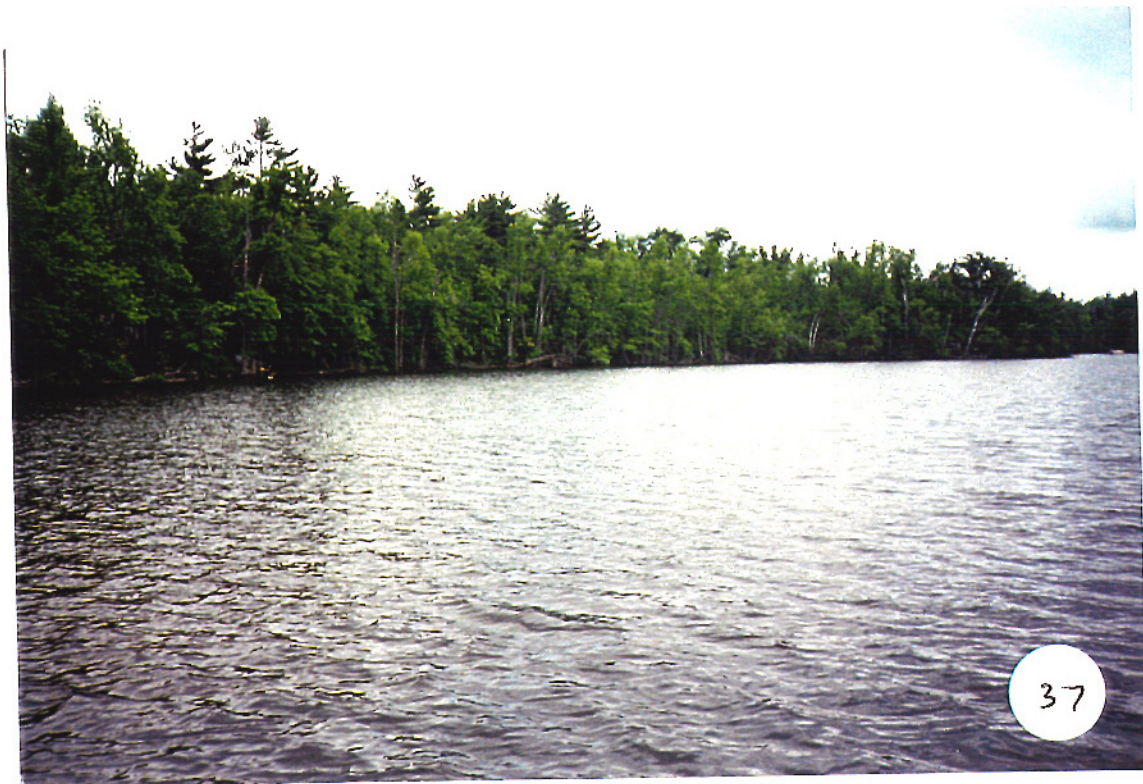
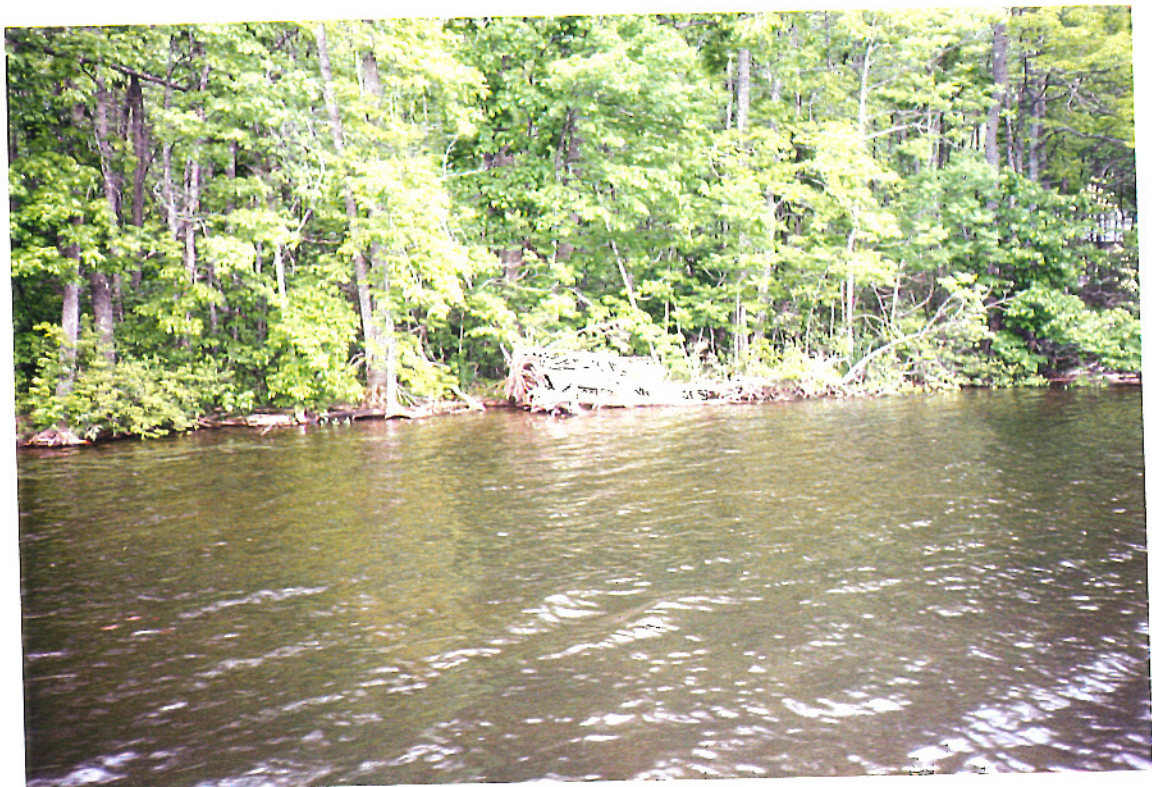
**6/12/2000 S.W. +5**

1000 foot section on East Shore opposite John Jones Island. This section shows ongoing erosion with variable amount of rock along the shore. There is much vegetation around the roots that stabilizes the soil but this is still an area at high risk than most others. There is little natural rip rap below the water line. High Priority area by relatively inaccessible. (2 pictures)

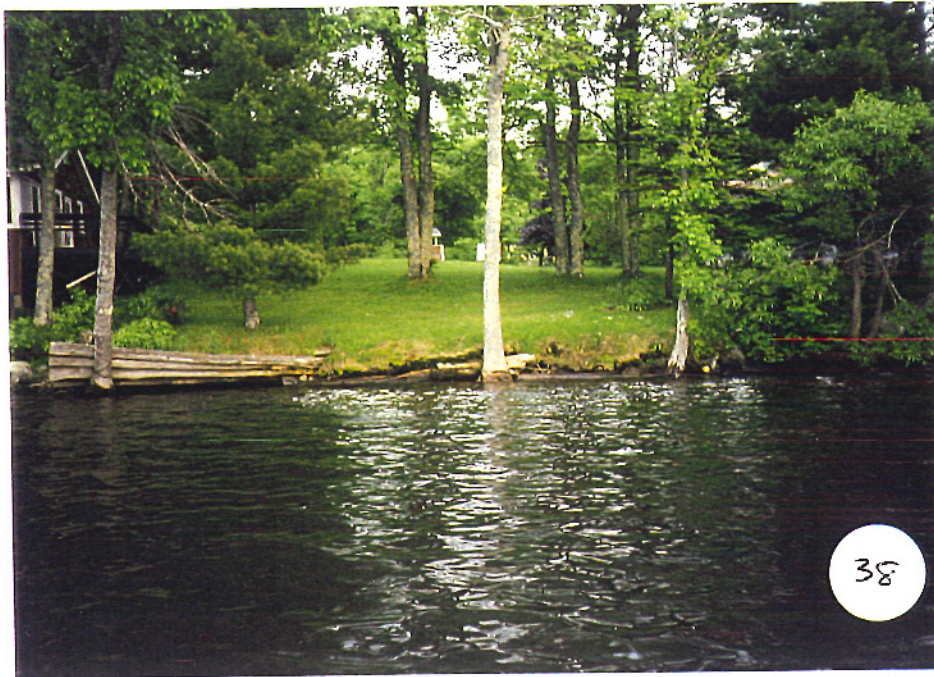
**6/10/00 S.W. +3**

Second property on F.R.#36 collapsing retaining wall 30-50foot of soils 8-10 inches in height. Retaining wall area may be difficult to repair. Name on cottage is Lawler, information left at camp. Medium priority.

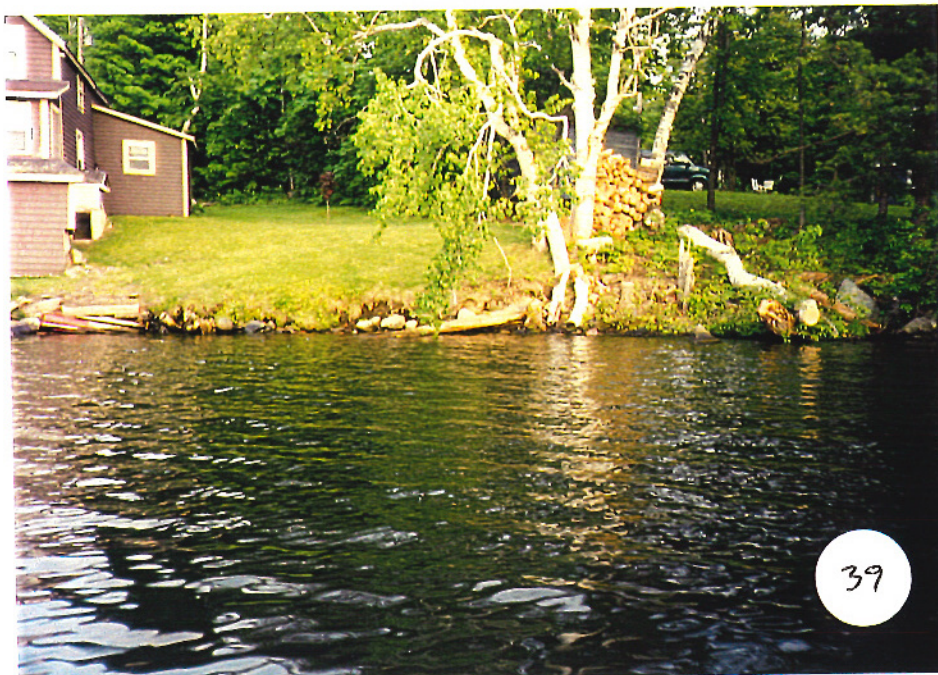
**6/10/00 S.W.+3**

Property on F.R. #36. Storm damaged tree with collapsed bank, 40 feet of eroding bank up two 2 feet in height. Fairly significant soil in lake. High/Medium priority. Information left in door.

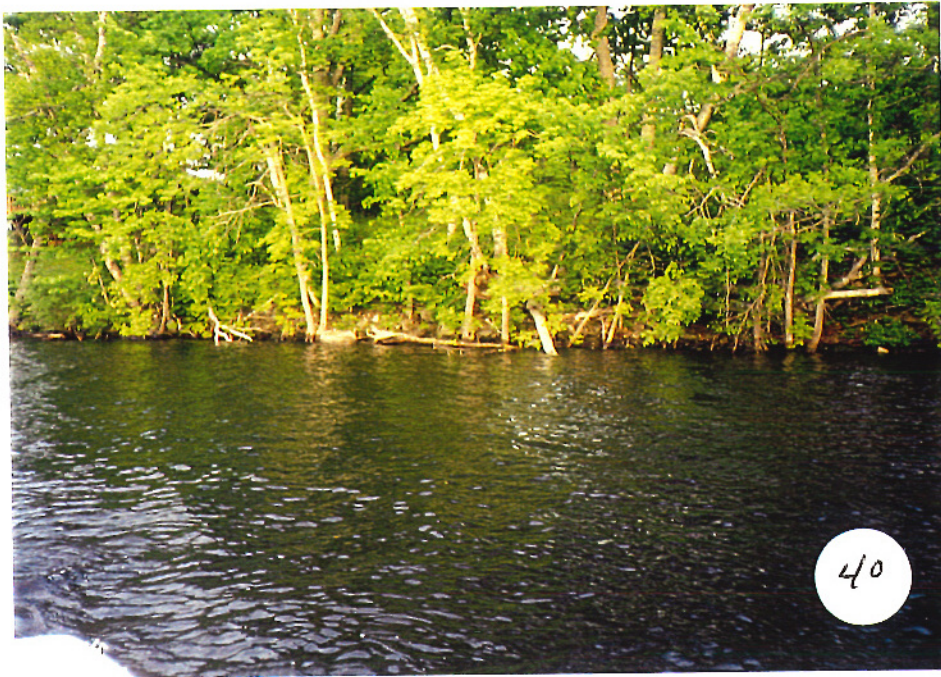
**6/10/00 S.W. +3**

On east shore across from Taconnet Island, 150 feet of previously eroded shore trees in water but with lots of rock around current bank. Does not appear to be actively eroding. Low priority

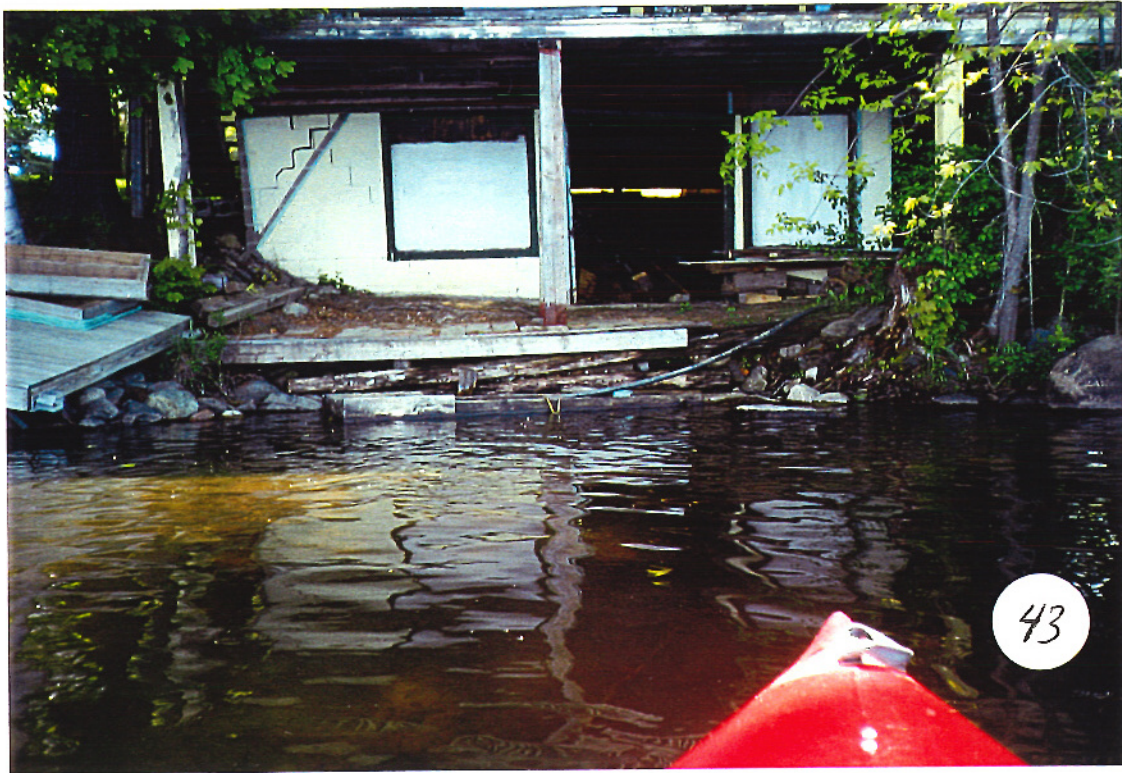
6/8/2000 S.W. +3

THIS 25' SECTION OFF OF FIRE RD 22 IS A ROTTING RETAINING WALL  
WITH A CAMP THAT IS FALLING DOWN. TO RIGHT TREE IS UNDERCUT OVERALL  
MINIMAL AMOUNT OF SOIL LOSS  
NOTICE LEFT AT PROPERTY  
**LOW PRIORITY**

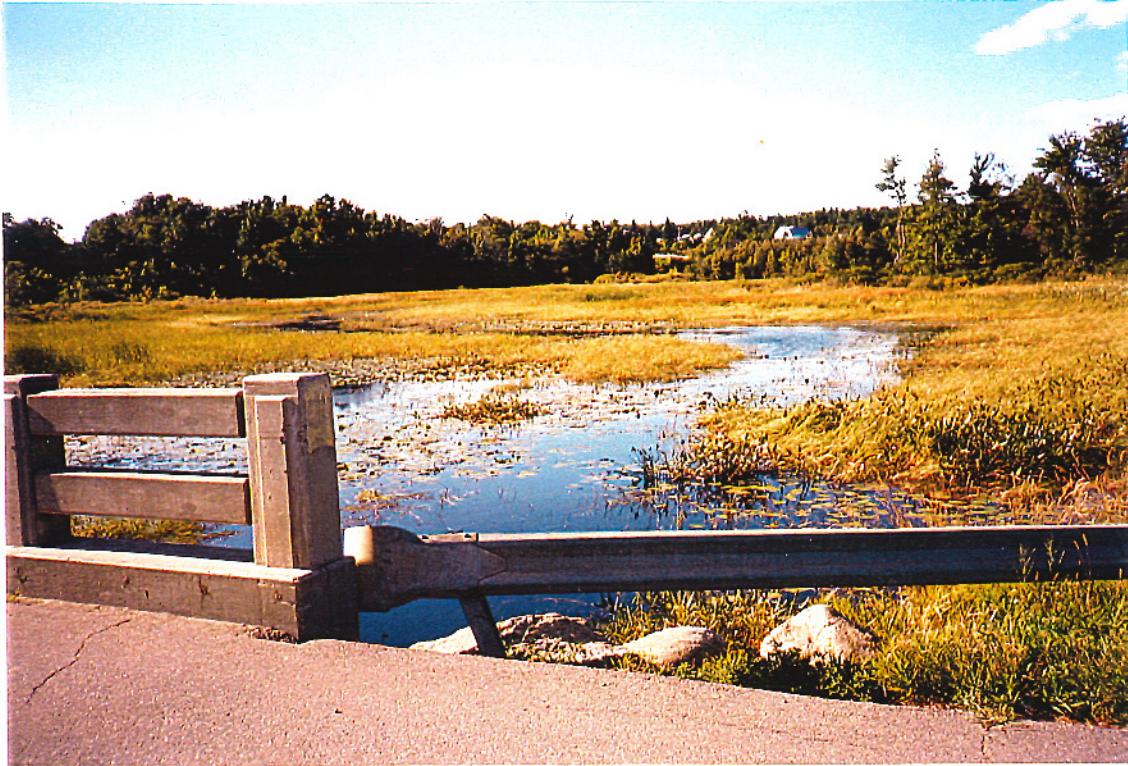
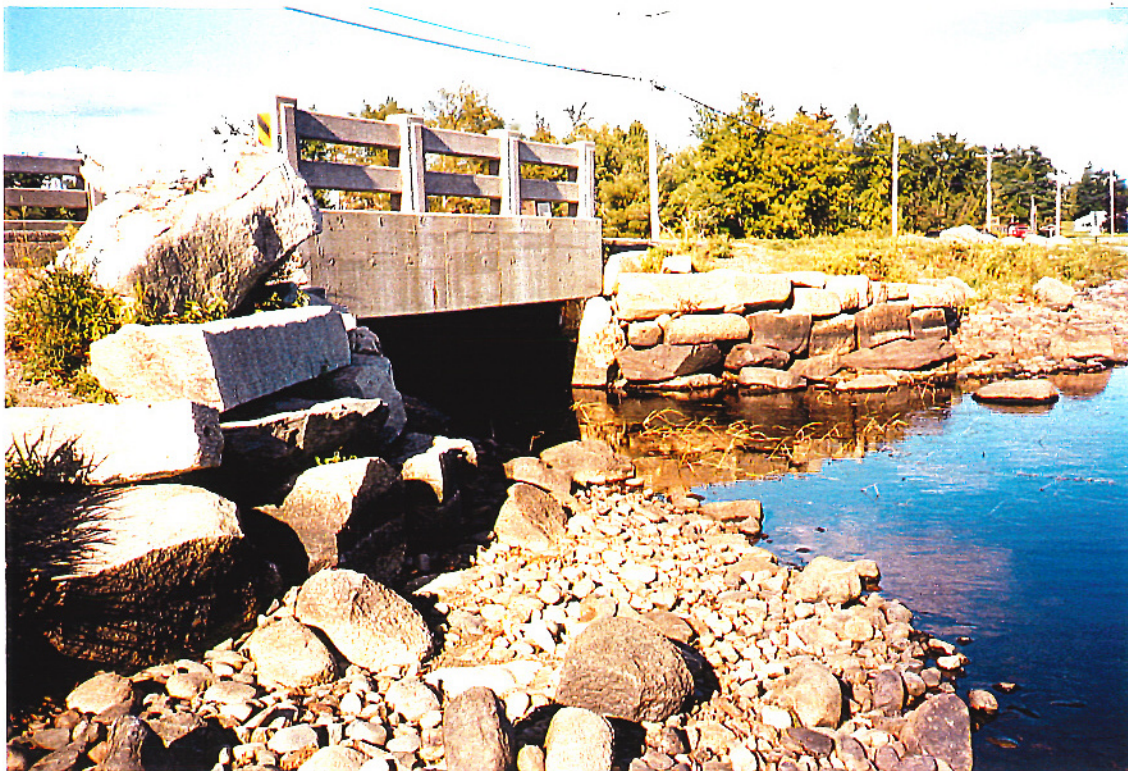
Muldoon Stream- this year round stream flows from a 50 acre marsh on the north side of Route 202 at the head of China Lake. It crosses under 202 and then then under the causeway near the boat landing. This stream appears to be the highest volume contributor to China Lake. In the Spring ripples and currents from this stream can be seen to extend 500 feet out into the lake. The stream's watershed is relatively undisturbed at the present time and the water runs clear although stained with tannins. During construction of Route 202 locals recount this stream being heavily silt laden for long periods of time. **Site A, 2 Photos.**

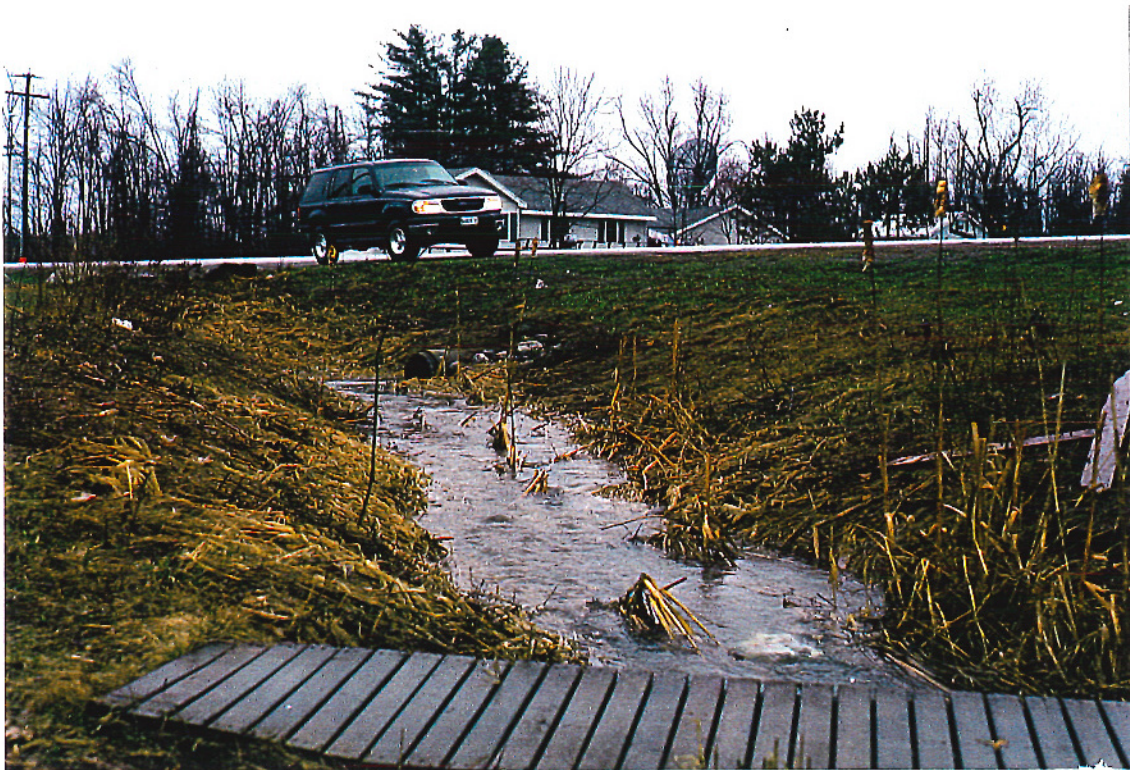
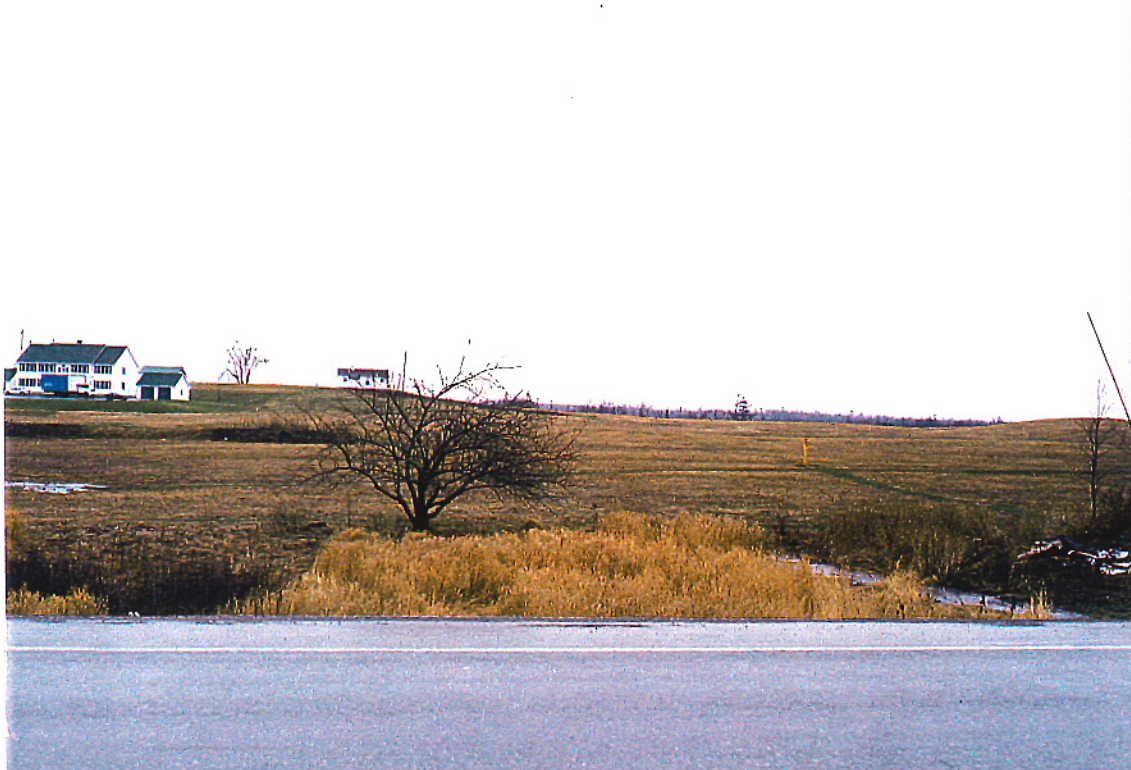
HEAD OF LAKE STREAM- Intermittent stream with cloudy water with obvious sand delta in lake . Drainage is from a 20 acre field that is well vegetated with stable soil. Small wet land present on upland side of culvert. Silt fencing or more permanent structure may help. **Priority Medium. Site B 2 Photos**

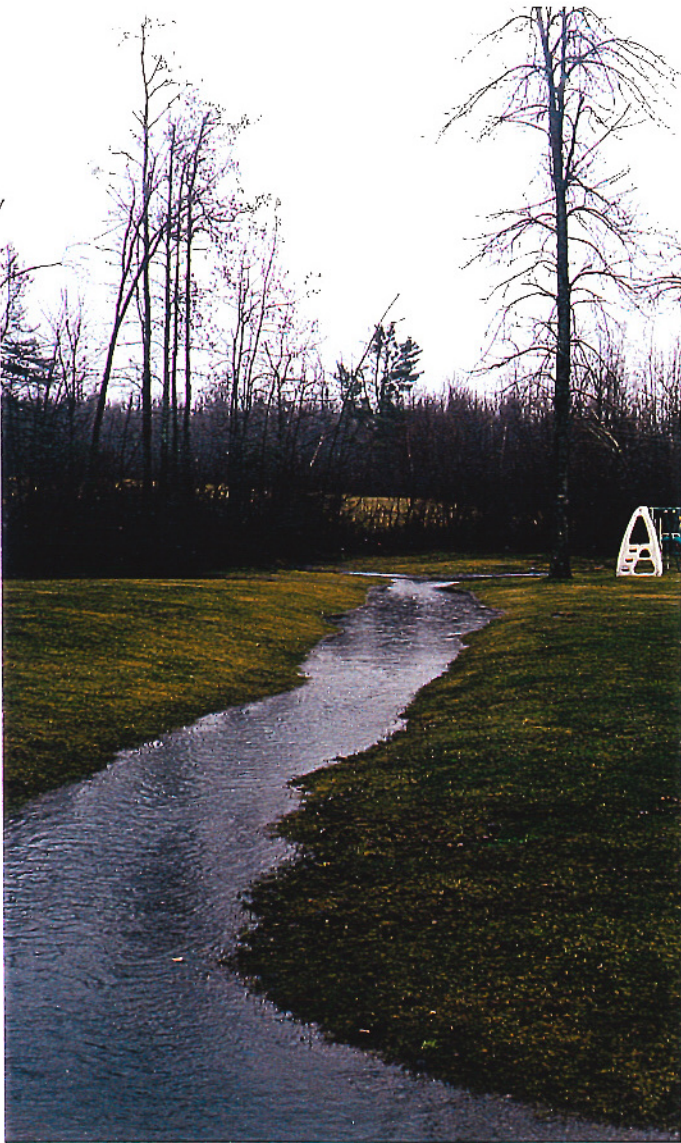
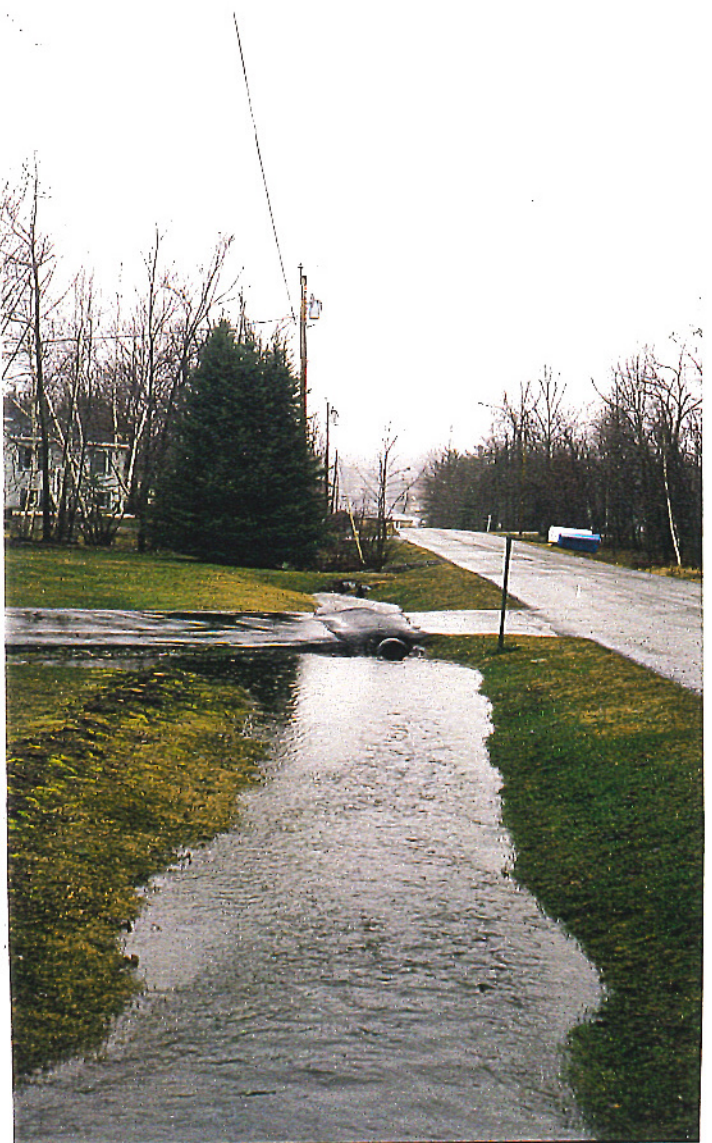
LAKEVIEW CULVERT SOUTH- High water flow with high levels of siltation crosses to Keso property. Siltation from indeterminate sites above but not from Lakeview Lumber property. Appears to be soil coming from upper end of Parmenter Drive with large amounts of water running in road side ditches. **High Priority. Site D. 7 Photos.**

Water along Paramenter Drive

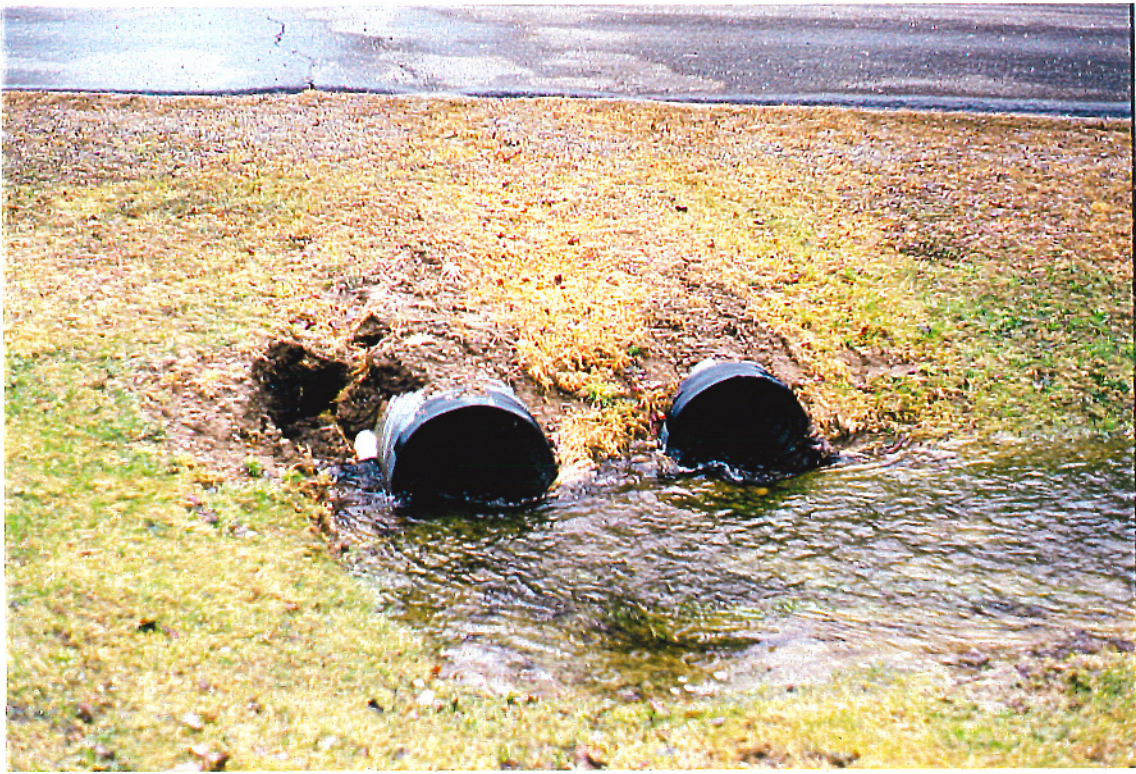
Eroding culverts on the upper portion of Parmenter Drive

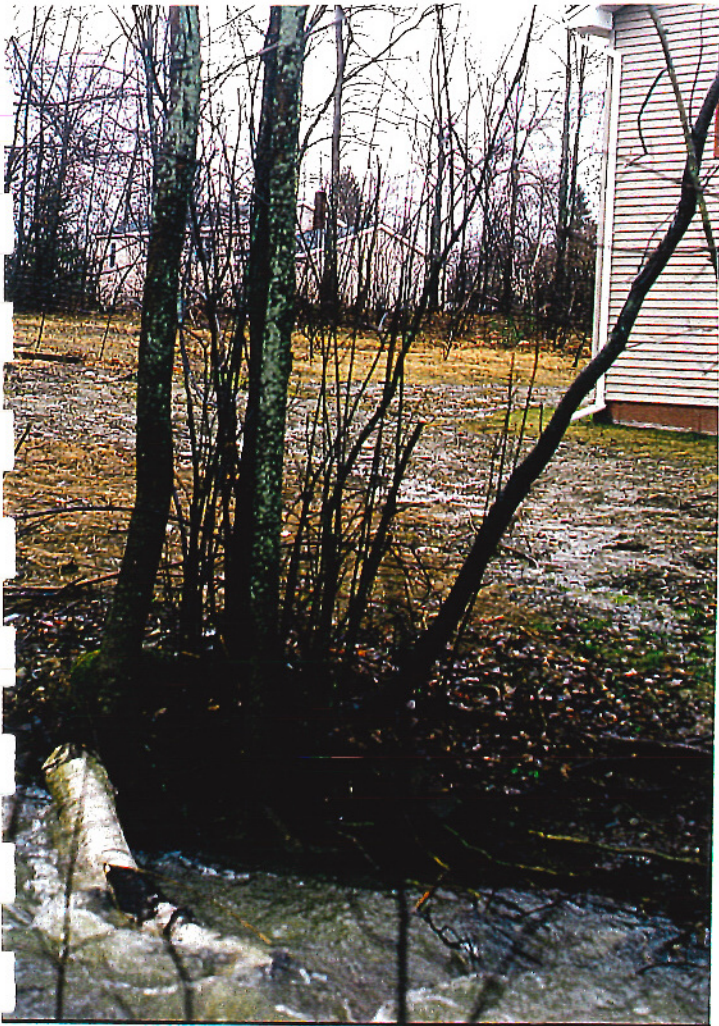
Runoff from Gagnon Property

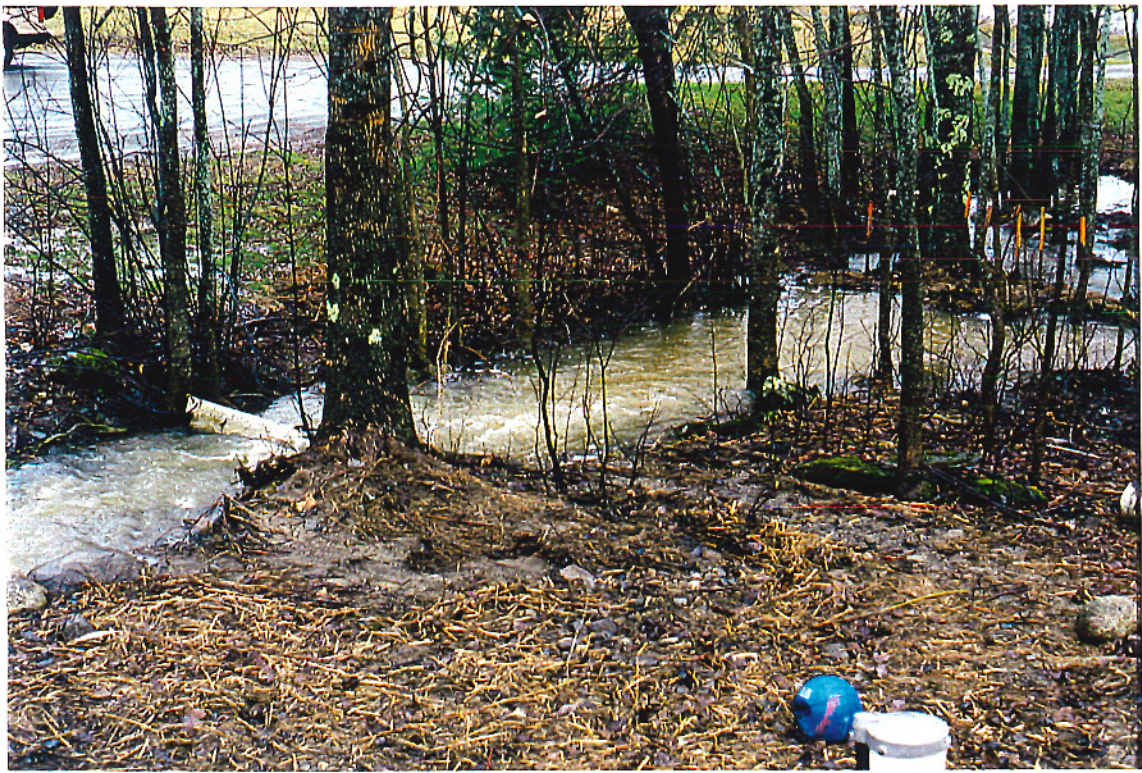
Heavily silted water

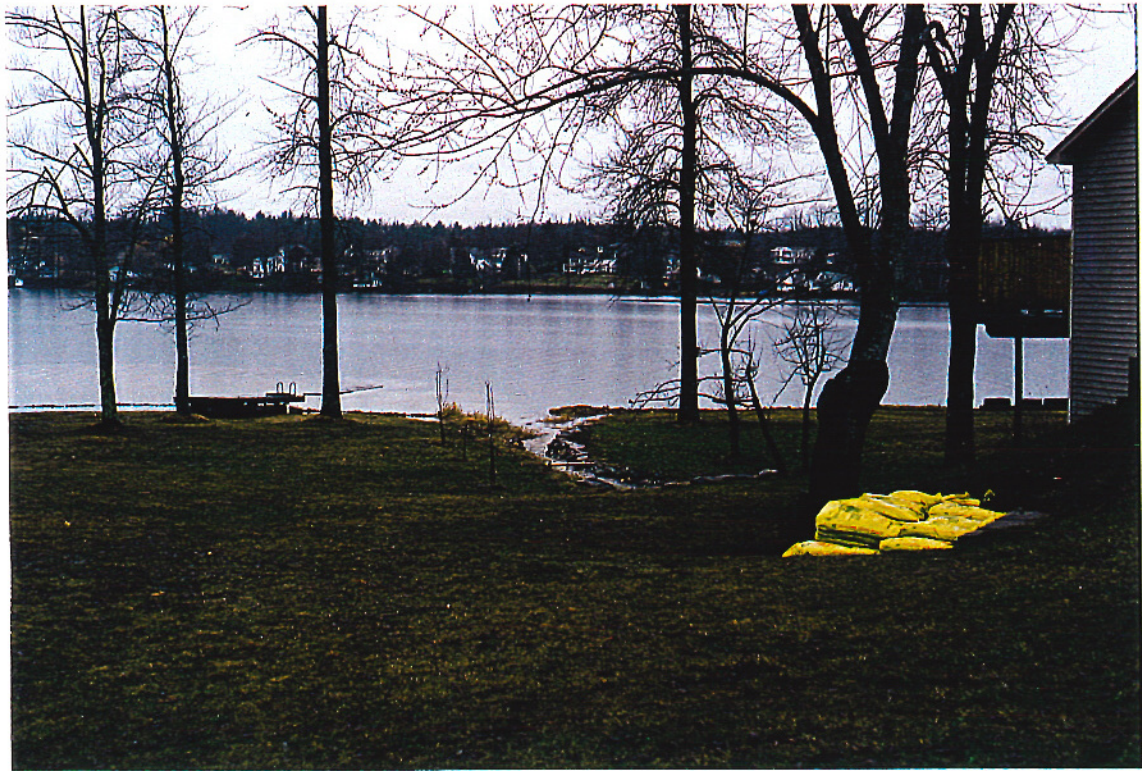
Stream empties into China Lake

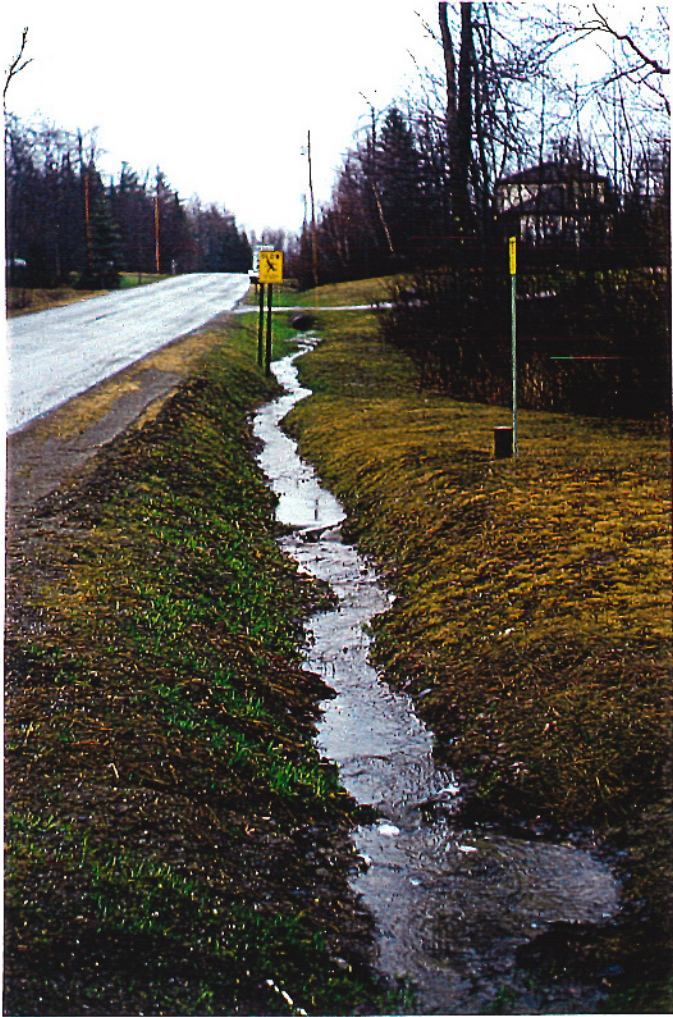
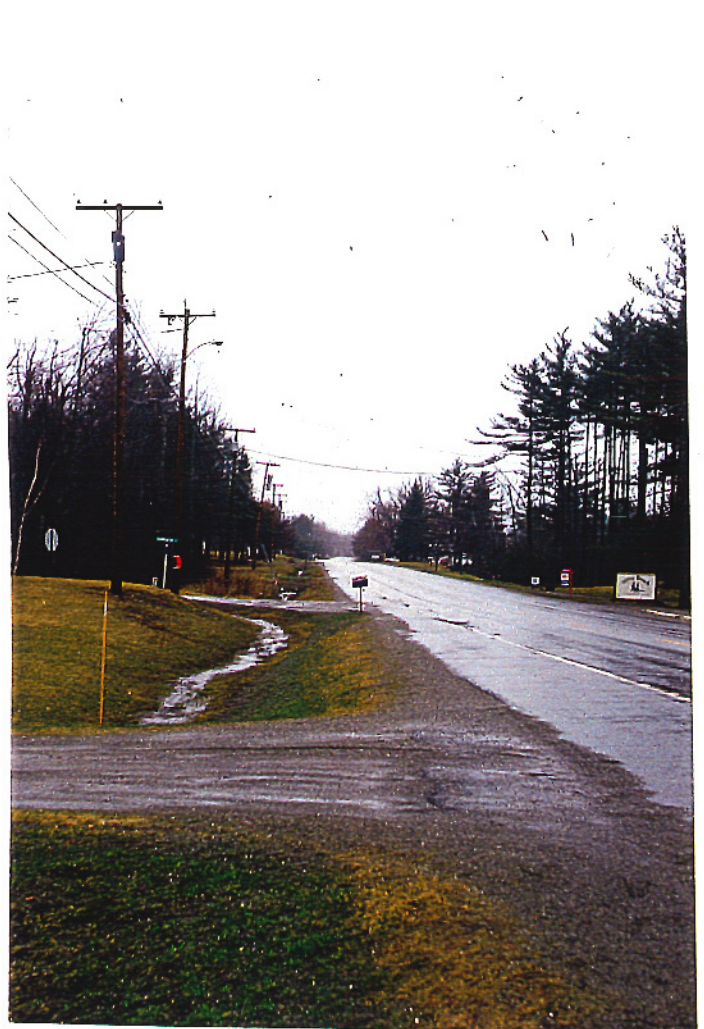
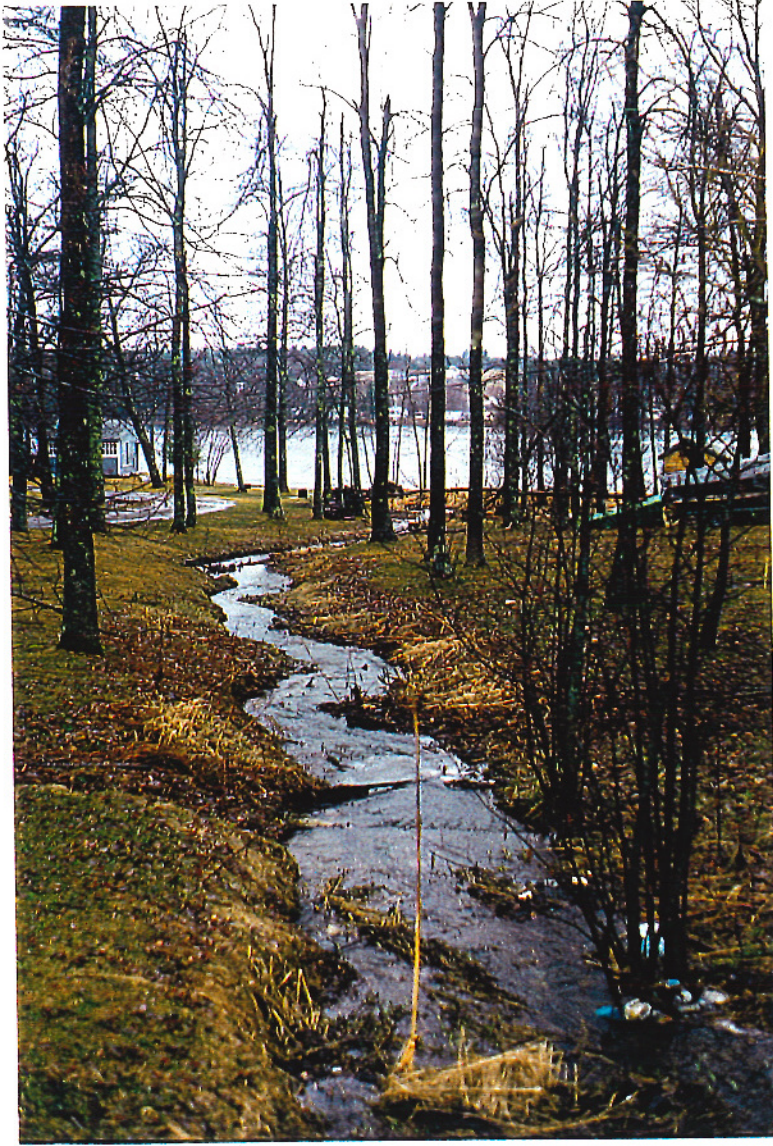
WHISPERWOOD STREAM- Intermittent stream that drains the South side of Parmenter Drive and a section of Route 202. **Medium Priority. Site E 3 Photos.**

Whisperwood Stream empties into lake

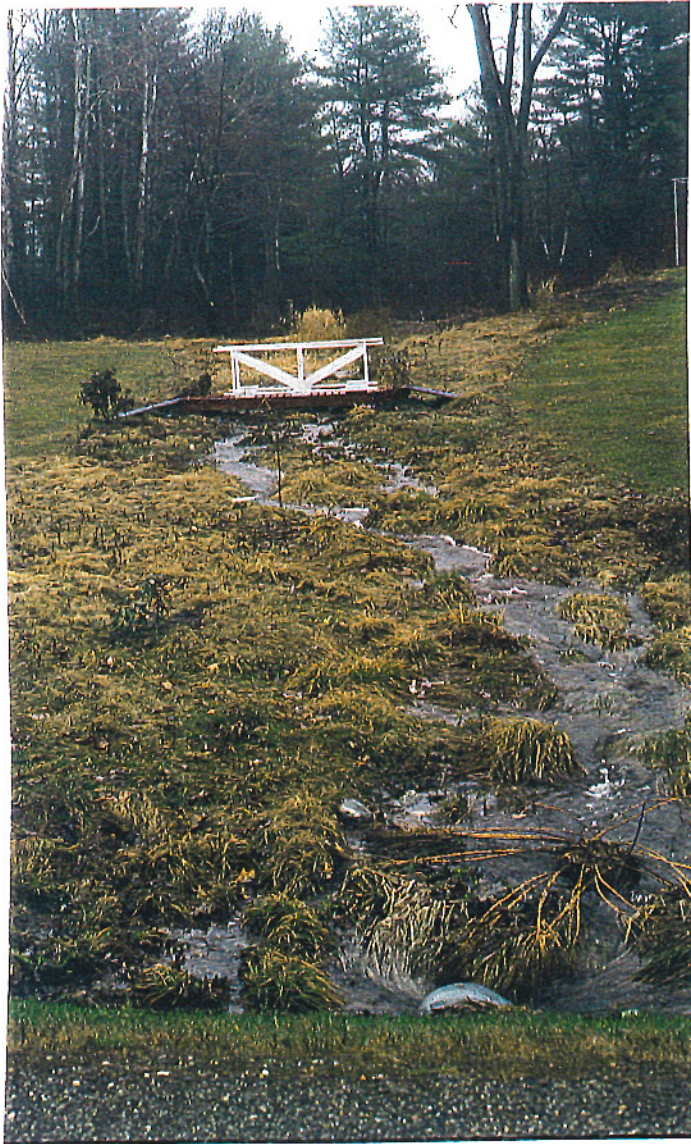
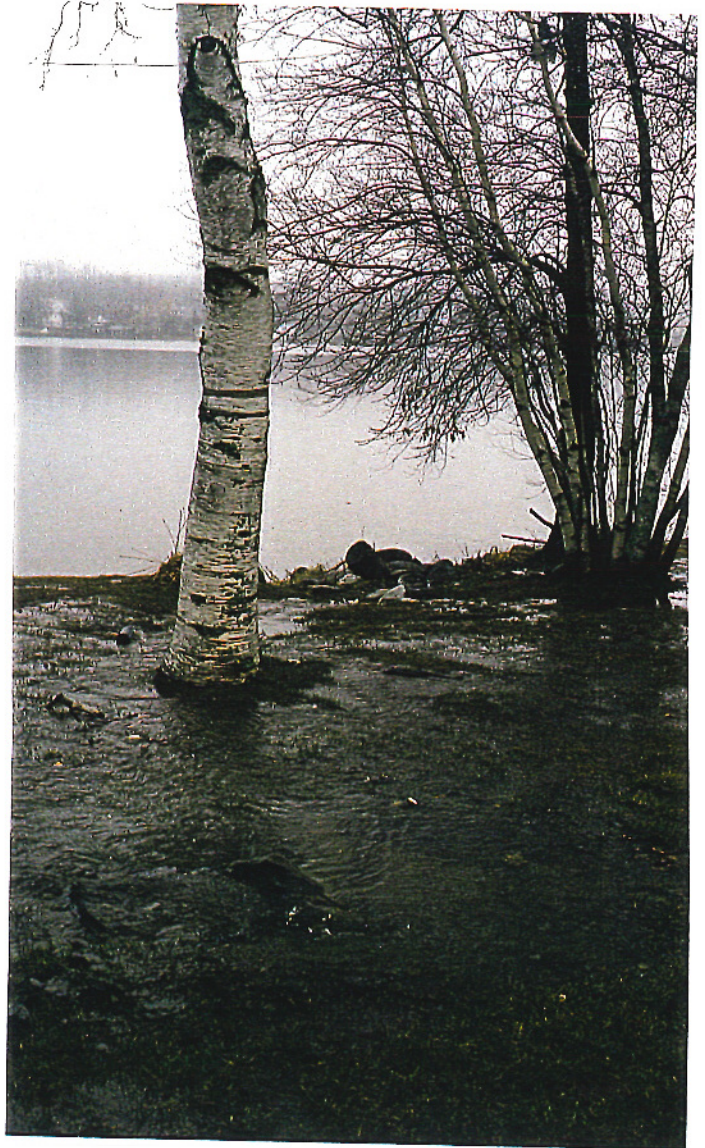
CANDLEWOOD NORTH- This intermittent stream runs only during the wettest periods draining a well vegetated area. It runs clear and travels under the north end of the Candlewood property in a culvert emptying through a French drain system that was placed as part of the lake restoration project. **No Work Needed. Site F. 2 Photos.**

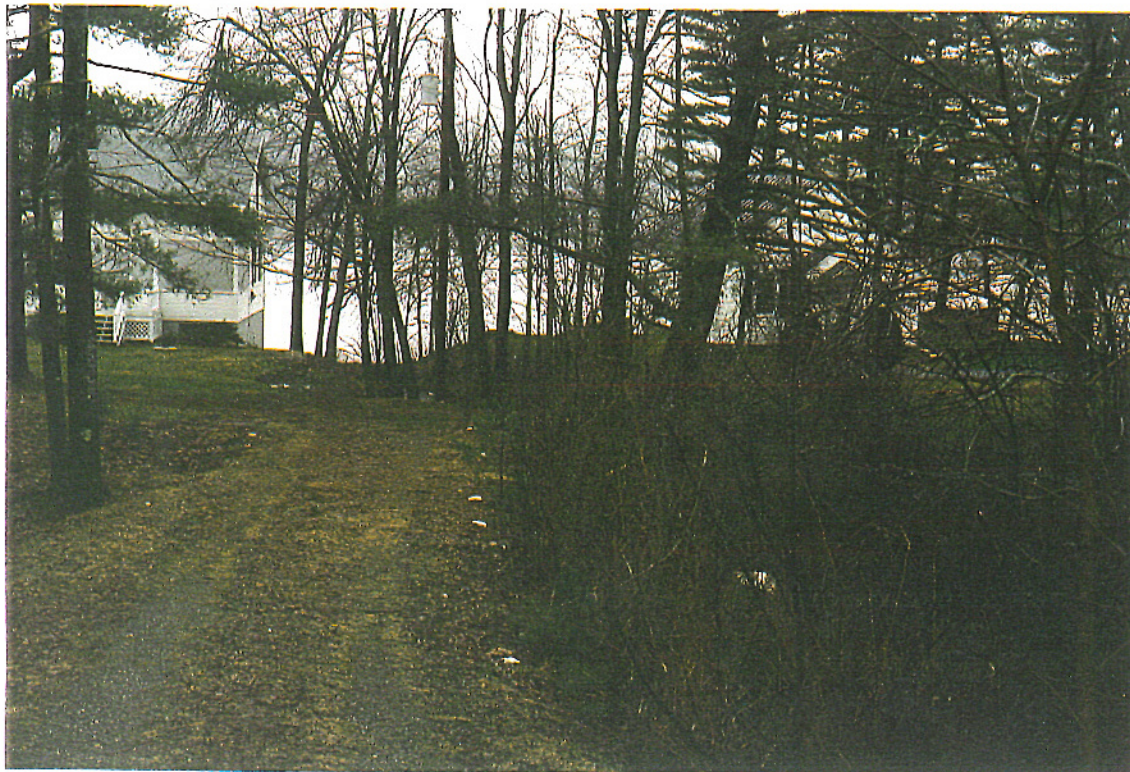
CANDLEWOOD SOUTH- Intermittent stream with culvert crossing 100 yards south of Candlewood runs fairly clear. Where the stream empties into the lake there is some minimal bank erosion. **Low Priority. Site G. 1 Photos.**

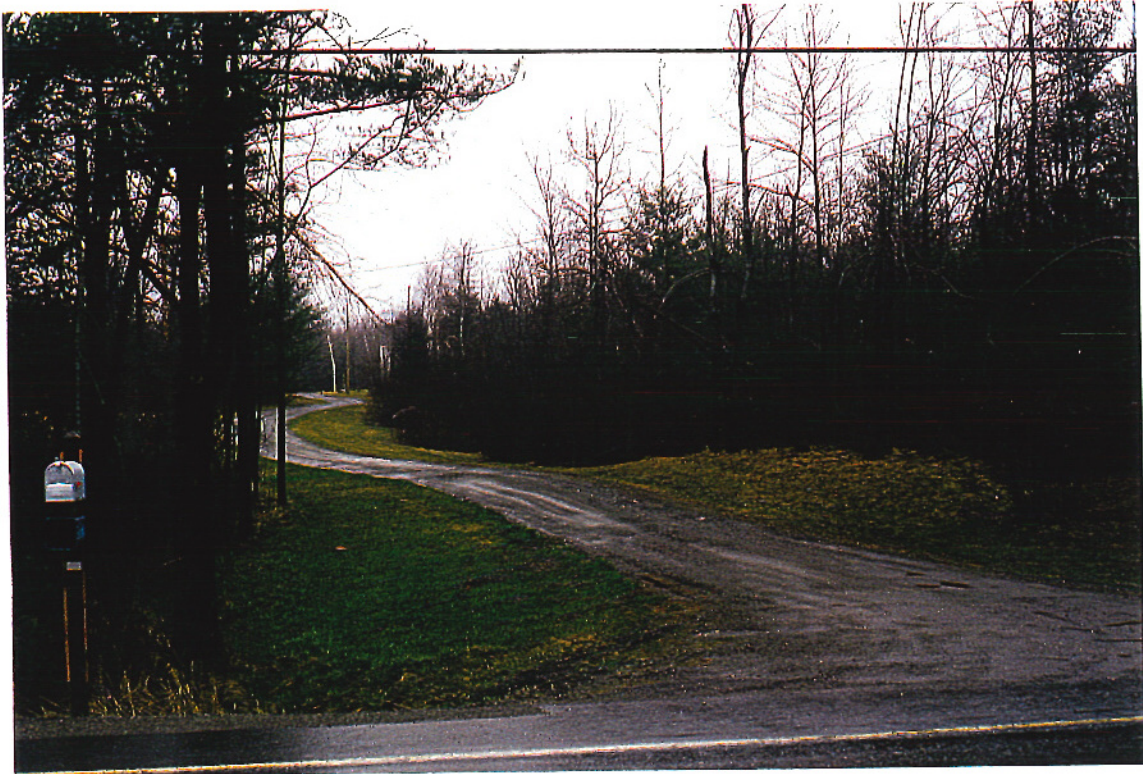
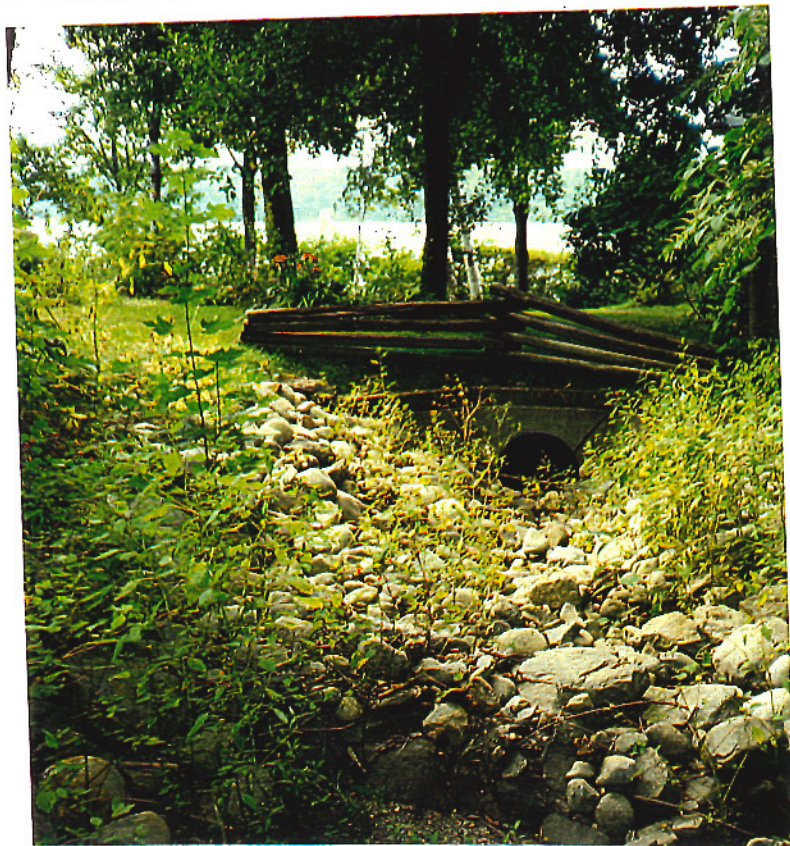
FIRE ROAD 20- This culvert crossing is 50 yards south of Fire Road 20. It drains an upland wooded area with significant amounts of runoff from a driveway on the upland side of route 202 marked by mail box number 1555. This stream empties into the lake by flowing in a culvert under Mary Halkyard's property. This 48 inch diameter culvert was replaced in 1999 through a cost share project with the China Lake Association. **Drive way is Medium Priority. Site H. 2 Photos**

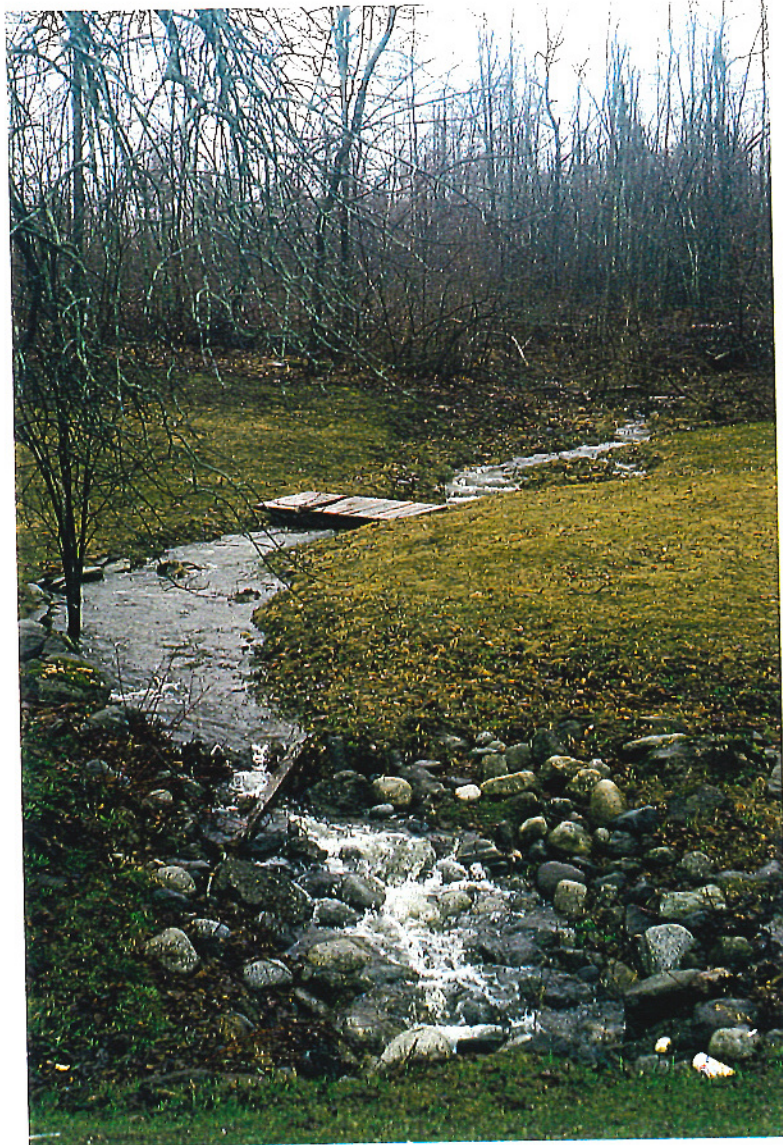
FIRE ROAD 21-22 - This small intermittent stream drains a wooded area and crosses under a small footbridge before crossing under 202. **Low Priority Site I. 1 Photo.**

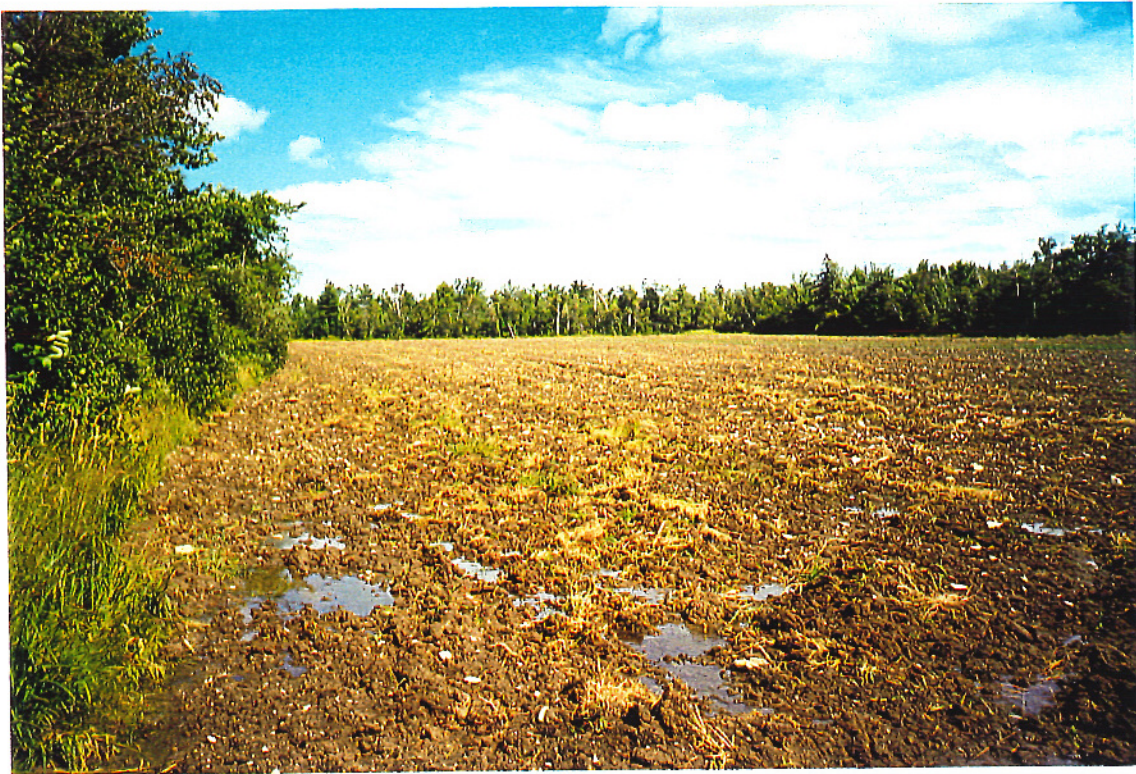
**BAILEY PROPERTY** · This intermittent stream has very high water volumes during spring runoffs and carries a large amount of silt. The stream drains a 20 acre cornfield, pasture, and gravel road. There are multiple areas in need of work and current efforts are being made to convert the cornfield to hay production and improve the flow of water in the badly eroded ditches. **High Priority. Site J Multiple Photos**

Bare soil in upland field
