# China Lake Association

## CHINA LAKE WATERSHED SURVEY 2000

**PRELIMINARY RESULT**  
**SHORE FRONT SURVEY**  
**STREAM AND TRIBUTARY SURVEY**

## SHORE FRONT SURVEY EAST BASIN 2000

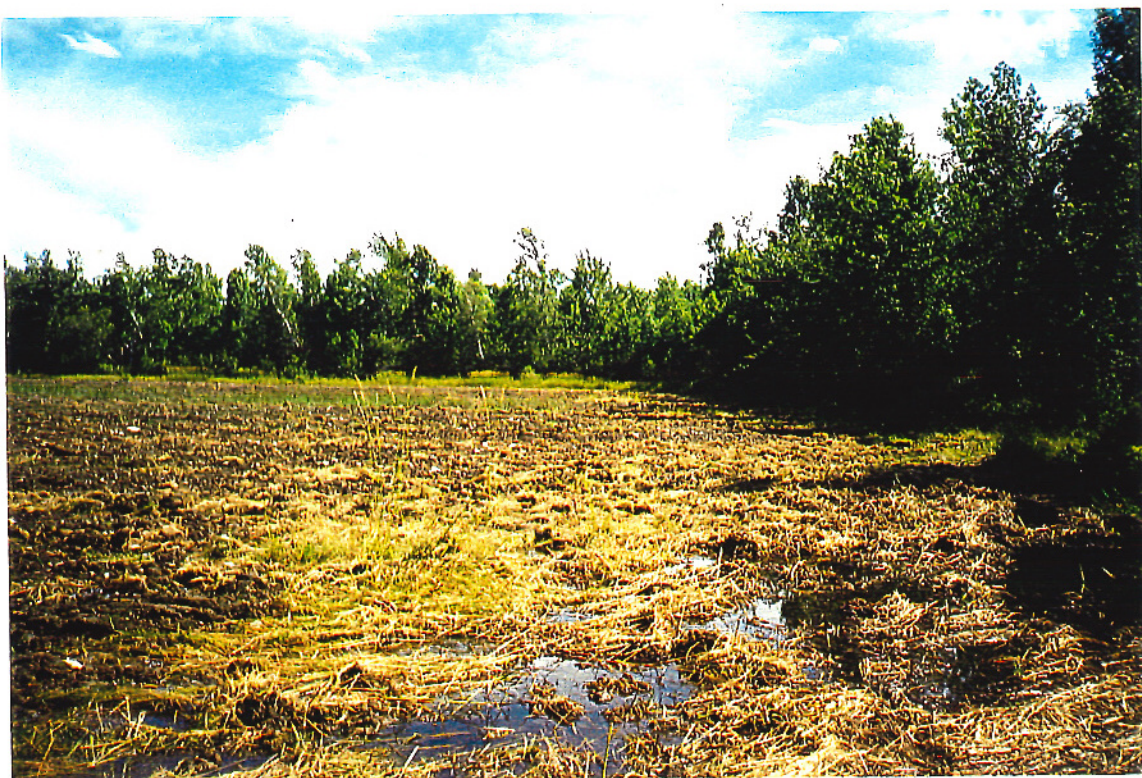
Erosion created ditches and water running down gravel road- Bailey Property

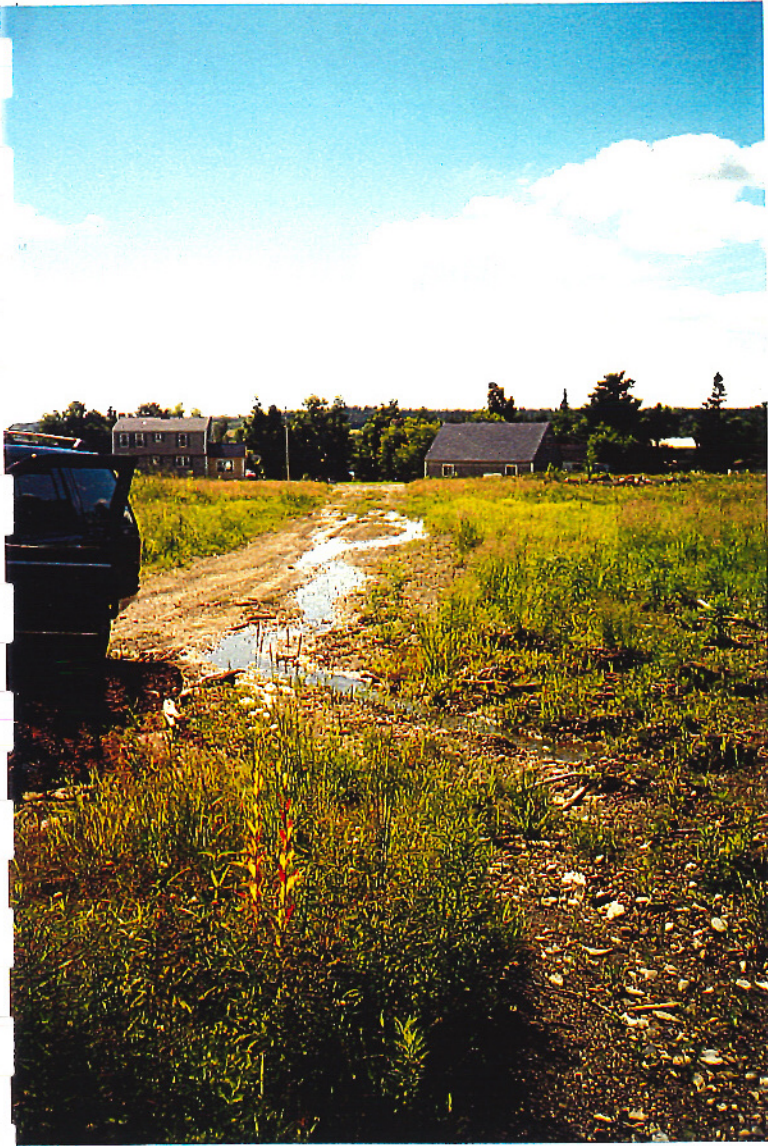
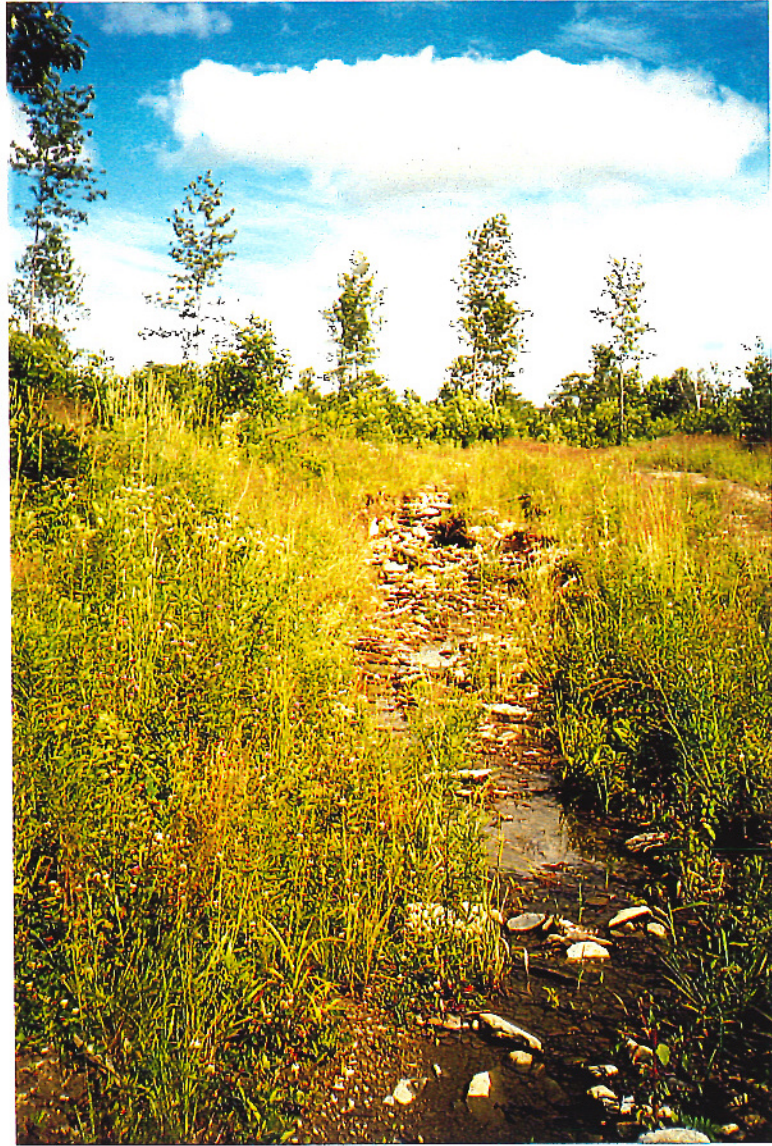
BICKFORD STREAM- This intermittent stream drains an upland wooded area but also runs down along the side of the gravel access road to Bickford's Garage. Obvious runoff from the road into the stream is occurring. **Road is High Priority. Site K.**  
1 Photo (poor quality)

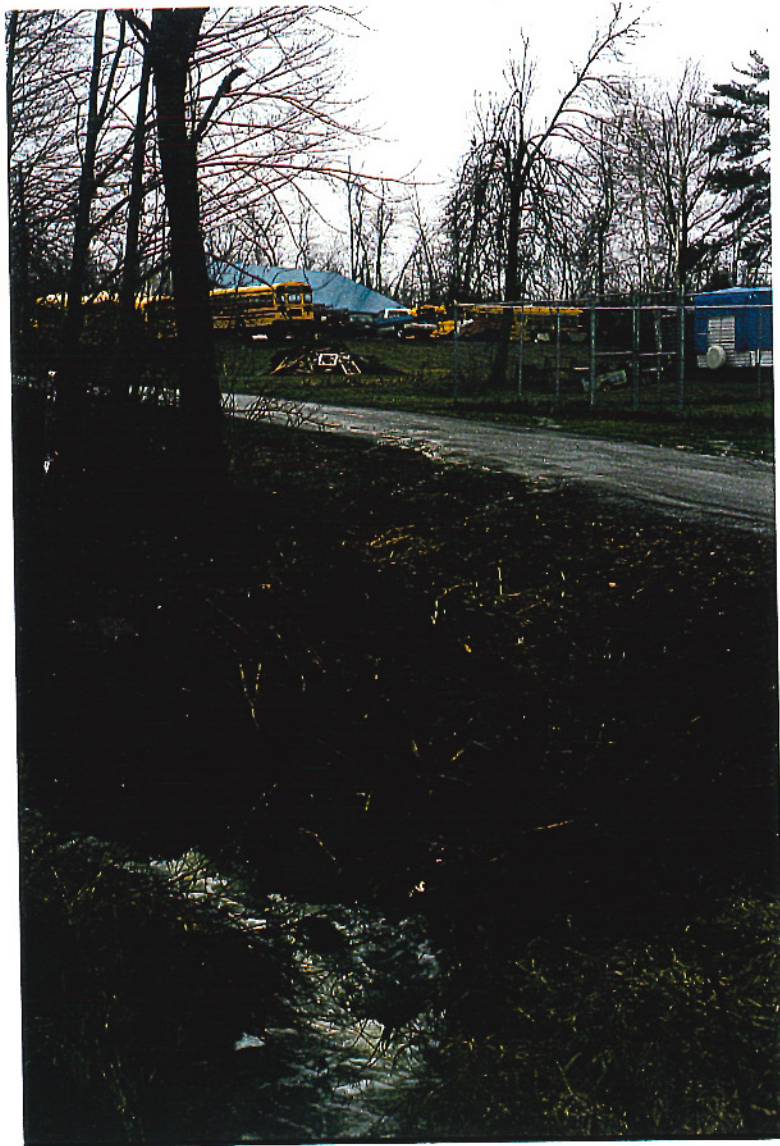
FIRE ROAD 25- Culvert crosses 202 about 100 yards south of Fire Road 25. No real stream provides ditch drainage. **Low Priority. Site L. 1 Photo**

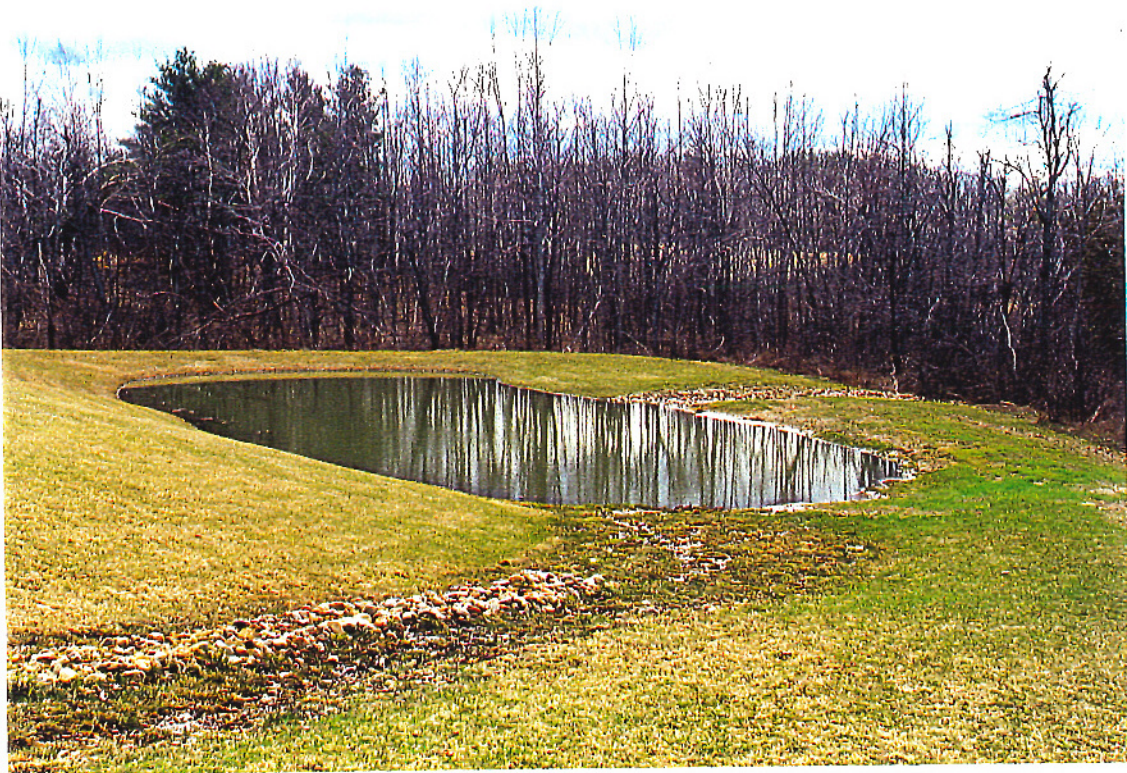
Siltation Pond

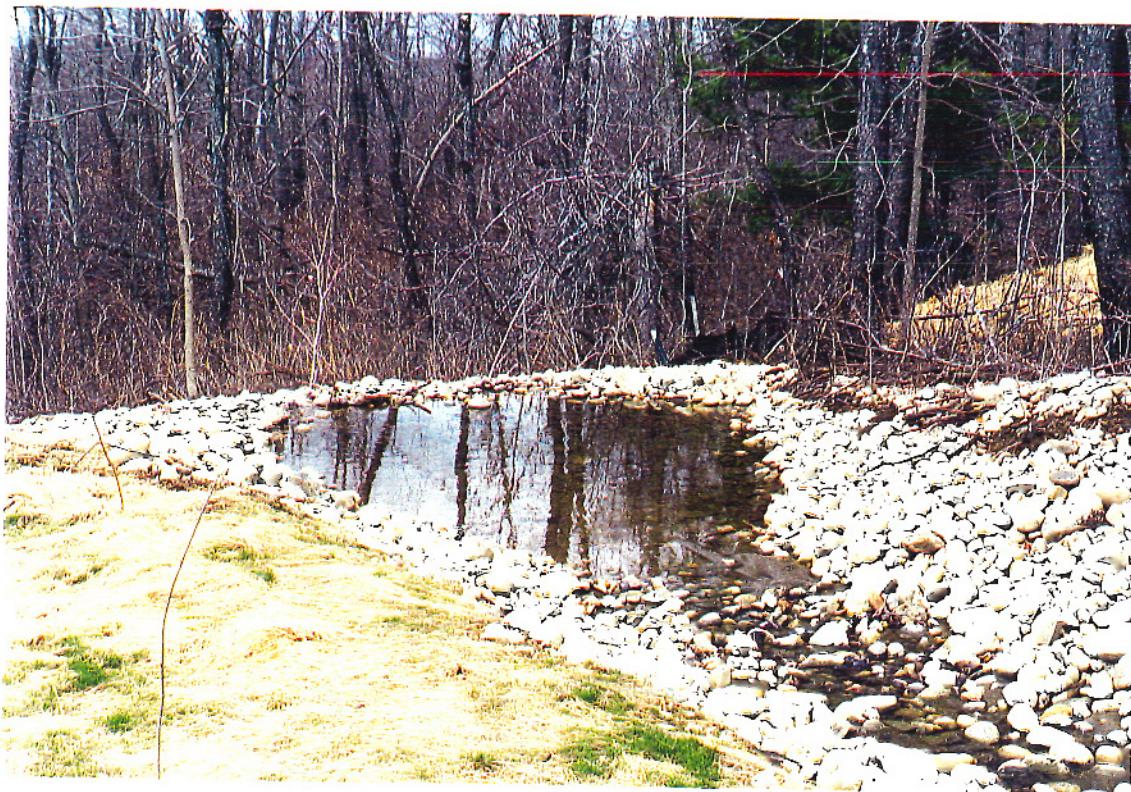
Ditch Turnout

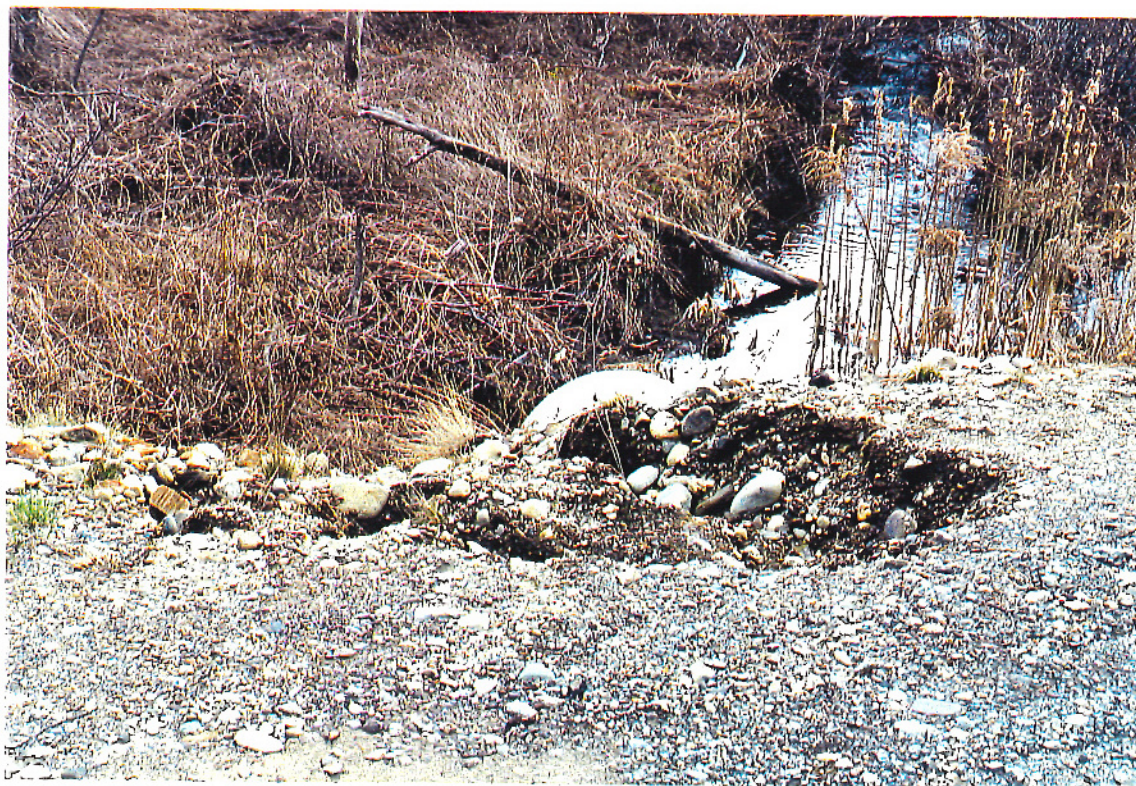
Poorly Maintained Culvert

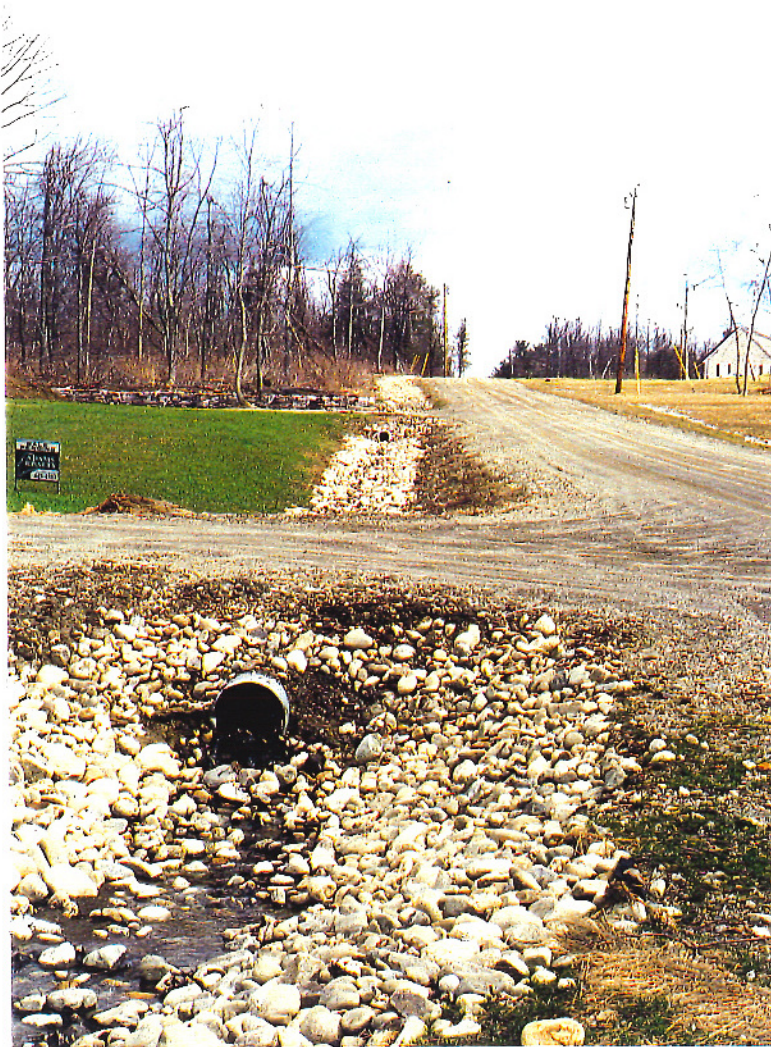
Looking up Slope of Tarabelu Drive

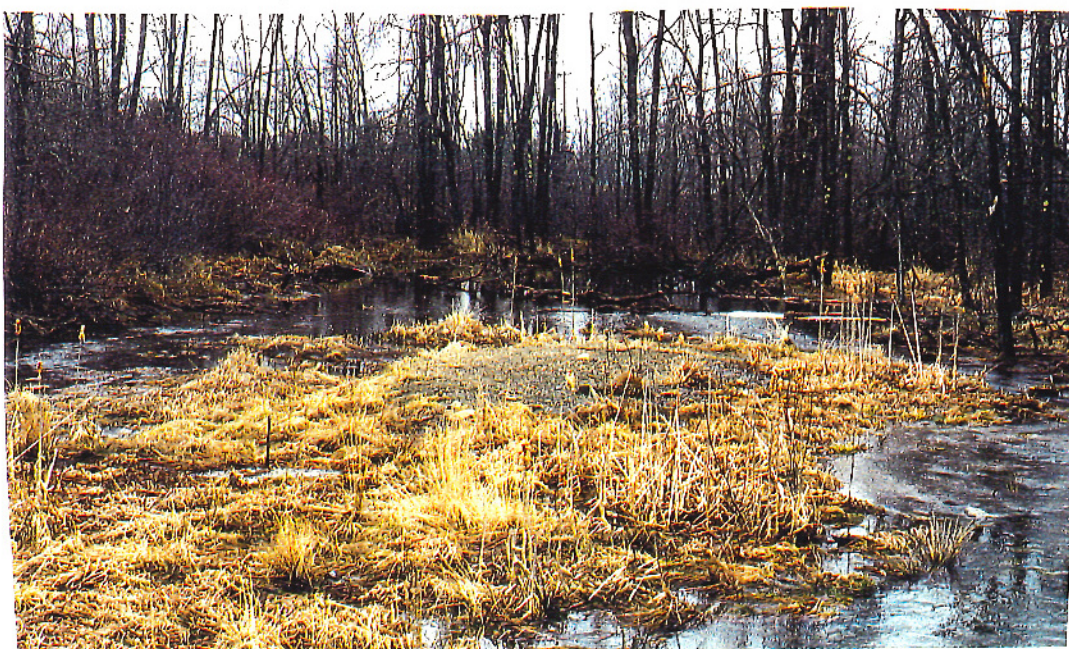
Large Amounts of Sand Seen in Stream Channel

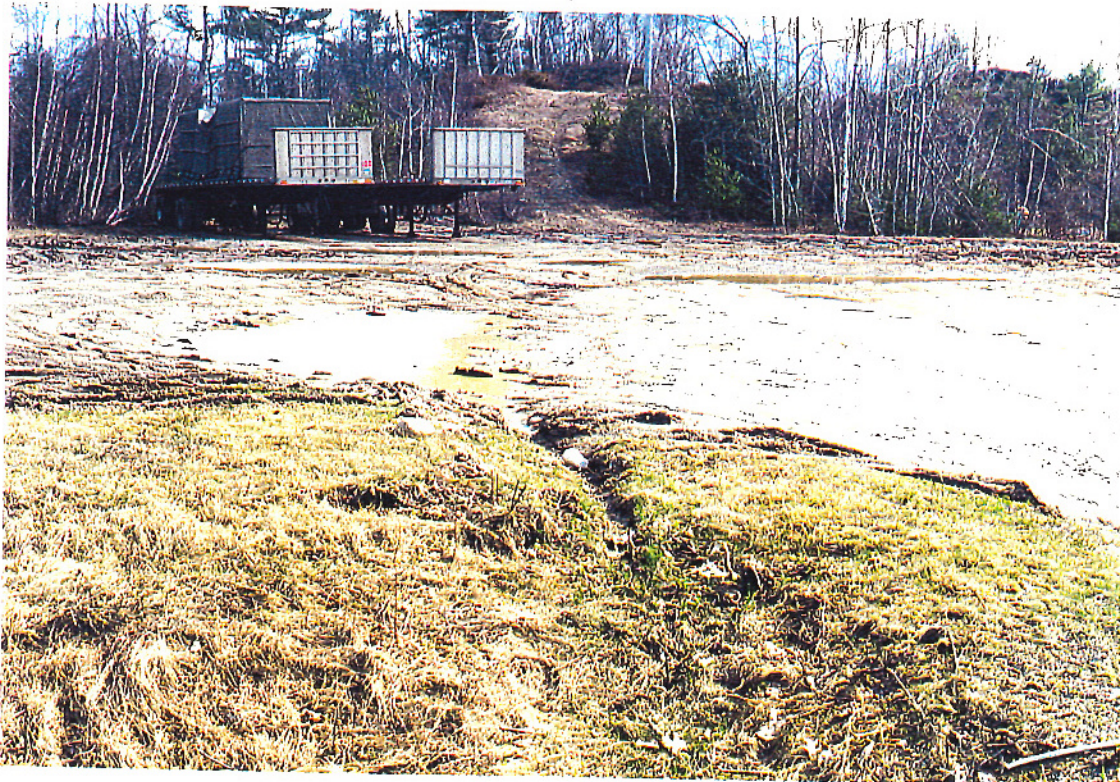
JONES BROOK- This continuous flowing stream is the site of much previous bank stabilization work. The stream runs much clearer than it did in past years although the clay banks are prone to erode under the best of circumstances. There is some erosion at the old Route 202 bridge (no photo) and also runoff from the parking area across Route 202 from Brach's Ice Cream. The parking lot is poorly sloped and dumps into Jones Brook during heavy rains. **The parking lot is a High Priority area. Site P. 1 Photo.**
