# Gravel Road Management Planning – Solutions for Associations

# Gravel Road Management Planning With MES

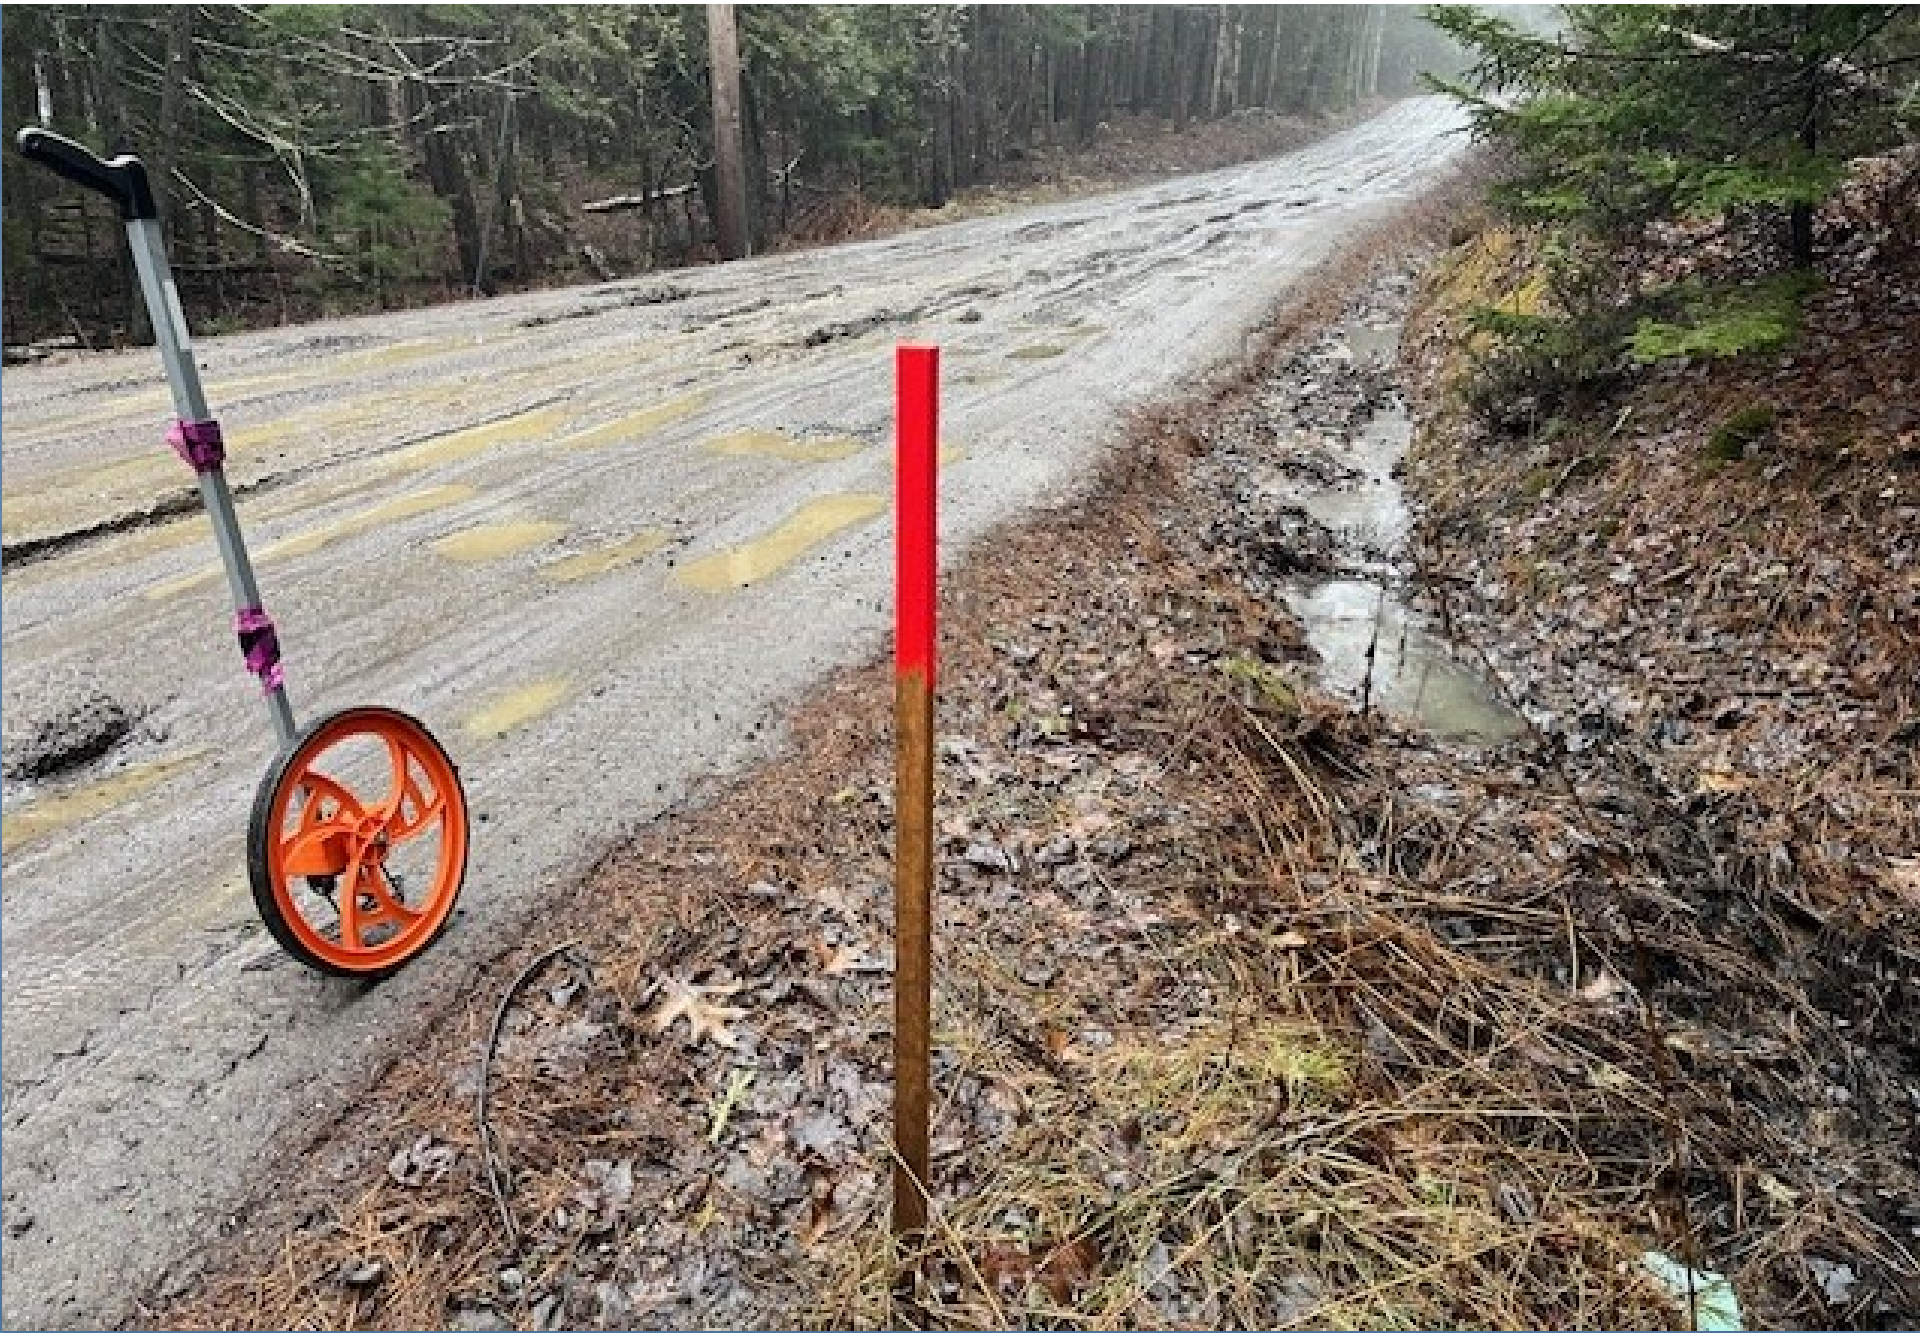
# Saturated Conditions: Mud and Ruts

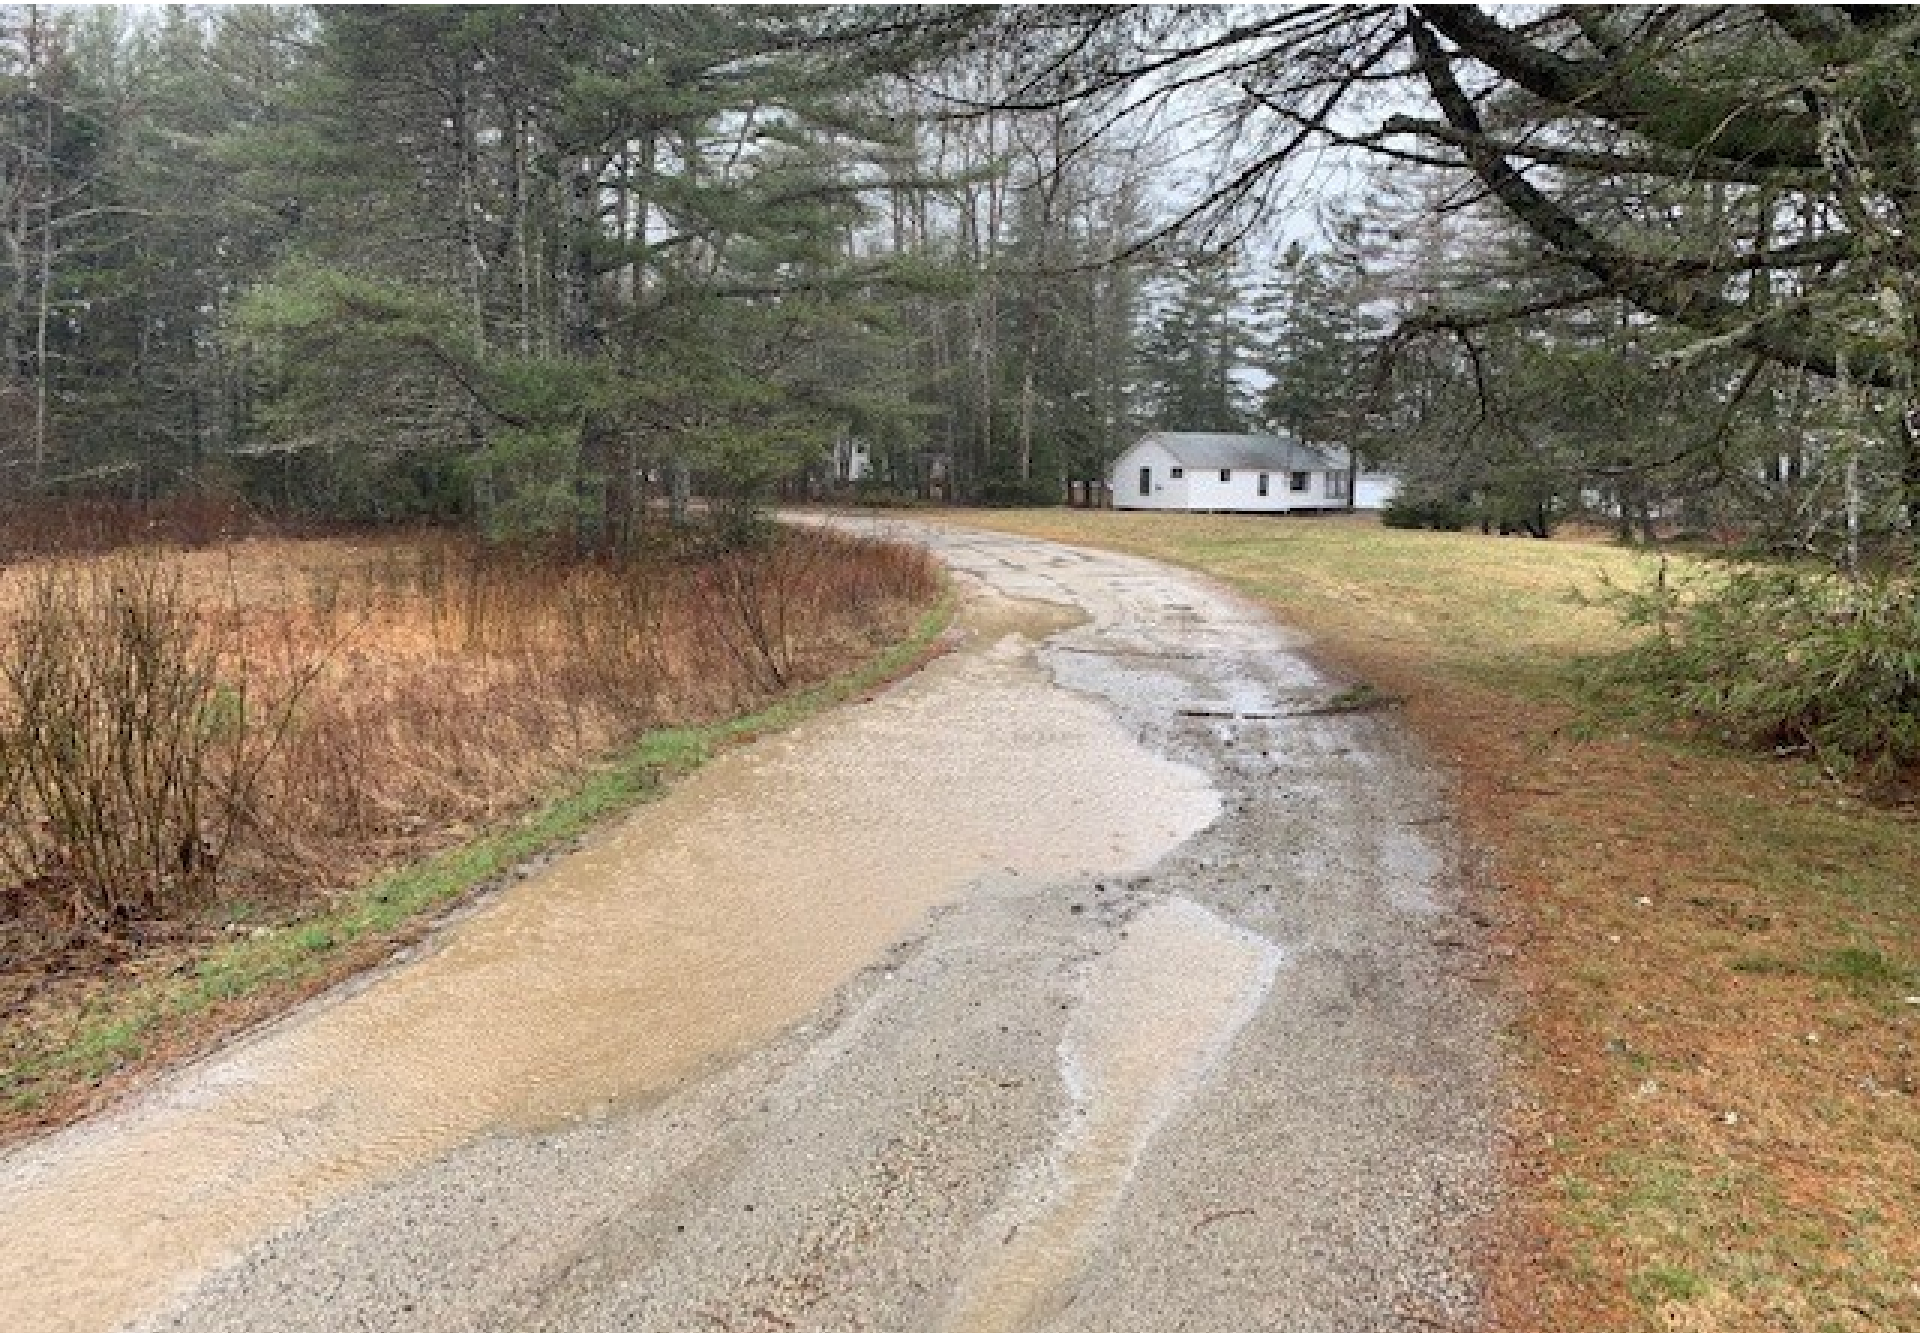
# Lack of Crown: Standing Water

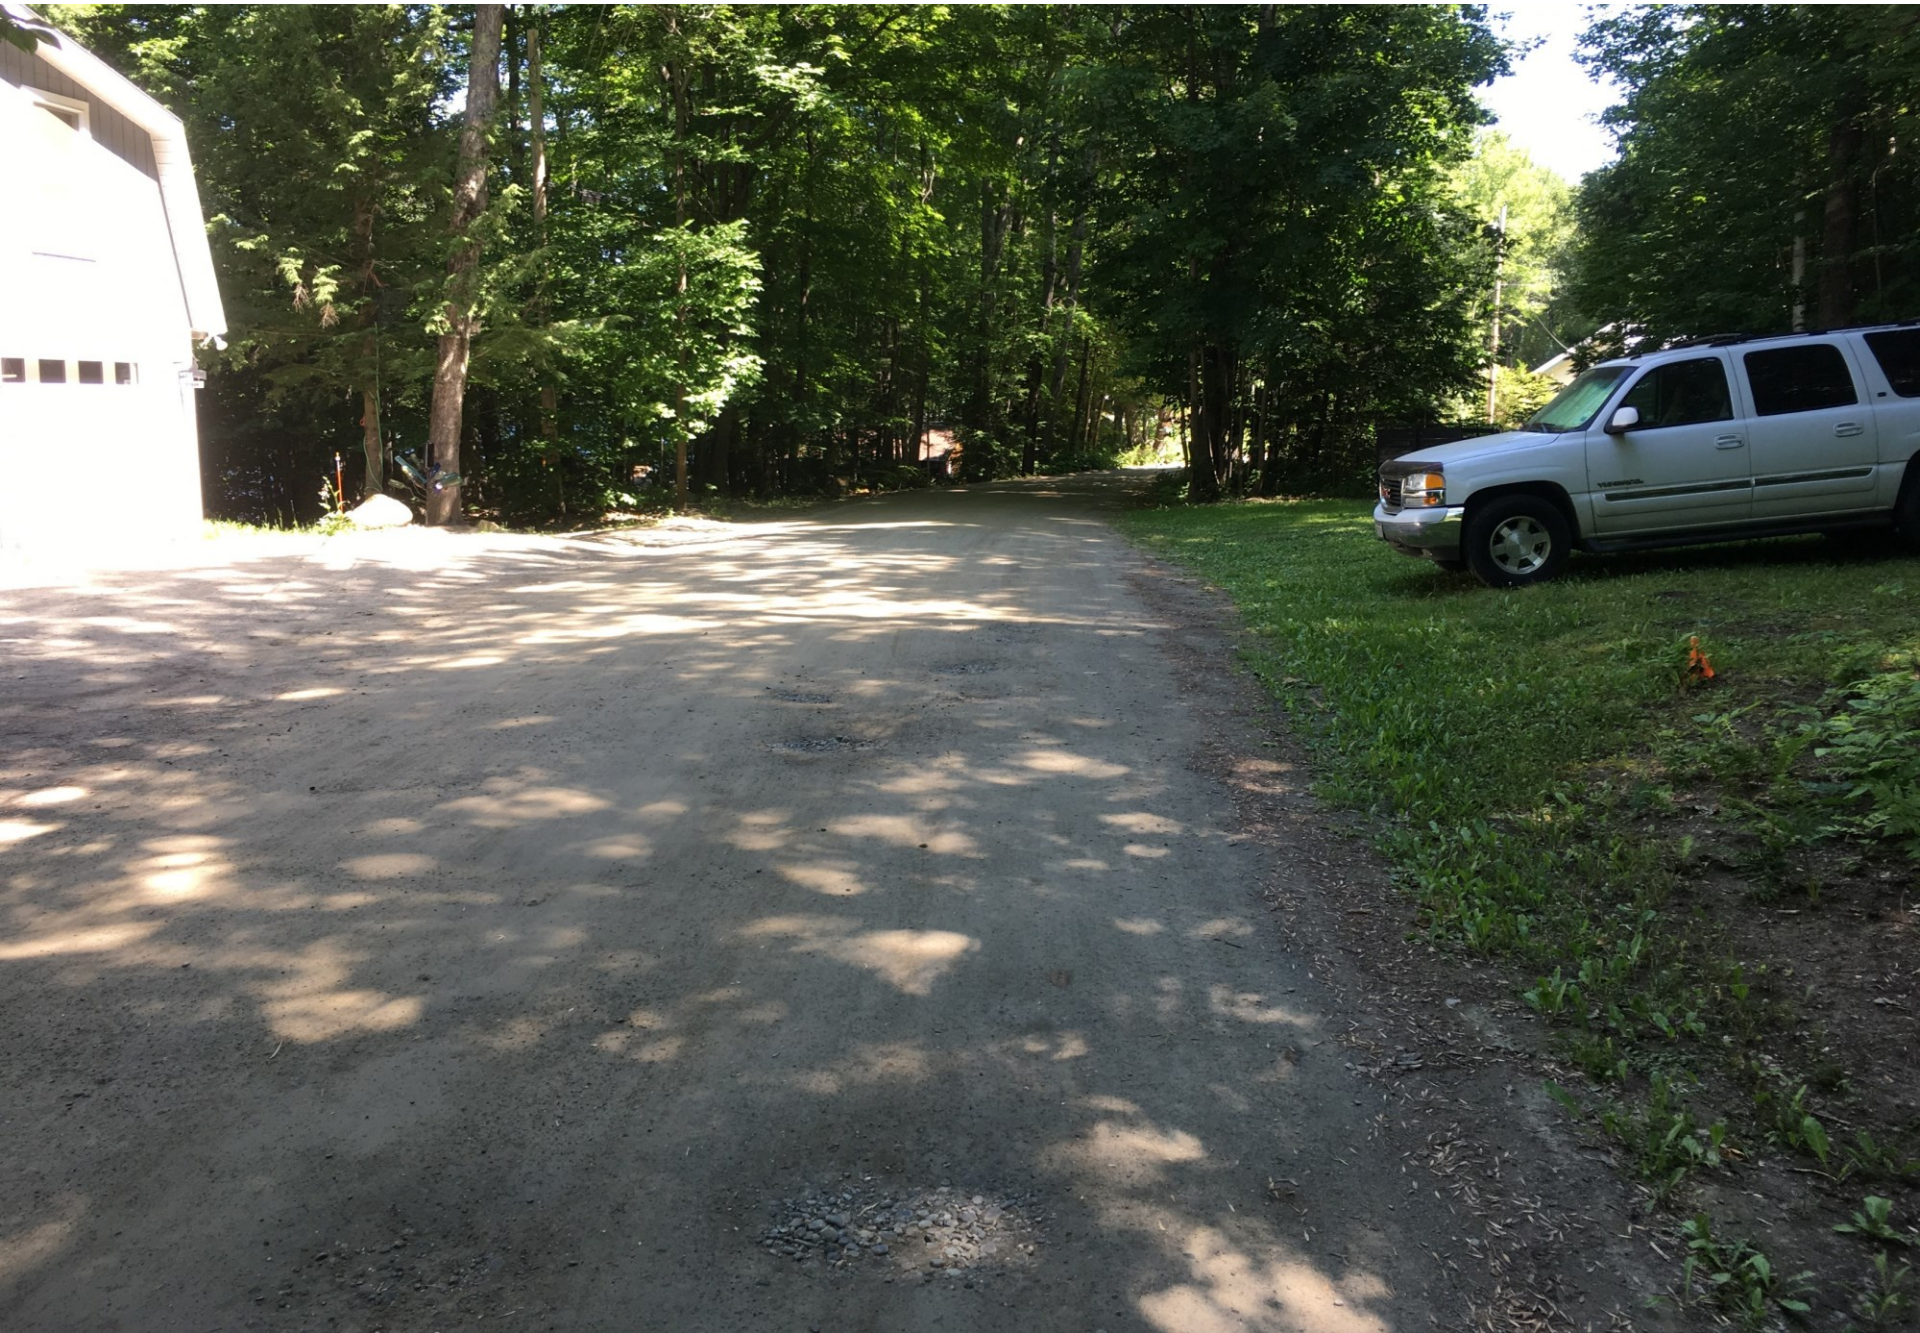
# Flat Surface: Potholes

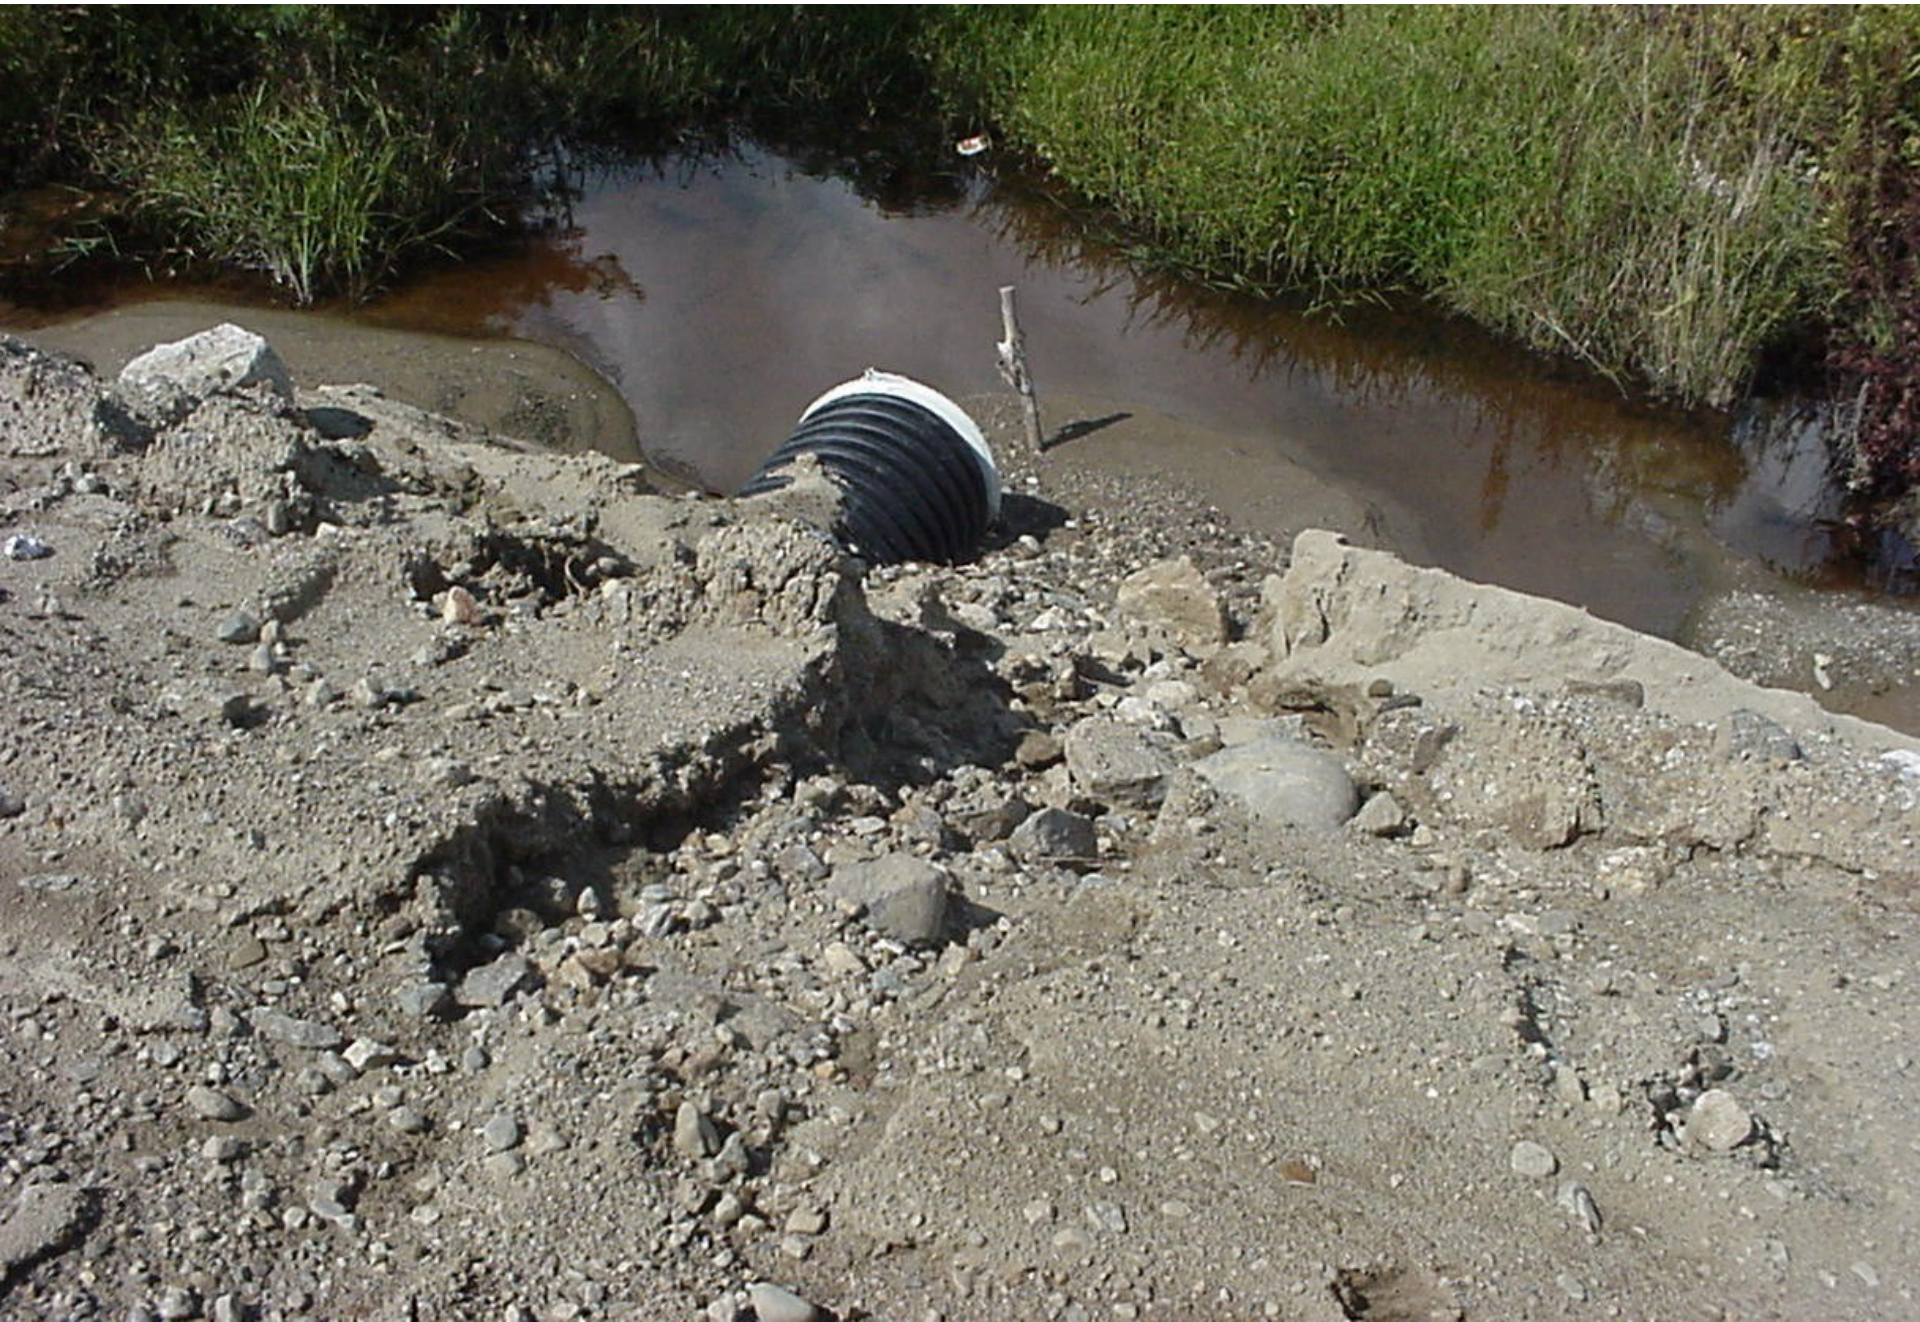
# Culvert: Unstable inlet/outlet

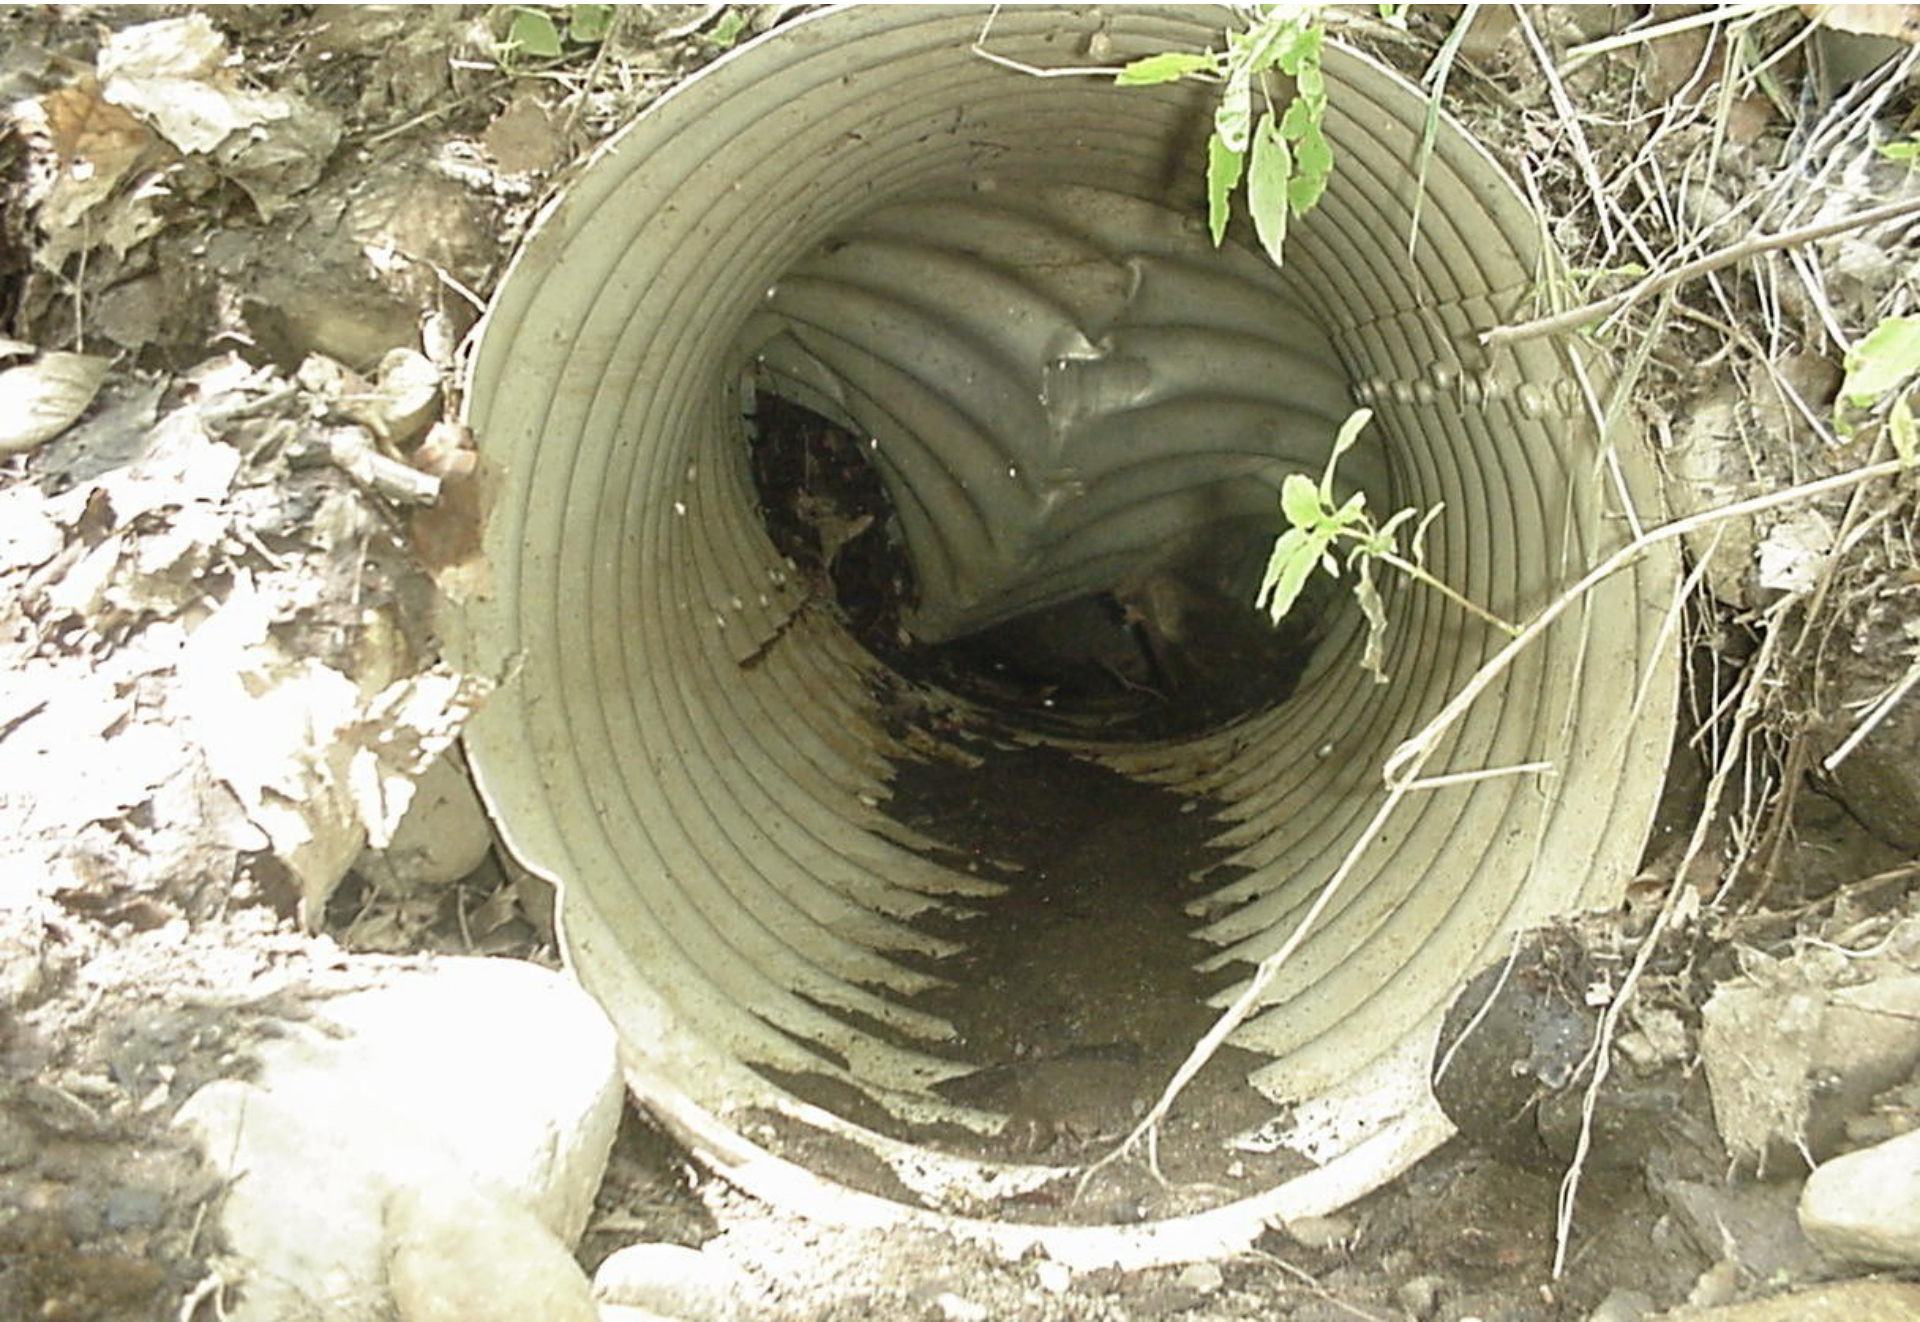
# Culvert: Crushed

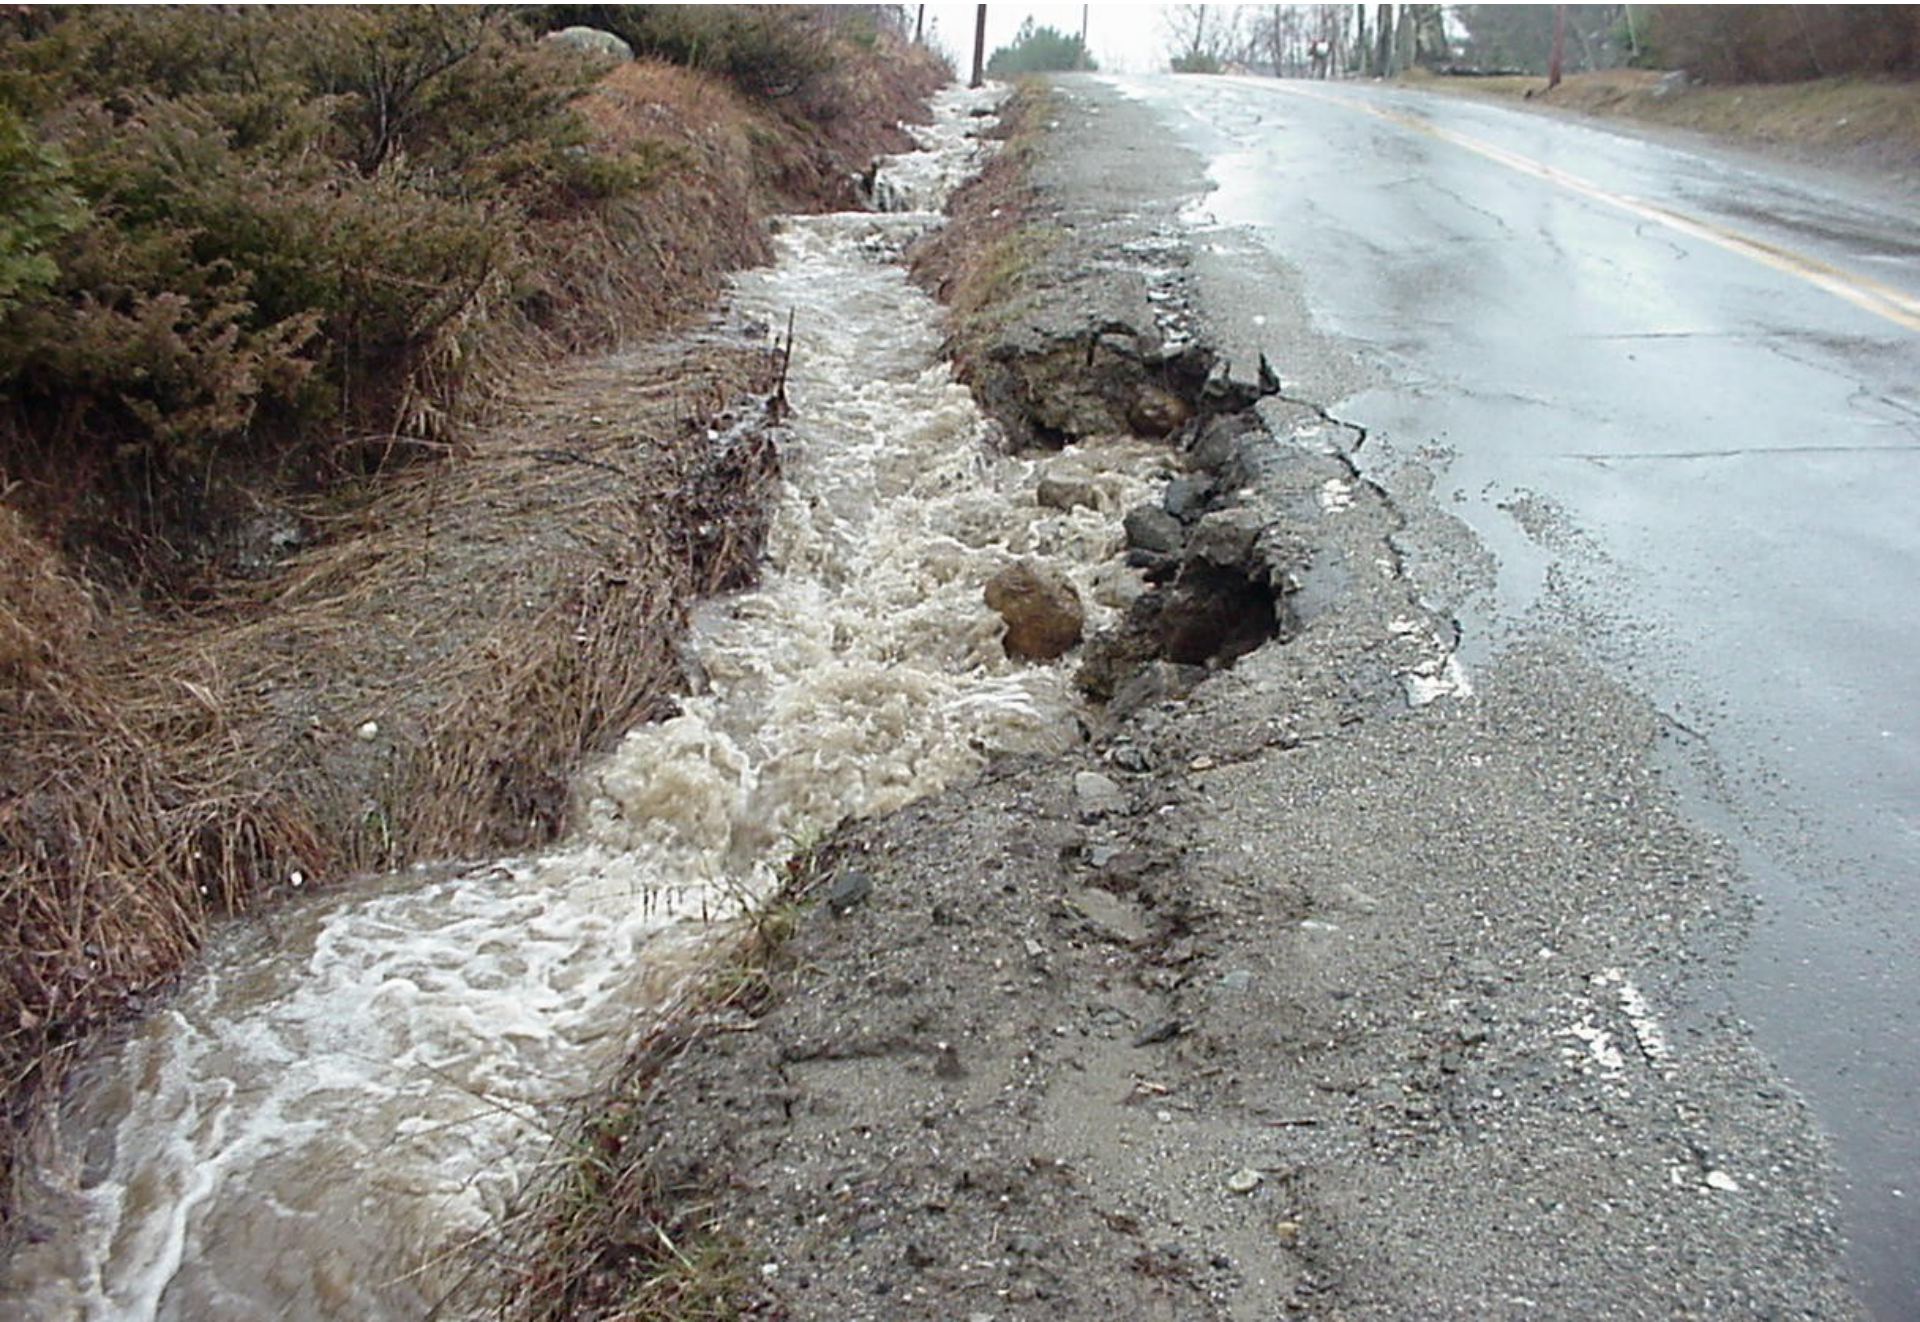
# Ditch: Severe Erosion

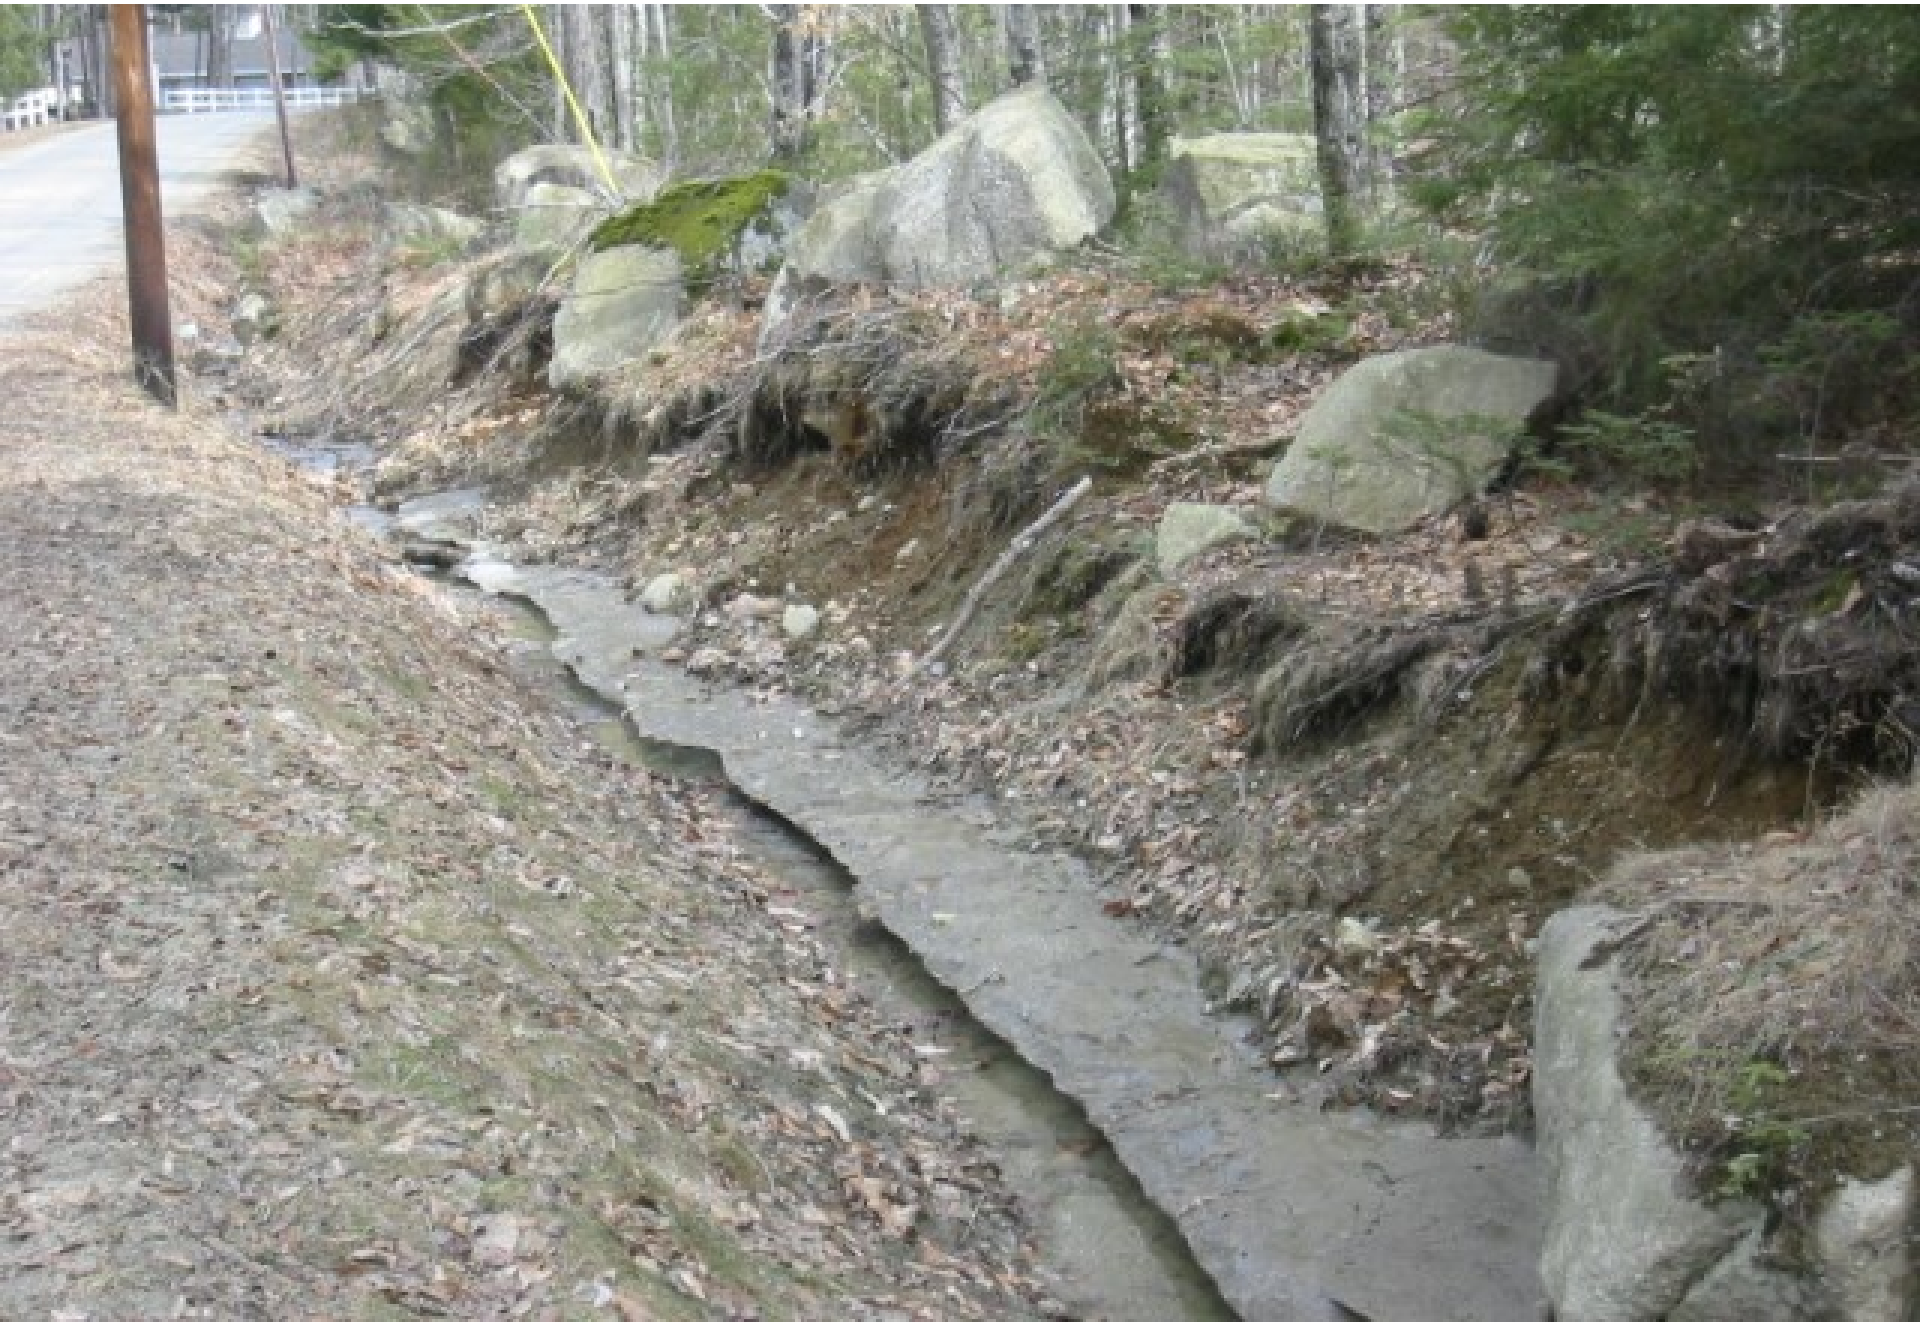
# Ditch: Bank Failure

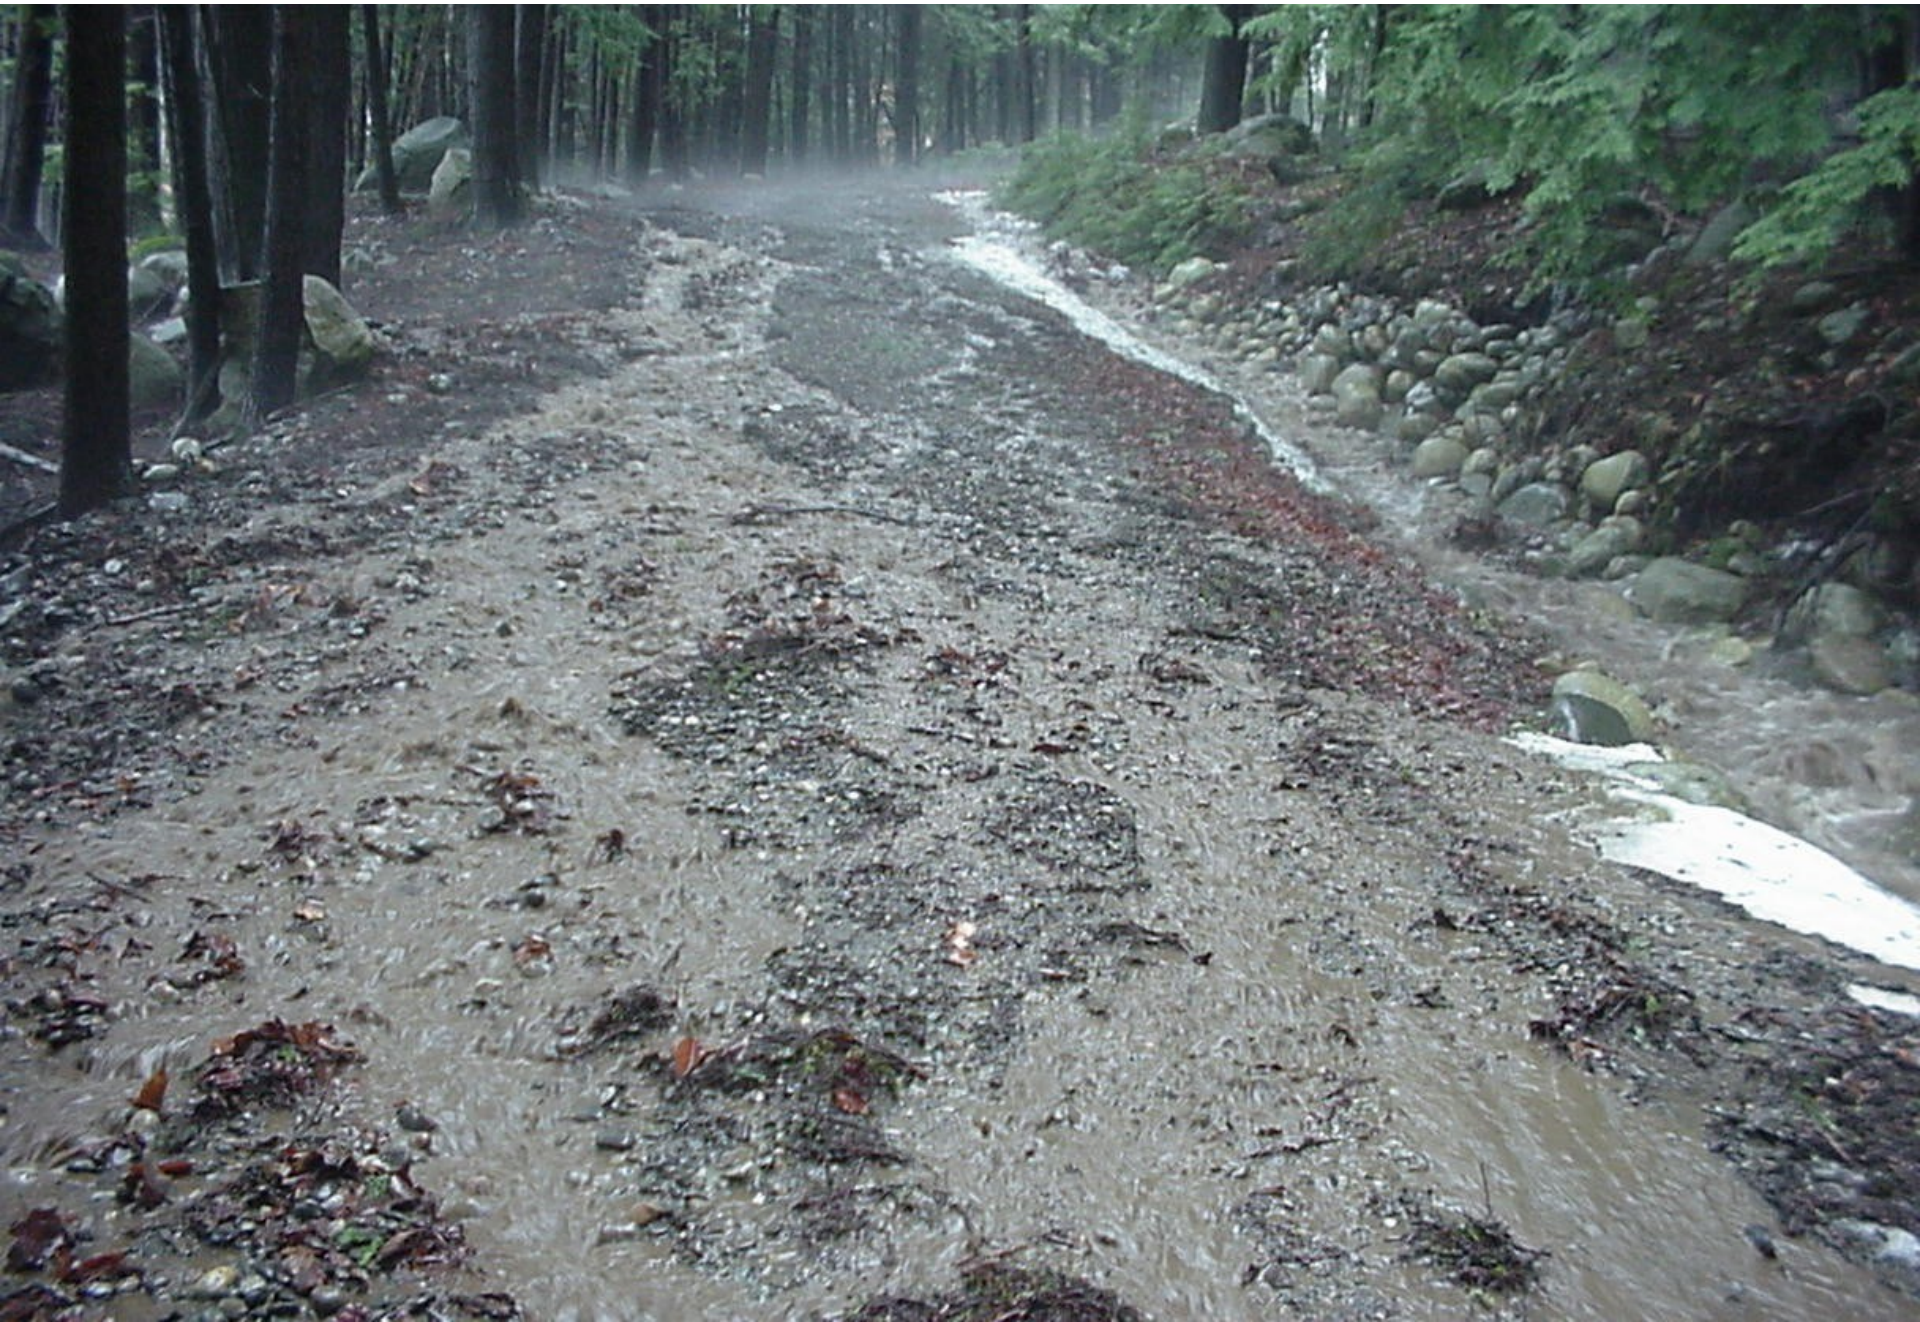
# Road Surface: Severe Erosion

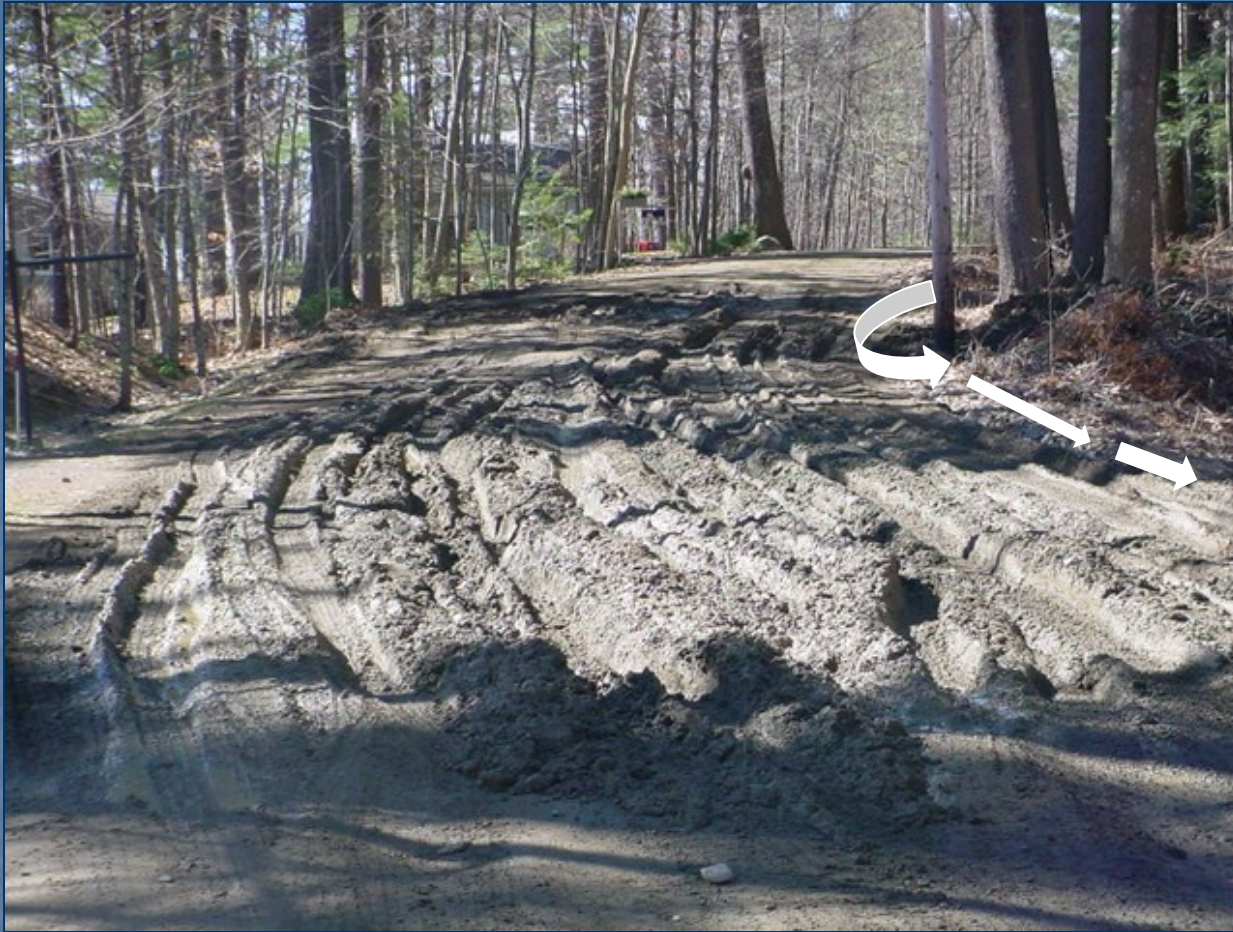
## Young Road - Site # 1

**Site # 1:** 140' section between driveway #87 & Pole #23 .

**Issue:** Water not reaching ditches, ground water coming up through road, lack of crown and insufficient ditching.

**Priority #: 1**

**Fix:** Box cut 140' section and install US 200 woven filter fabric, 1' of 3" minus base gravel compacted in 6" lifts and 6" of 1" minus surface gravel with 7-12% fines. Road surface should be shaped and compacted to a 1/2" per foot crown.

Install 85' of ditching on west side of road between poles #21 & #23 & tie into existing ditch to the north. Stabilize ditch with seed and hay.

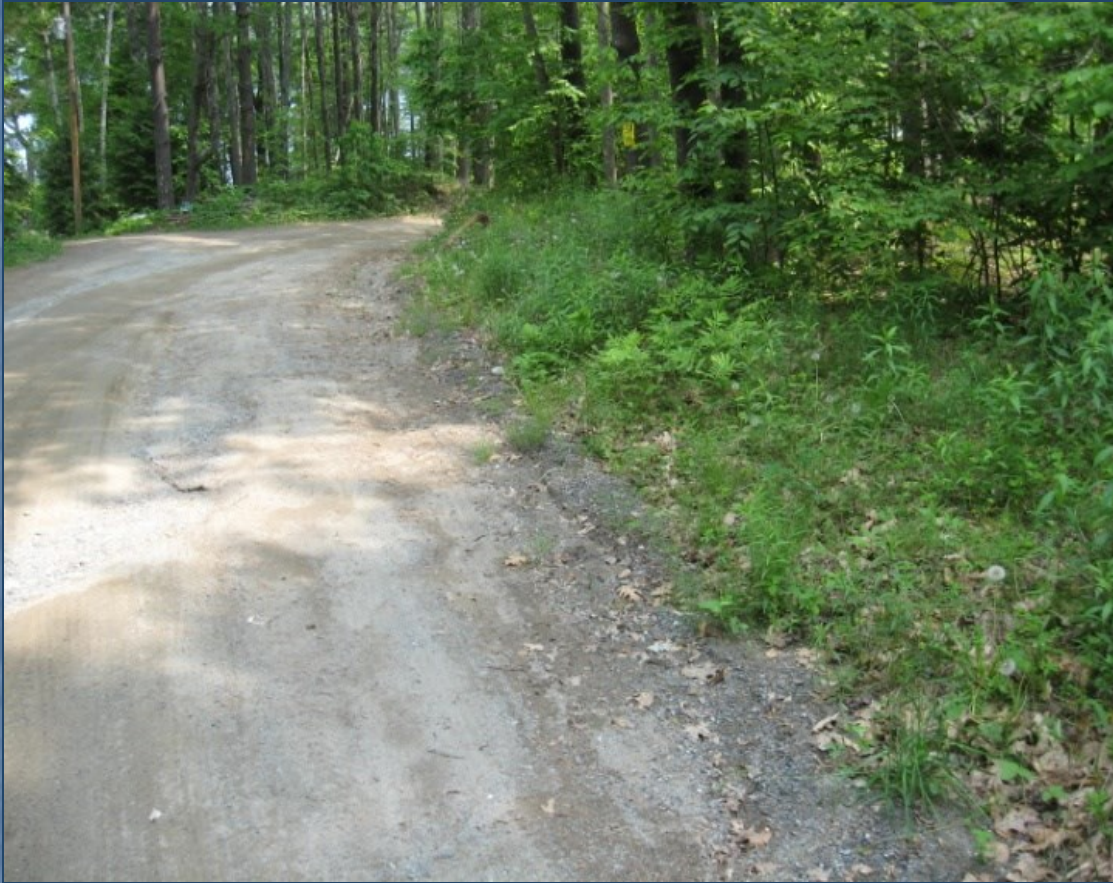
## Cedar Point Road – Site # 4

**Site # 4:** 300' section from turnout at the bottom of site #3, around corner to Camp sign.

**Issue:** Lack of ditching, surface erosion, road material accumulation at bottom of hill.

**Priority Ranking #: 2**

**Fix:** Install ditch on east side of road (Approx 230') where water cannot get to woods and stabilize with 6" angular rock. (ditching this section will be a challenge due to site conditions)

Super-elevate road surface (approx 300') to east & direct water into new ditch that will end in a turnout at the bottom of the hill.
