# Gravel Road Management Planning – Solutions for Associations

# Gravel Road Management Planning With MES

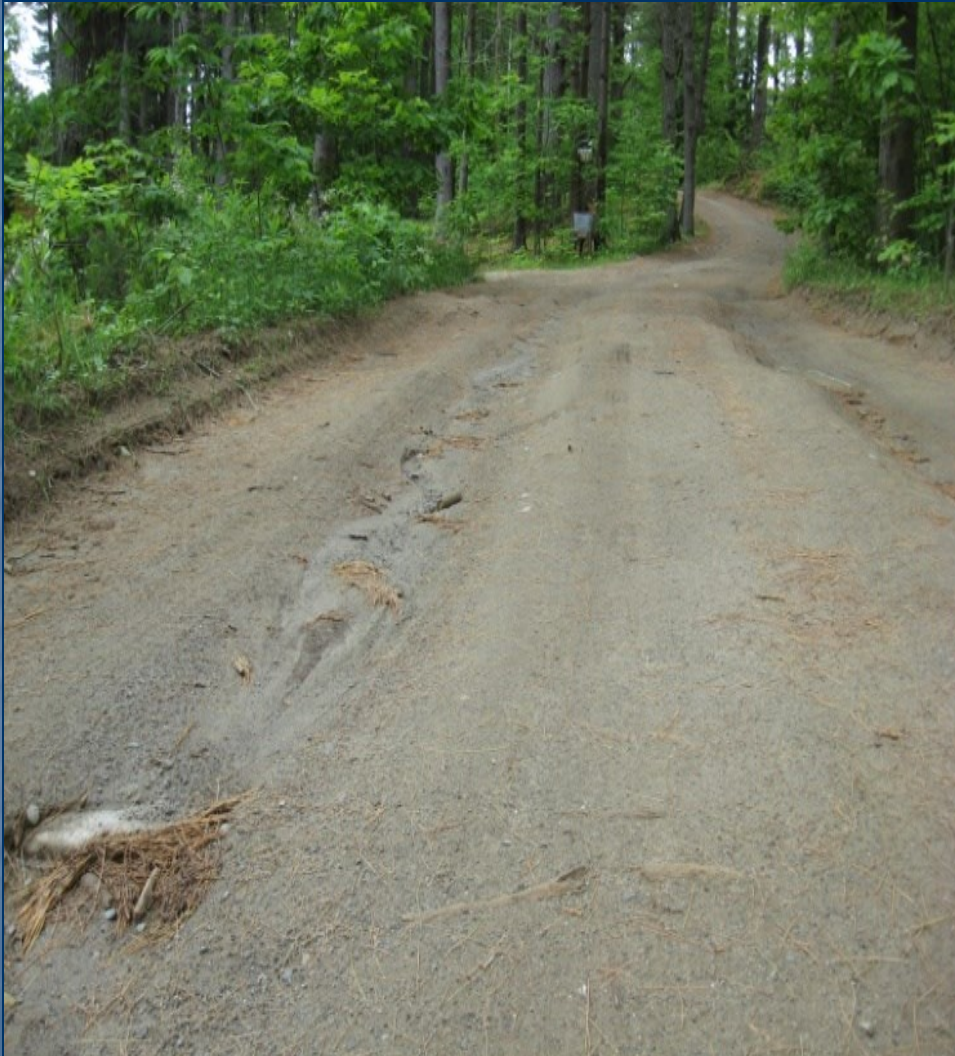
## Pine Point – Site # 5

**Site # 9:** From Pole #88 to Pole #91 for a distance of 630'

**Issue:** Road is lower than surrounding grade. Surface erosion is occurring and there is no way to get water off road surface.

**Priority Ranking #: 3**

**Fix:** This is the most challenging section of Horse Point Road to address. To significantly improve this section would require a complete rebuild to raise road 1' above existing grade.

**Steps:** Install woven filter fabric over road surface using specs provided. Add 1' of 3" minus material compacted in 6" lifts. Install 6" (compacted depth) of 1" minus surface gravel and crown to 1/2" per foot.

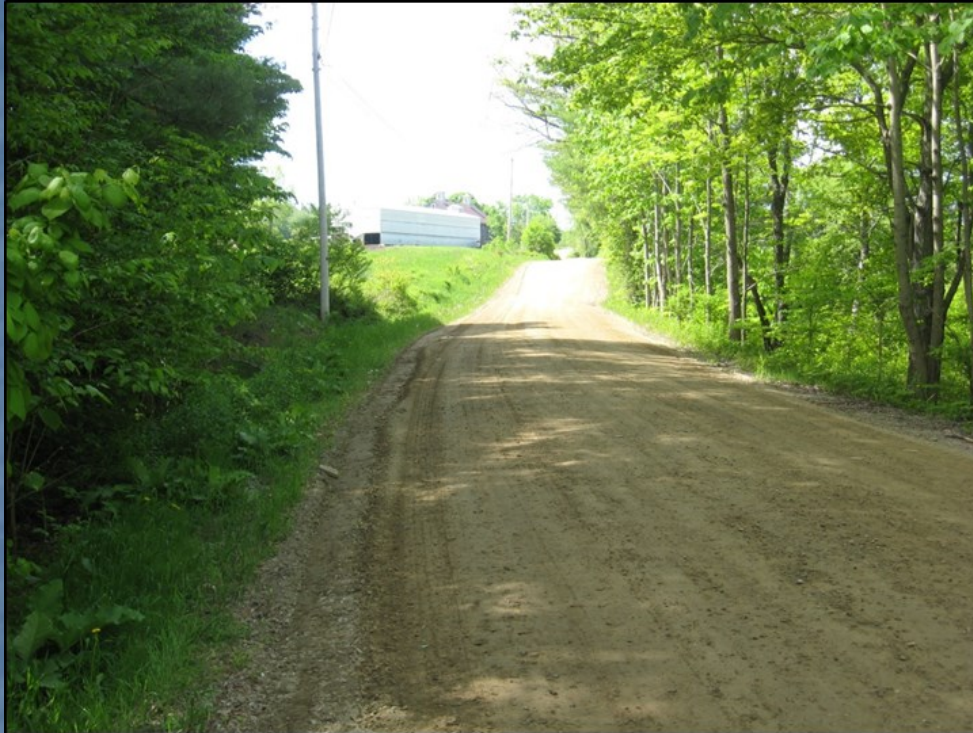
## Dondero Road – Site # 4

**Site # 4:** From end of Site #3 - 420' to south.

**Issues:** Vegetation and debris buildup in left side ditch. Ditch also needs to be reshaped and deepened.

3-6" DBH (diameter breast height) trees encroaching road surface on right

Shoulder berms are present along the sides of road.

**Priority #: 4**

**Fix:** Clean and reshape left side ditch to increase capacity and ensure uninterrupted flows toward culverts. Remove closest trees on right side of road surface growing in shoulder. Shave shoulder berms & cut in several turnouts on right where trees and topography allow. Maintain crown

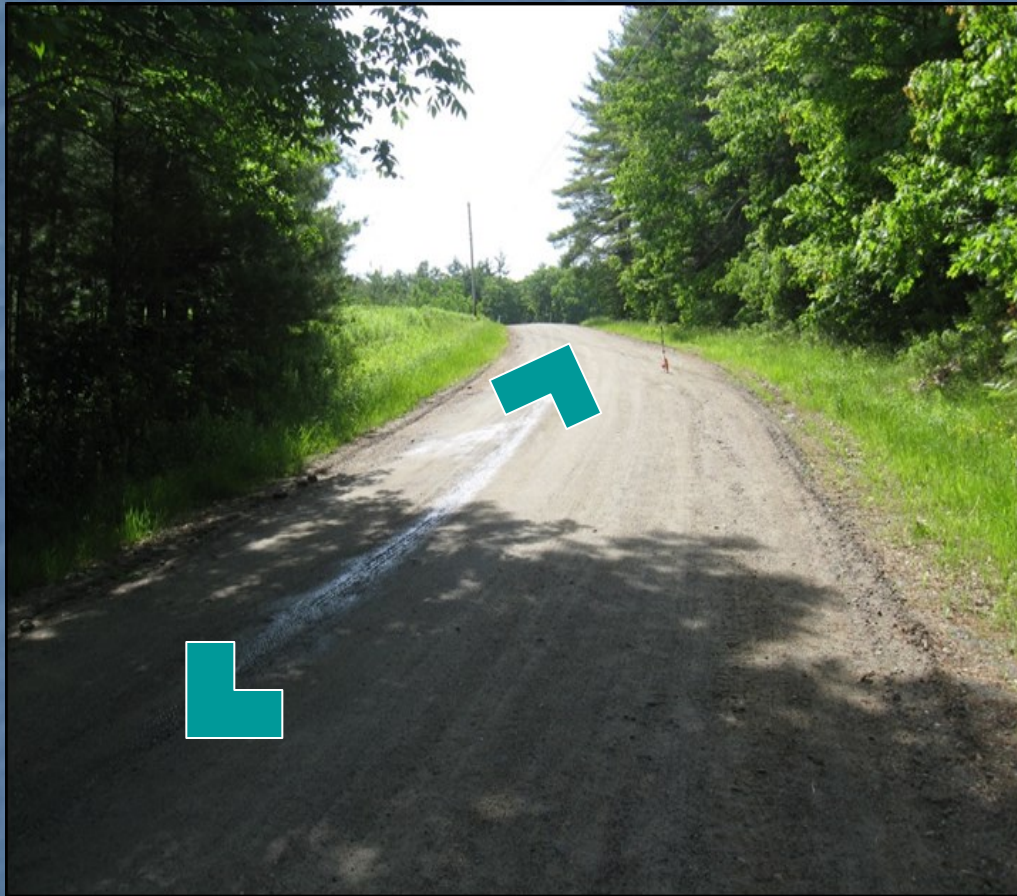
## Searls Mills Road – Site # 3

**Site # 3:** From Pole #13 – 275' to Pole #14

**Issues:** Lack of ditching and shoulder berms  
A wet spring is weeping water through the road surface causing rutting, mud and saturated conditions.  
Poor surface gravel with very high fine content and sandy

**Priority #: 1**

**Fix:** Continue right side ditch for 271' to Pole # 14 and stabilize with seed and hay.  
Box cut 75' saturated area and rebuild road. Install woven geotextile fabric and rebuild base with 1' of 3" minus base gravel rolled in 6" lifts. (Compacted depth will be approximately 6")  
Install 6" of 1" minus surface gravel (pre-compacted depth) and crown to a 1/2" per foot.
