# China Lake Association

## CHINA LAKE WATERSHED SURVEY 2000

**PRELIMINARY RESULT**  
**SHORE FRONT SURVEY**  
**STREAM AND TRIBUTARY SURVEY**

## SHORE FRONT SURVEY EAST BASIN 2000

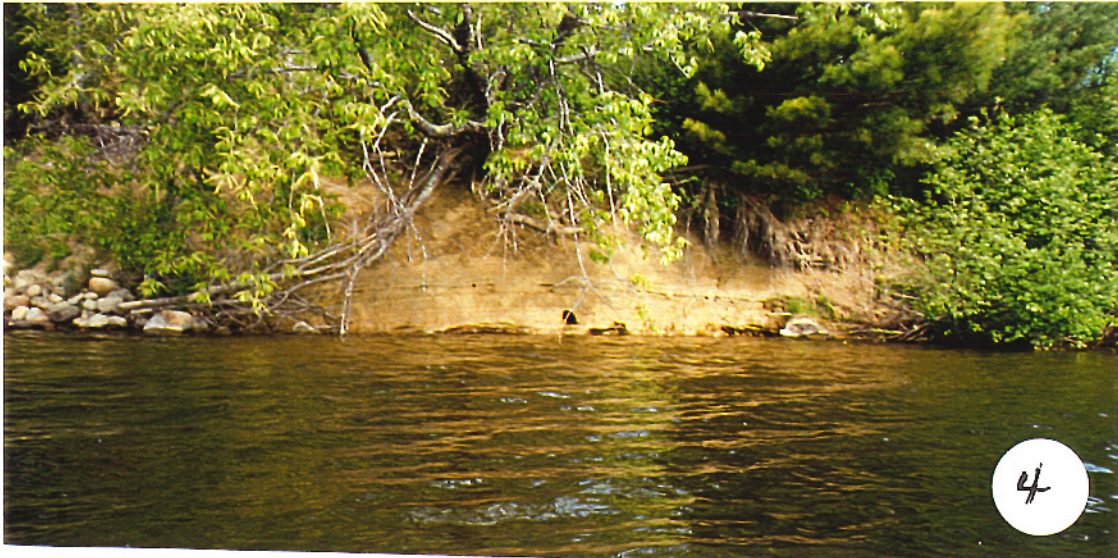
S.W +4

THREE SITES IN WENTWORTH COVE ON THE PROPERTY OF THE BAPTIST CHURCH CAMP. THE TWO SHORE FRONT SITES ARE HIGH PRIORITY WITH ONGOING LOSS AT CURRENT WATER LEVELS. ABOUT 75 FEET OF SHORE NEED RIPRAPPED. THE OFF SHORE SITE IS AN ERODING AREA IMMEDIATELY AT THE TOP OF THE BANK AND IS MARKED BY A YELLOW RIBBON. THE DANGEROUS BRANCHES FROM THE ICE STORM ARE GONE. ROCK IS ON SITE BUT MAY BE INSUFFICIENT FOR THE PROJECT.

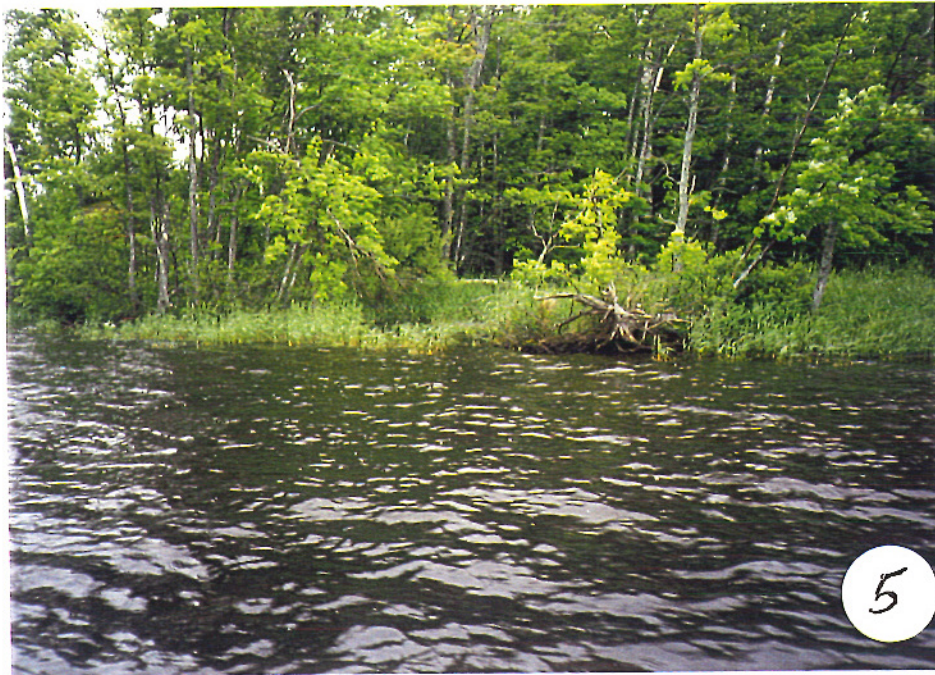
**6/9/00 S.W.+4**

Point of land extending back into Wentworth Cove has been eroding for a number of years with wave action washing over vegetation at current water levels. Much of what was land (120 square feet) has lost most of soil and is a small rock base now. Access difficult, Low Priority

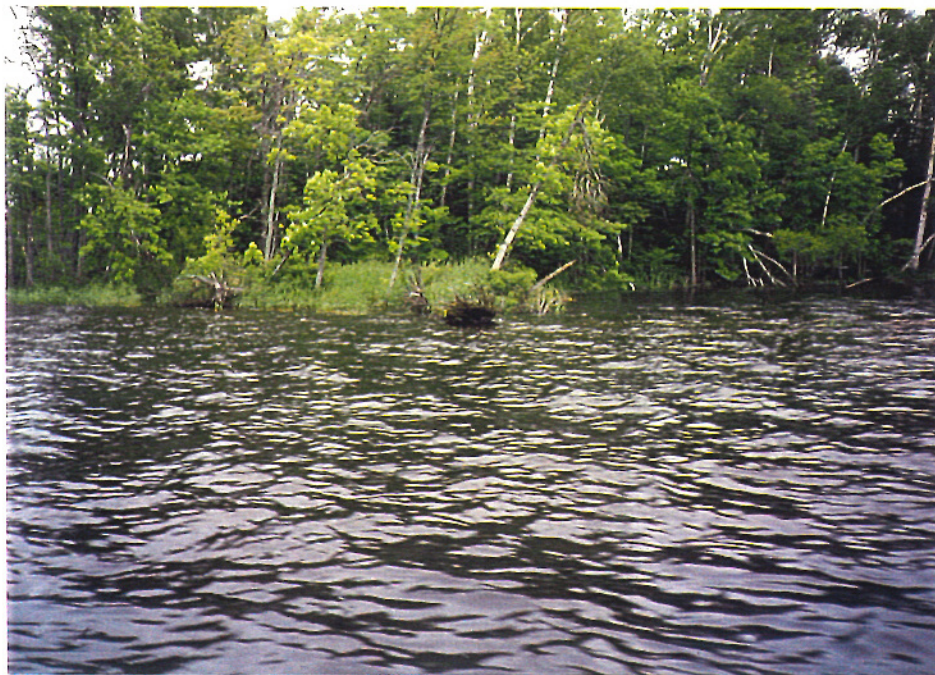
6/8/00 S.W. +3

THE FOLLOWING SITES ARE ALONG FIRE ROAD #9 ACCESS IS RELATIVELY EASY TO THE SITES.

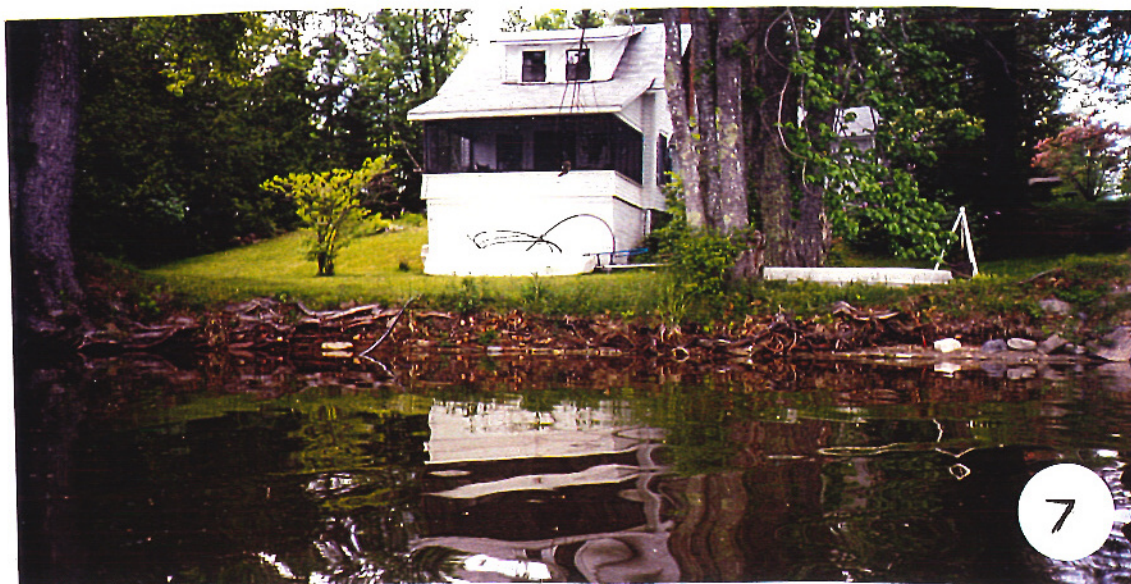
ALICE KING F.R. 9 75 FEET MODERATED PRIORITY. INFORMATION SHEET LEFT AT CAMP NEIGHBORS WILL TALK WITH HER

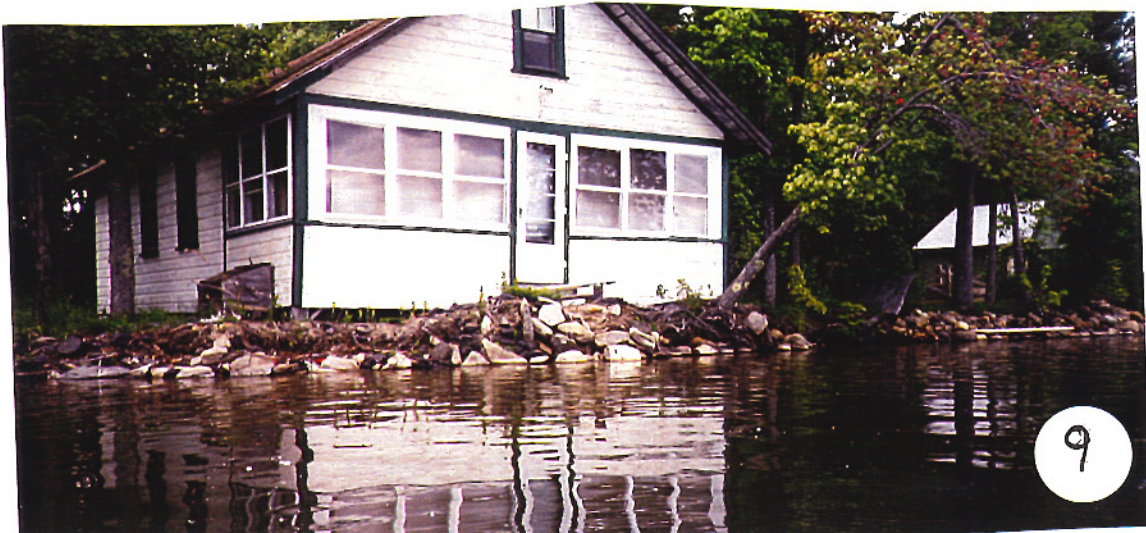
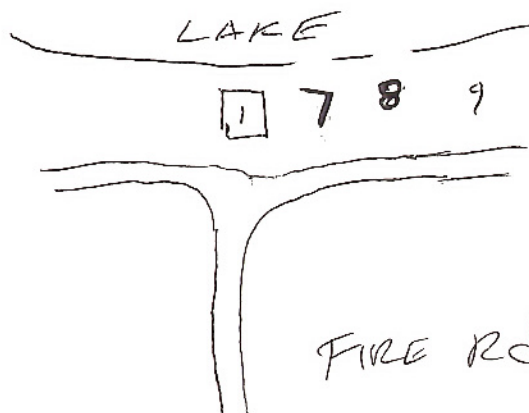
- ① - Doug Herzman to do riprap himself (no picture)
- 7 - Alice King
- 8 - Raincourt
- 9 - unknown white with green trim

SITE BELOW NEXT TO PREVIOUS 2 SITES COTTAGE ALMOST FALLING IN LAKE. THIS IS AN AREA OF ICE DAMAGE. FLYER LEFT. SEE MAP OF SITES.

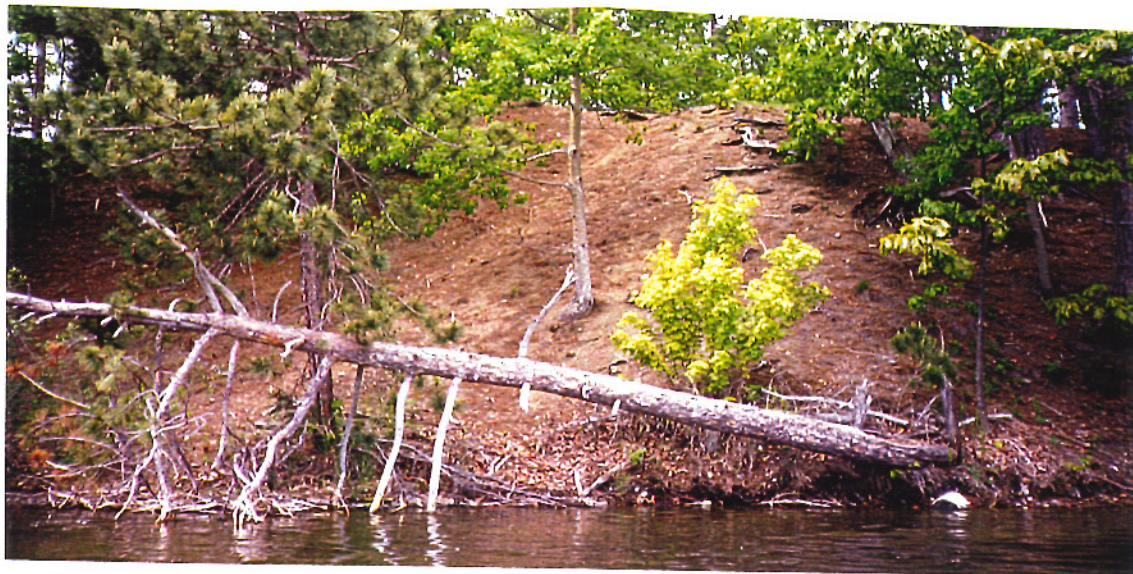
ERODING HILLSIDE SAME AREA, SAME OWNER 25 FEET HIGH AND 50 FEET ACROSS AT BASE NEED REVEGETATED IF POSSIBLE. **PRIORITY ?**

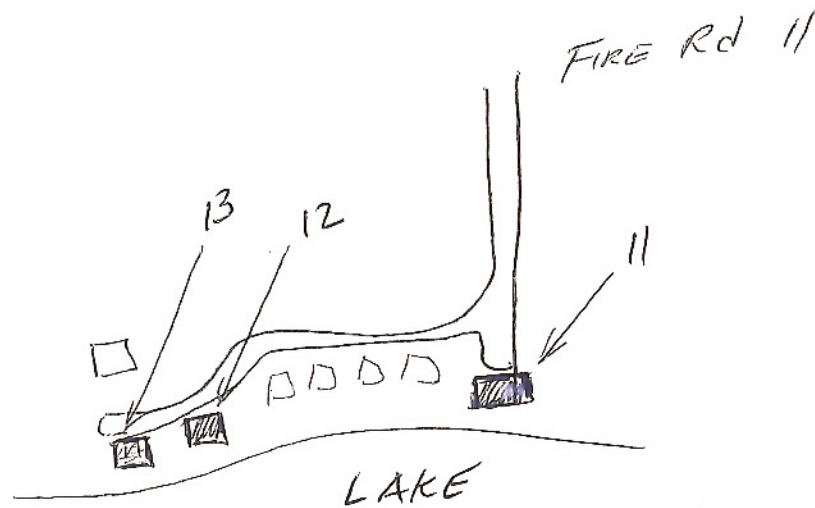
6/9/00 S.W. +4

Last camp on F.R. 11 owned by Roy Dowe of China 40 feet badly eroded bank to maximum height of 18 inches. High Priority project but spoke to owner who has little interest. He will consider.

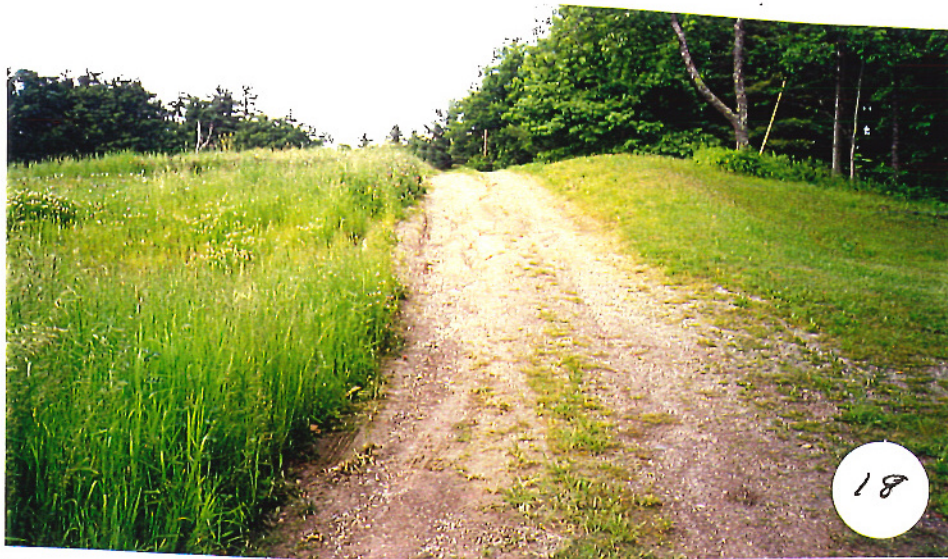
**6/9/00 S.W. +4**

Eroding ground around Tedstone camp on FR # 18 heavy foot traffic, steep slope. Medium-low priority.

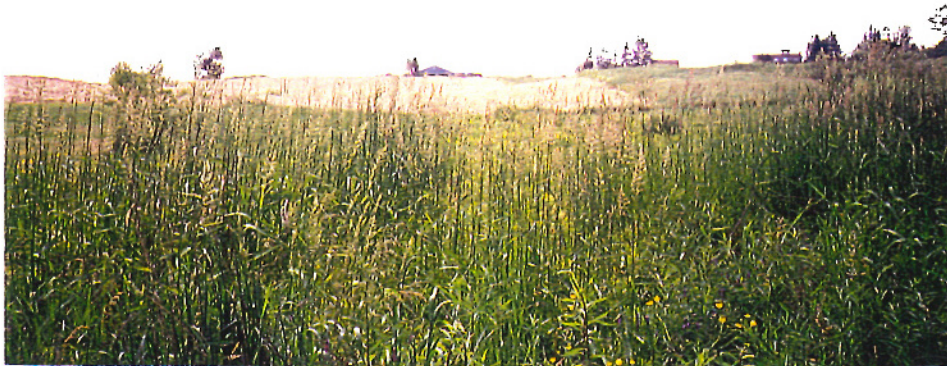
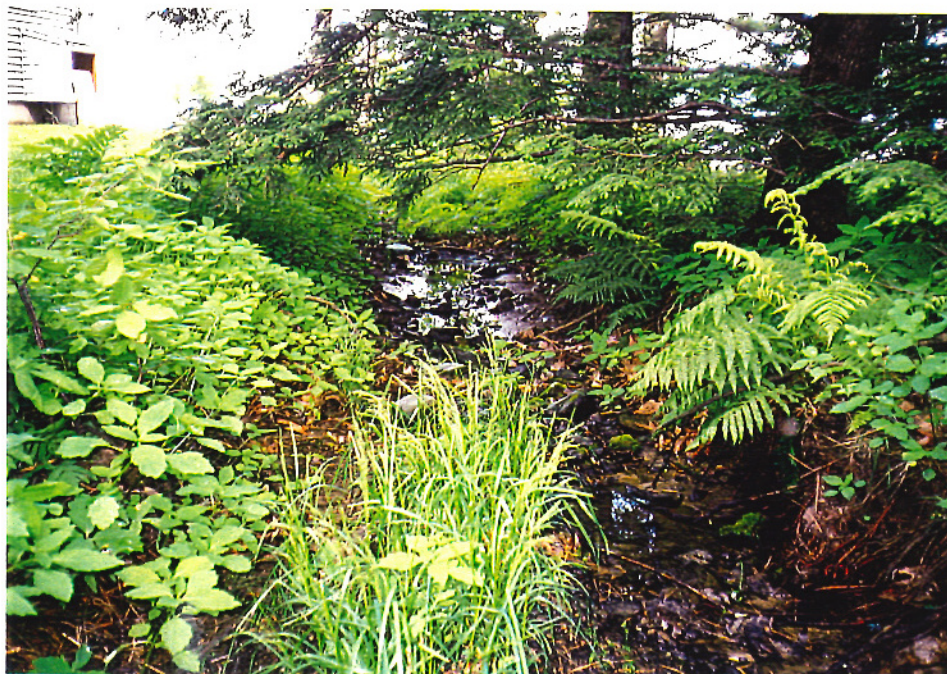
6/22/00 S.W. +5

These 3 photos show the south end of Fire Road 18 where resident Mike Ledger (207-785-3256) reports heavy silt laden runoff onto the ice in Spring. The runoff is from 2 sources, first a well vegetated hay field about 10 acres in size, and second from the fire road itself. The water runs down a rock bottomed ditch south of the Ledger property. Fire road work is **High Priority**.

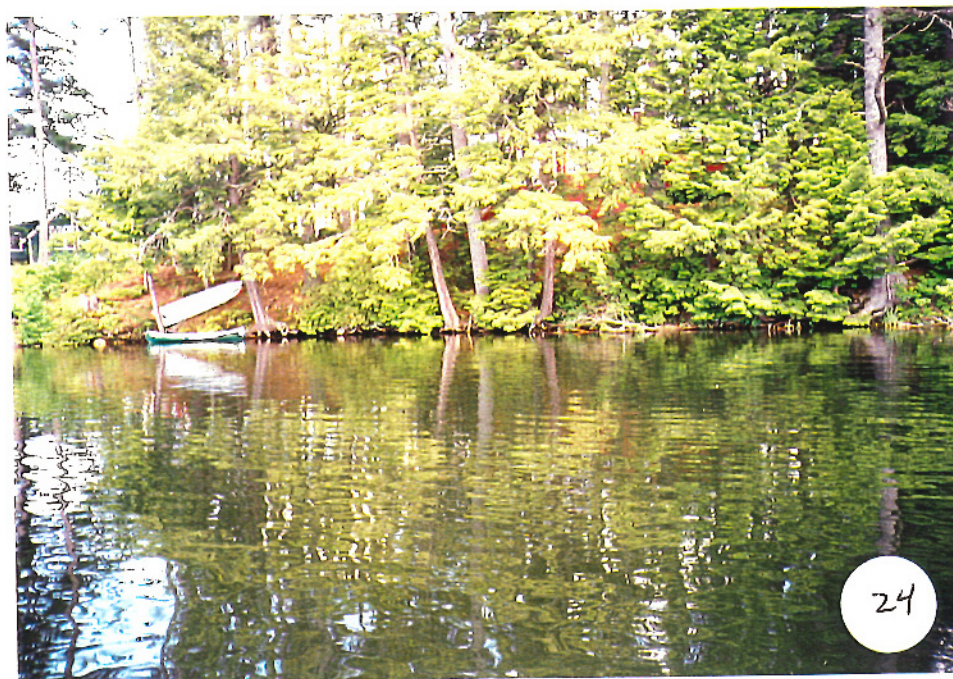
6/10/00 S.W.+3

Property of Bernard Pellerin FR #61 site of previous rip rap and revegetation now with up slope erosion fairly extensive in some places. Interested in plantings. Left info and talked with sister of owner (jackie)

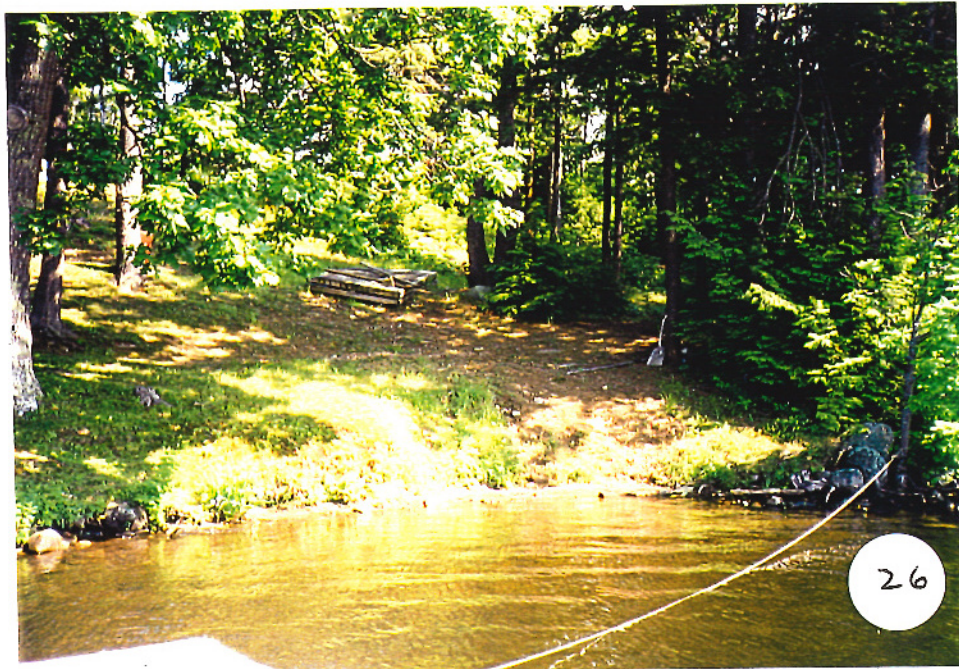
**6/22/00 S.W. +5**

South China boat landing was survey immediately after a brief thunder storm. There was significant runoff from site into the lake with obvious turbidity of the lake near the landing. High Priority.

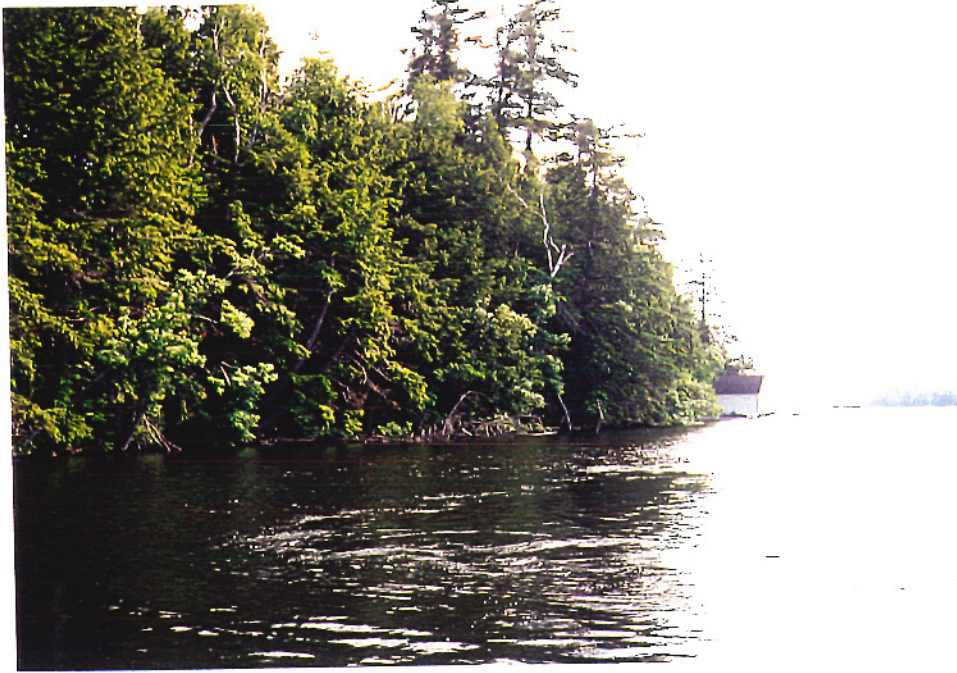
**6/22/00 S.W. +5**

This is the property of Nelson Glidden Fire Rd #57 (445-2087). There is significant upland erosion starting with the fire road and then coming down the steep bank to the lake. Some erosion along the water line. Complex set of problems with large amounts of runoff into lake give this site a High Priority.

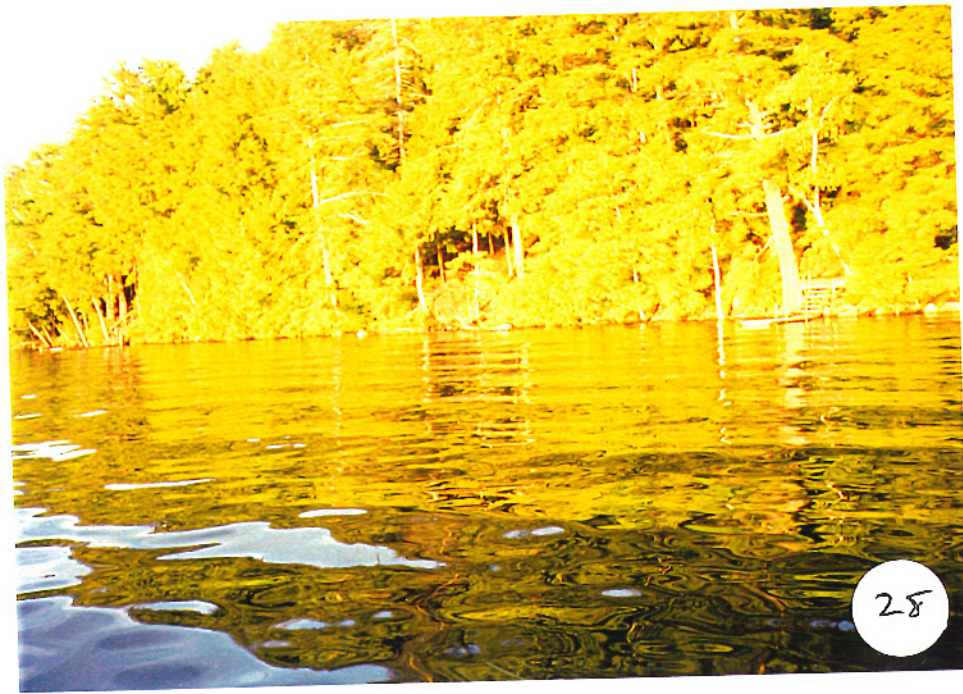
6/22/00 S.W. +5

This 2 photo set shows 600 feet of shore North of Jennings' boathouse that shows signs of past erosion with trees and roots in water but generally good rock protection of shore. Low Priority.

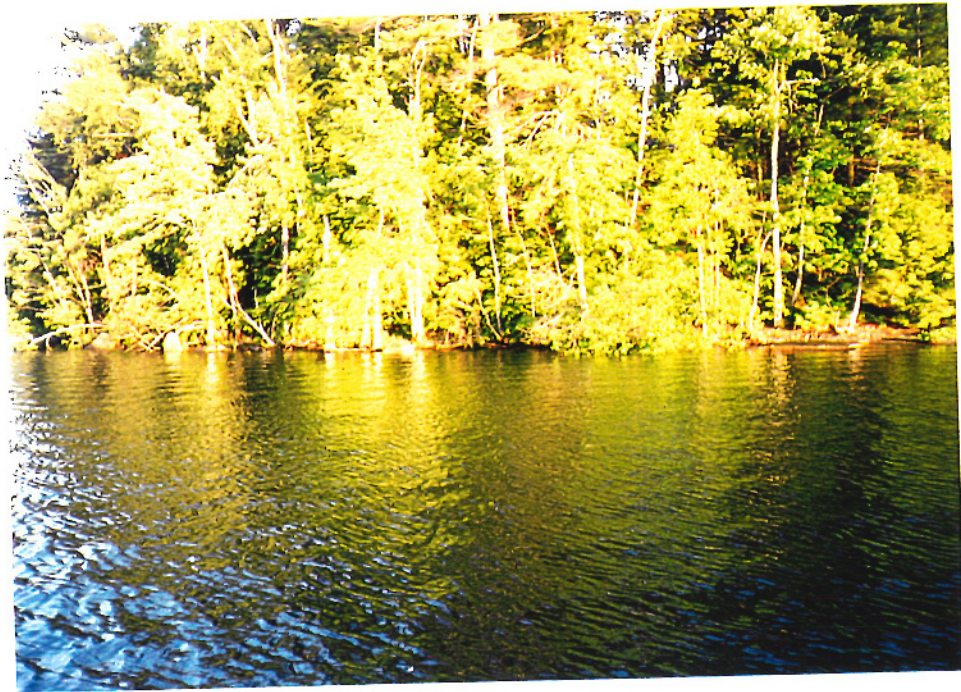
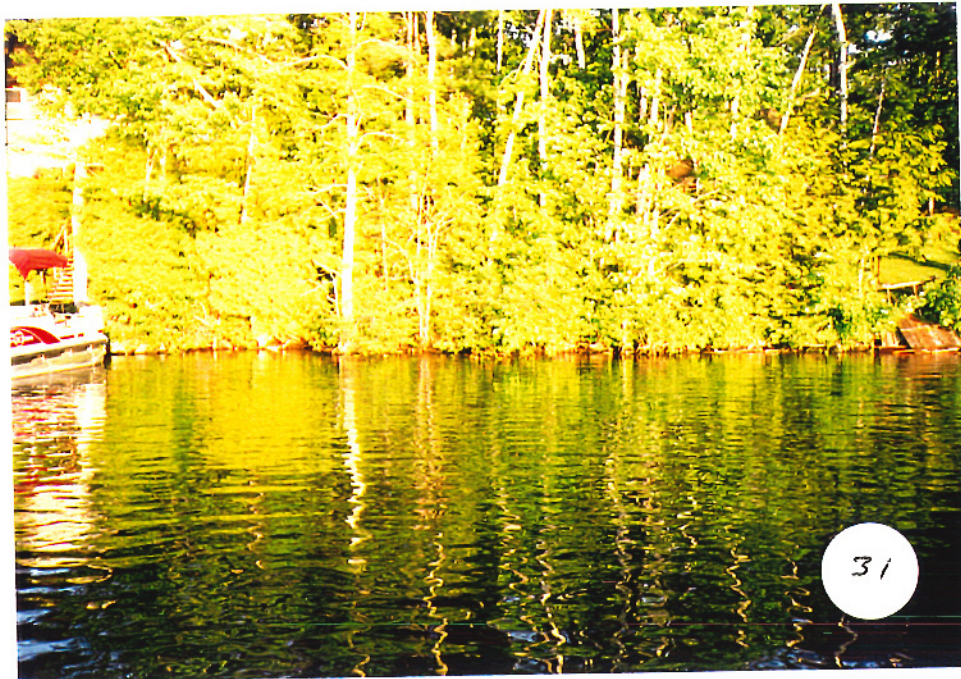
**6/18/00 S.W.+5**

This is the pine tree at the end of Killdeer Point. At current water levels and high wave action the tree is still dry. Moving around the North side of the point (lower photo) there is eroding soil amid scattered amounts of rock. This area is exposed to strong wave action. Along the point there is 300-400 feet of eroding shore but without bank collapse. Difficult access. Medium priority. Killdeer Point Association contacted.

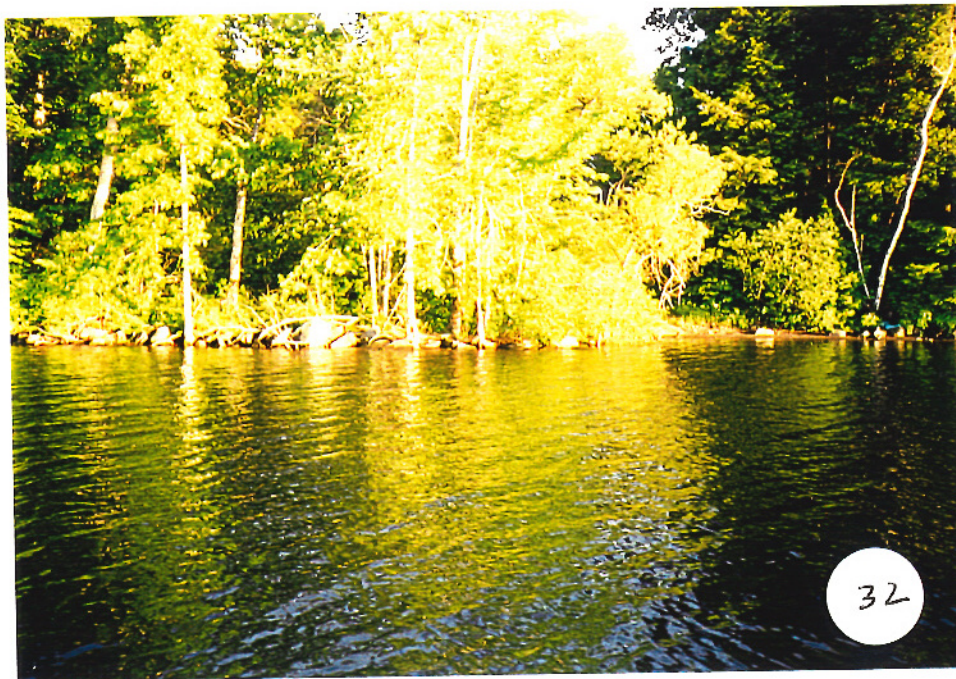
**6/18/00 S.W. +5**

On the north side of Kildeer Point this wooded section between 2 small sand beaches is exposed to significant wave action from NW winds and is eroding showing exposed roots with bank height of 8-12 inches. This section is 75 feet in length. Medium Priority.

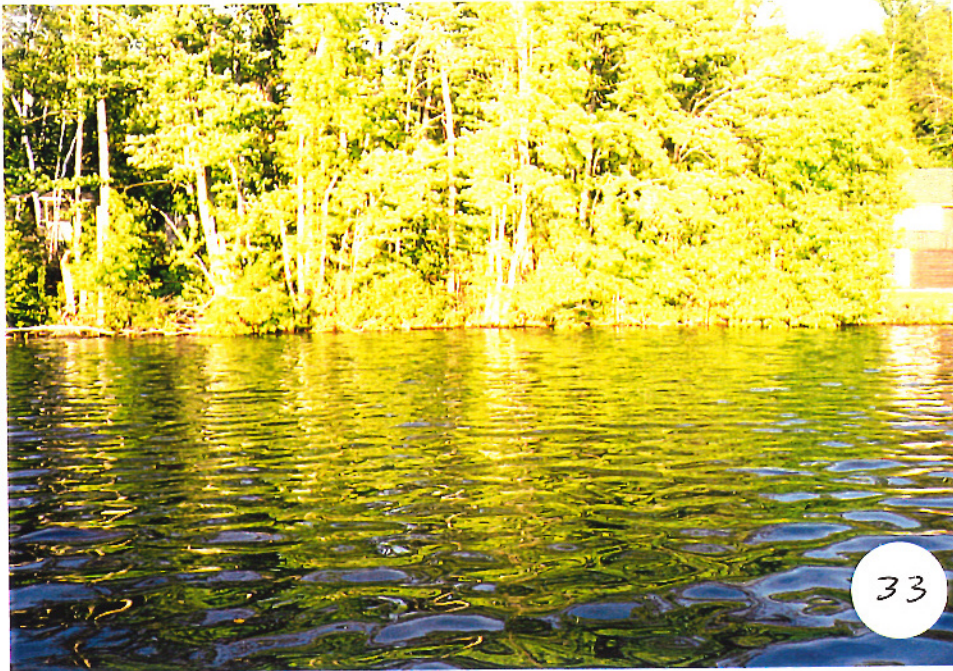
**6/18/00 S.W. +5**

Just south of Robert O'Connors 35 feet of trees in water stable soil Low Priority

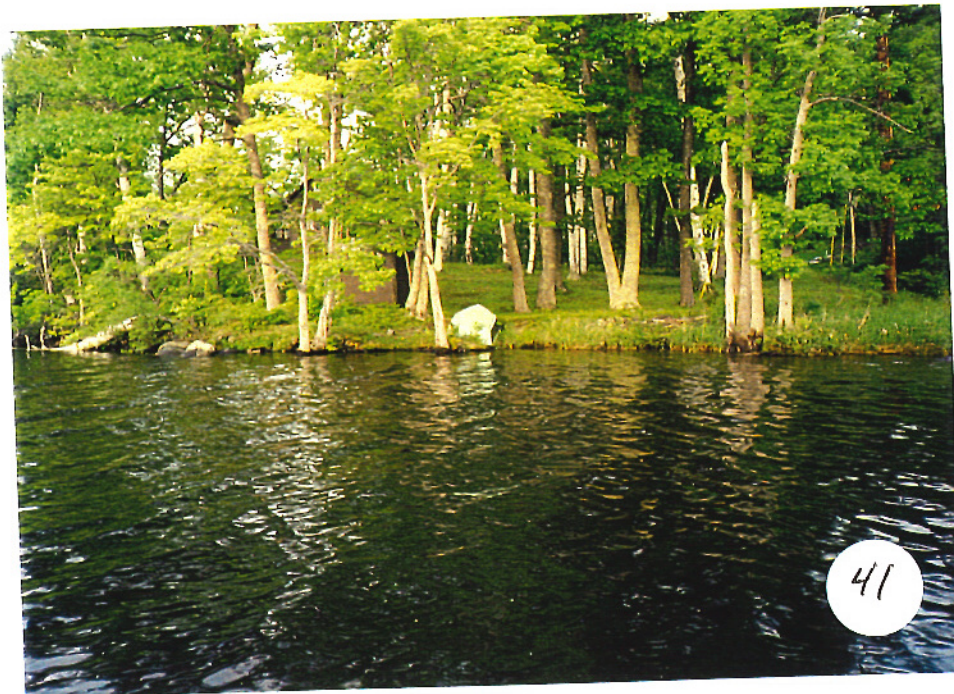
**6/10/00 S.W. +3**

On east shore across from Taconnet Island, 150 feet of previously eroded shore trees in water but with lots of rock around current bank. Does not appear to be actively eroding. Low priority

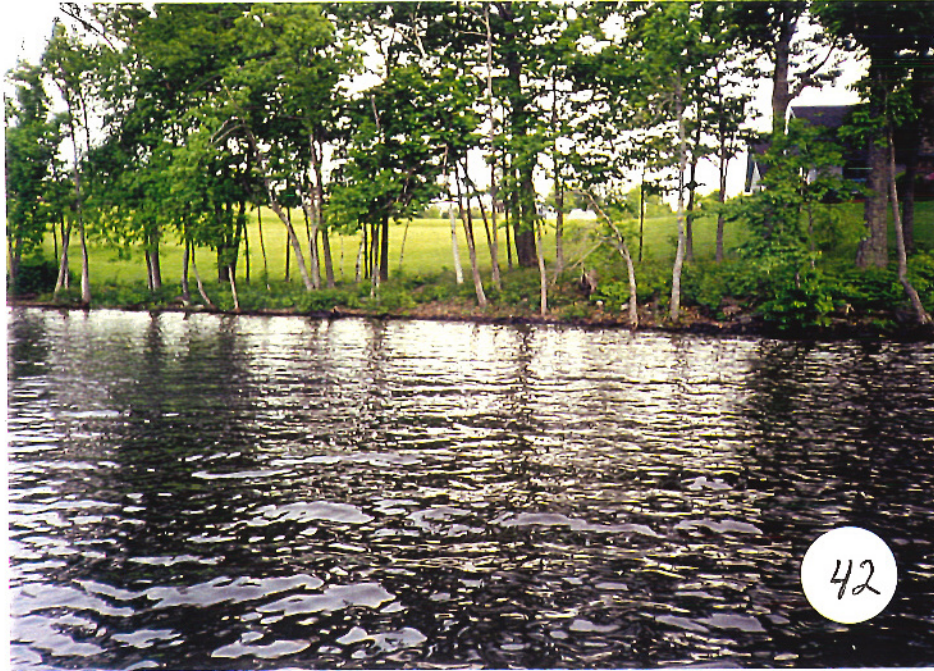
**6/10/00 S.W. +3**

Opposite from cable crossing for Taconnet Island 75 feet of exposed shore rooted, vegetated Low Priority

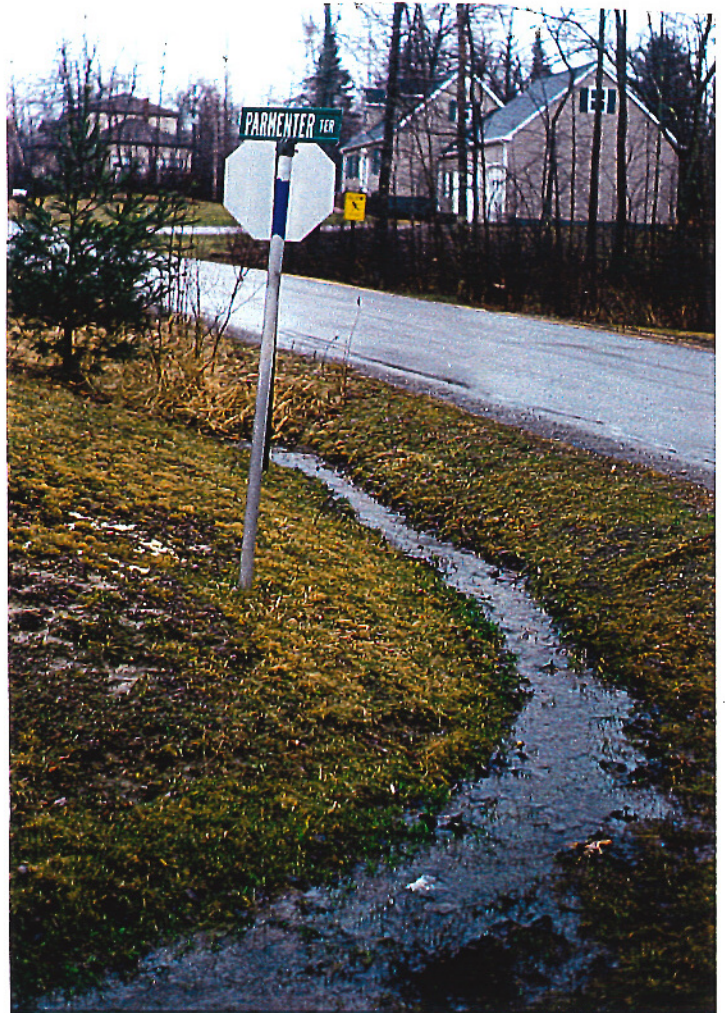
Runoff from Gagnon Property

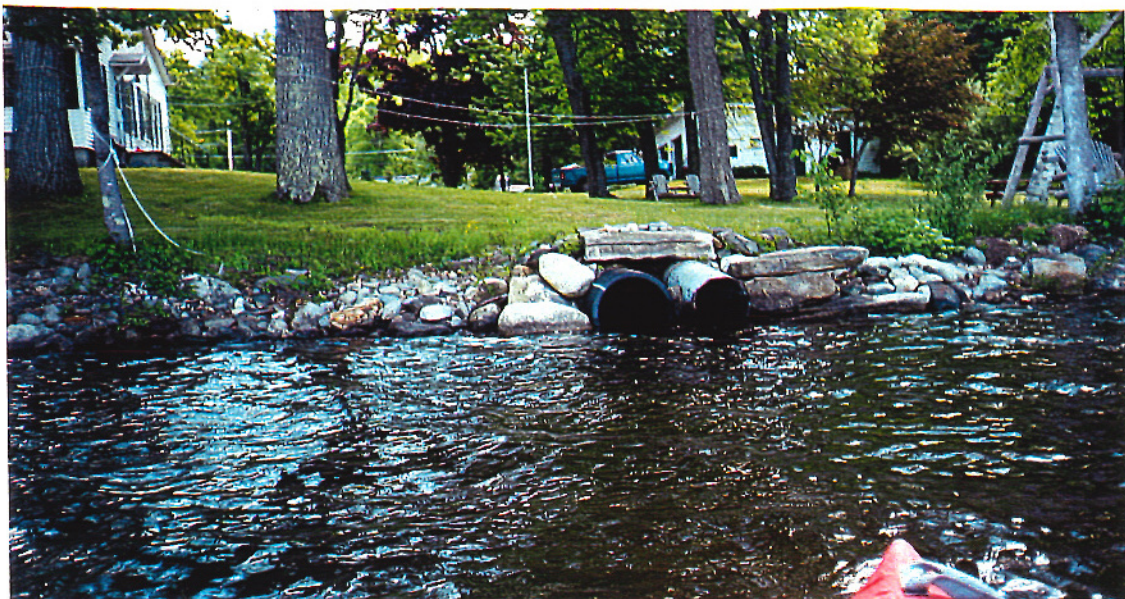
FIRE ROAD 27- Culvert crosses 202 75 yards north of Fire Road 27. Provides ditch drainage only. **Low Priority. Site M. 1 Photo**
